Re: Budget Decision on the Cafeteria Building at Camp 30

Prepared by GBCA

Goldsmith Borgal & Company Ltd Architects

3.1 CONDITION REVIEW - CAFETERIA/DINING HALL

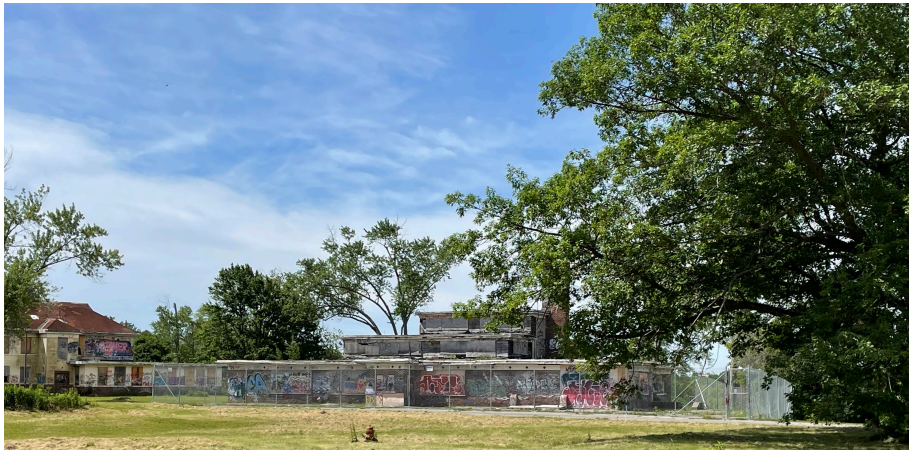
Cafeteria building, east side, July 2024

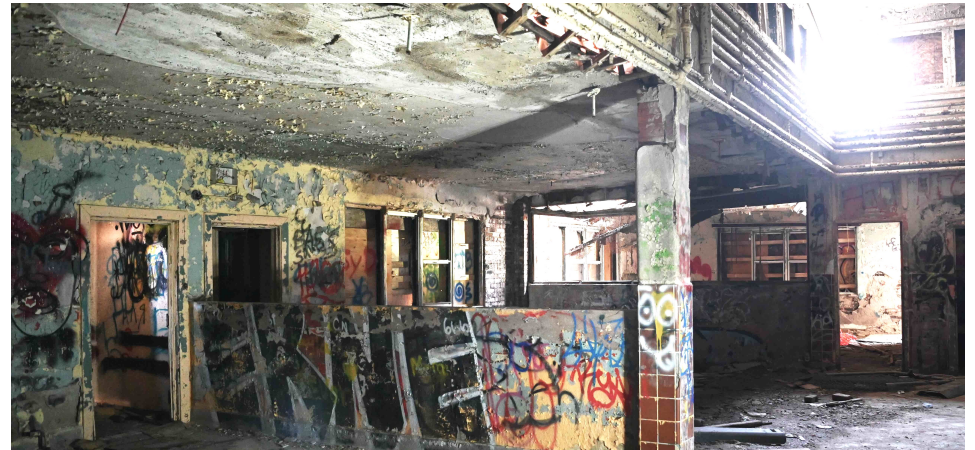
Cafeteria building, interior photograph, July 2024

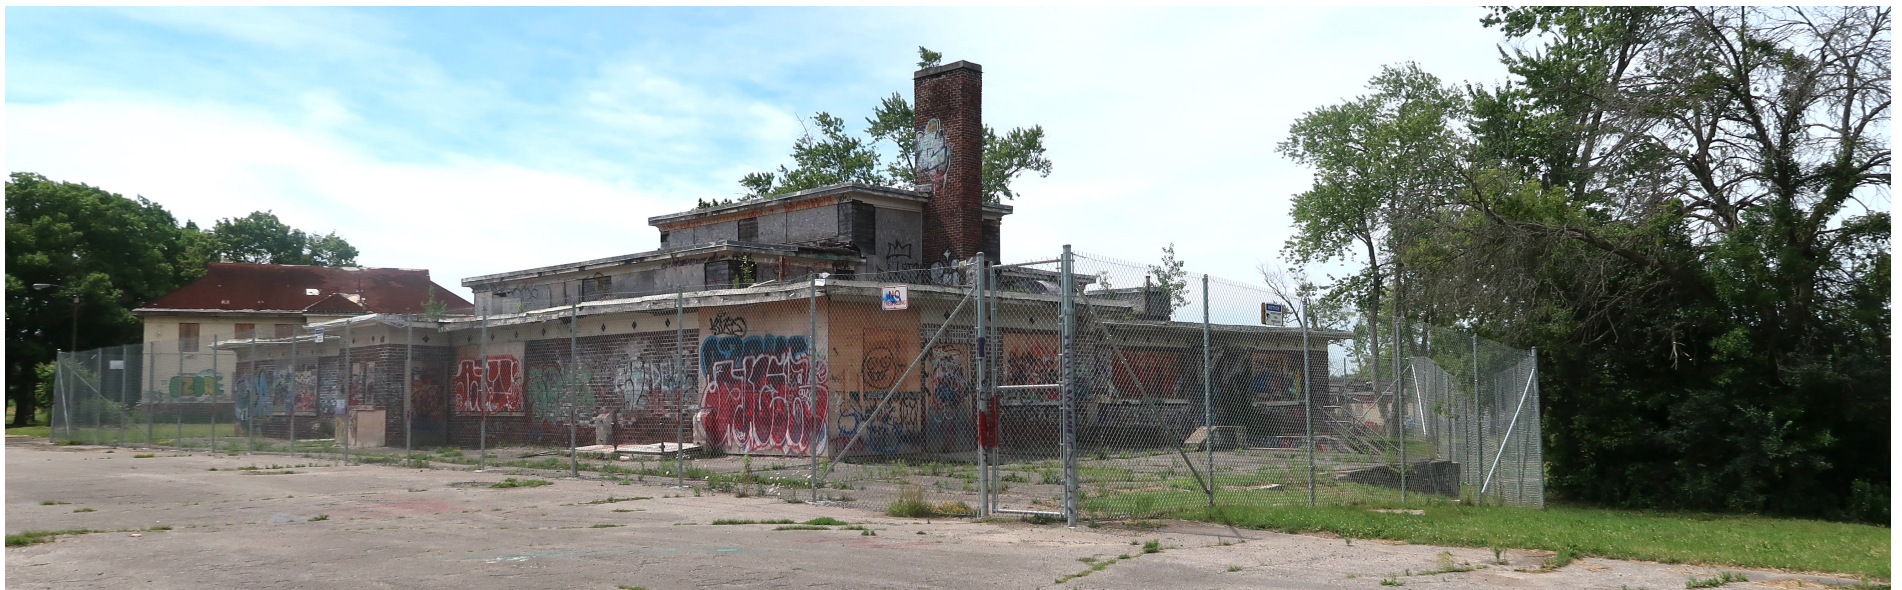
Cafeteria building, south east side, July 2024

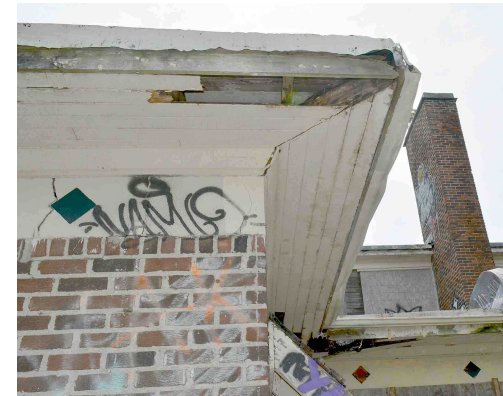
- Overall condition of wood elements vary from good to very poor.
- Condition of the wood fascia and soffit are in very poor condition caused by moisture or water penetration and/or freeze thaw cycles. Soffits appear to have collapsed in particular wherever downspouts once existed.
- Bird nests appear through the fascia in many locations. Paint is peeling.
- Original wood doors and windows, where existing, are missing all glazing. Paint is peeling and much of the hardware is missing.
- Wood canopies are in very poor condition and severely deteriorated.
- Wood cove mouldings appear to be in good condition.
- Overall condition of structure (wood structure, decking and steel) reviewed by BBA structural engineer engaged by Town of Clarington)

Wood Soffit, Fascia Board & Cove moulding

- Patch fascia boards, remove deteriorated flashing and gutters throughout and install new flashing with drip edge, gutters and rain water leaders required for the entire perimeter (for both upper and lower levels). Sealant should be applied to opened joints between pieces of flashing. Run off from downspouts should be directed far away from any walls.

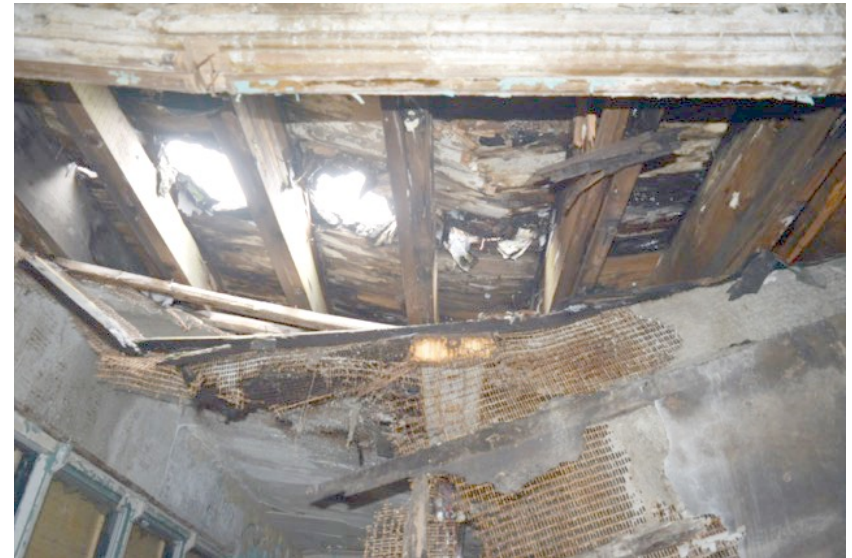
Collapsed lath and plaster ceiling including wood decking and joists.

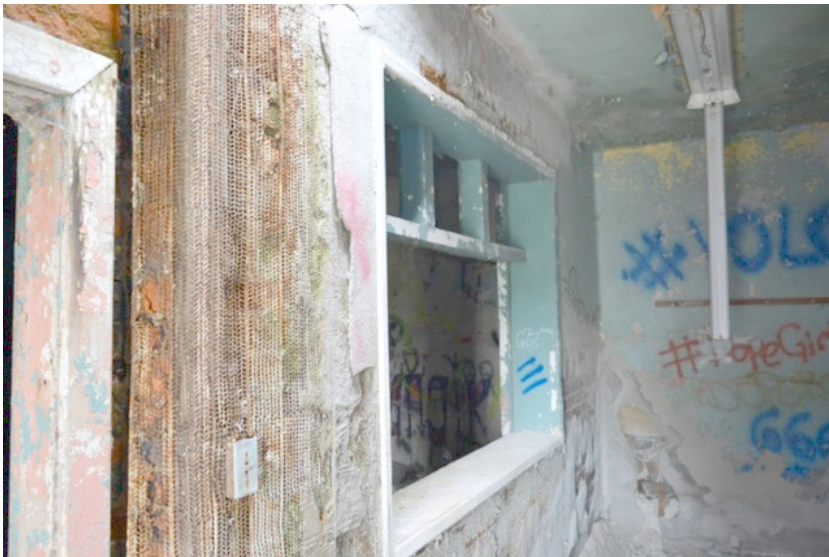
Wood window frame inside south-east addition.

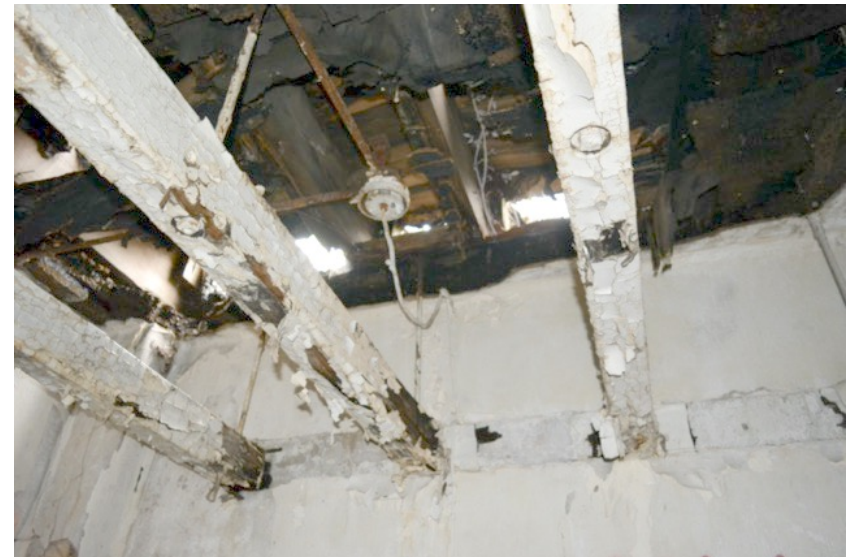
Wood ceiling joists in very poor condition where ceiling has caved in.

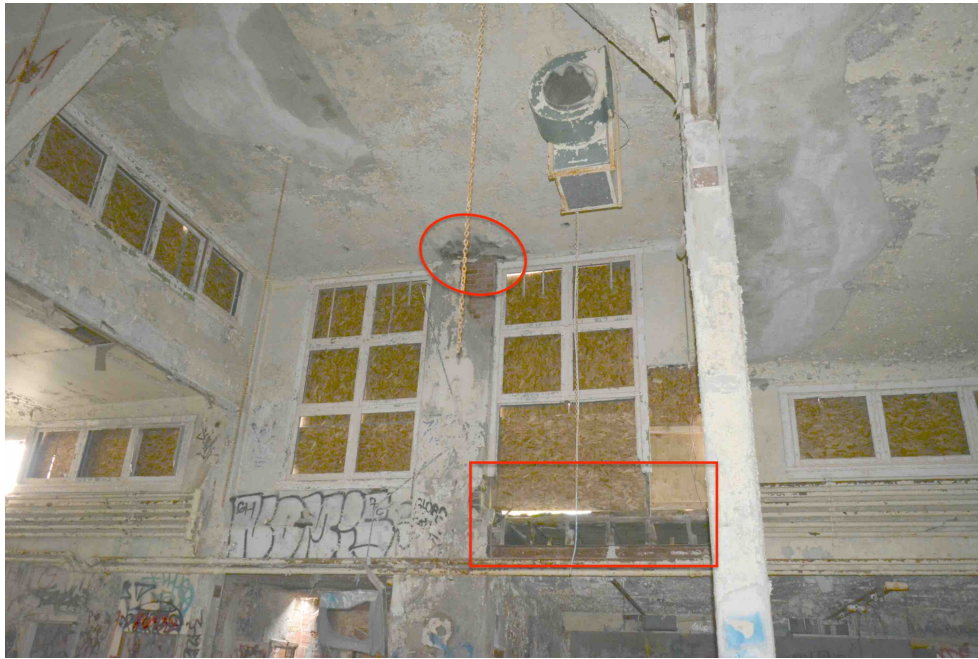
Water accumulation on third level roof, even the top tier, is rotting out walls, window frames and ceiling and roof joists. The roofing situation is at a critical level for both heritage preservation and human safety. If the ceilings continue to rot, this will result in a clean up requiring hazmat procedures. Wood window frames are typically without glazing throughout.

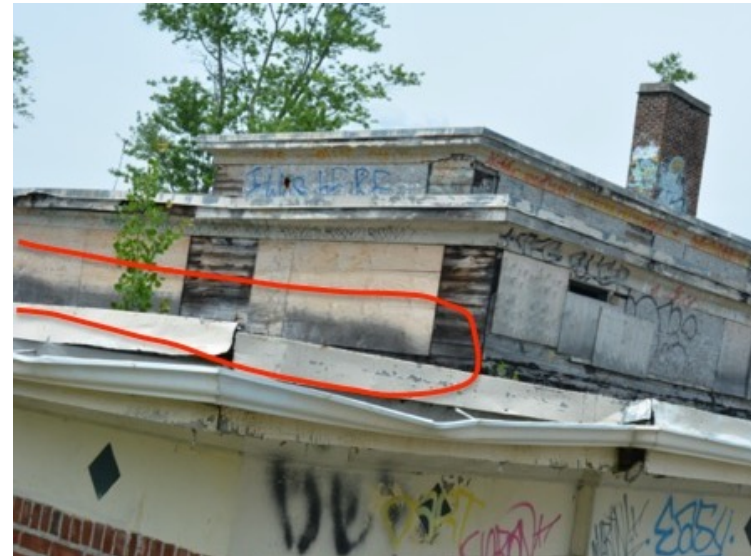
Exterior view of south wall showing evidence of water accumulation at the first tier clerestory level.

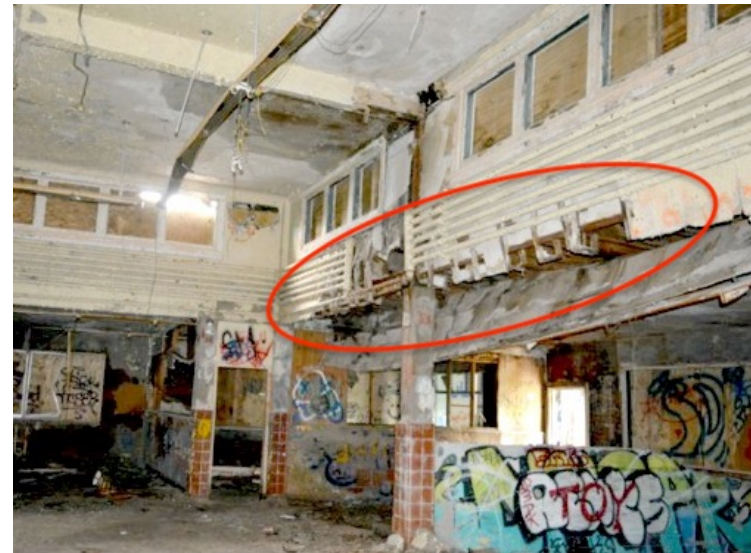
Corresponding interior view of south wall showing deterioration of wall and ceiling at the first tier.

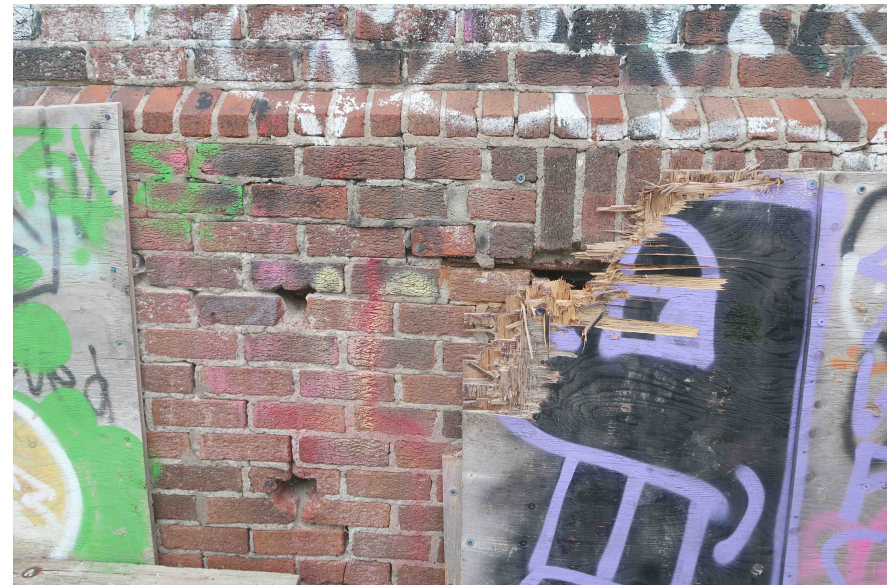
Holes in brick. This surface hoarding is damaging to the brick.

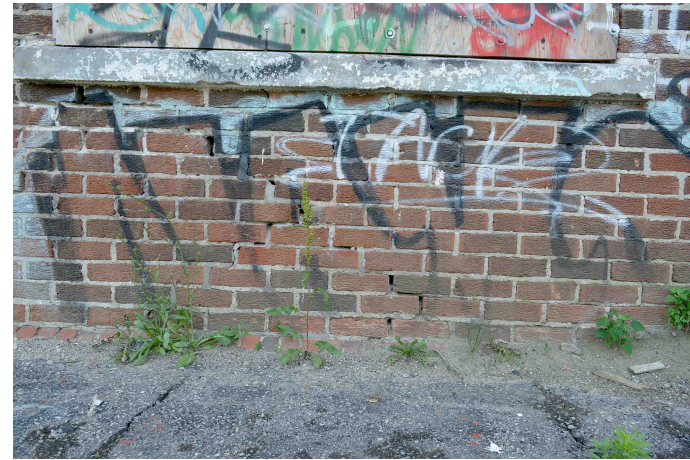
Cracks in west side wall.

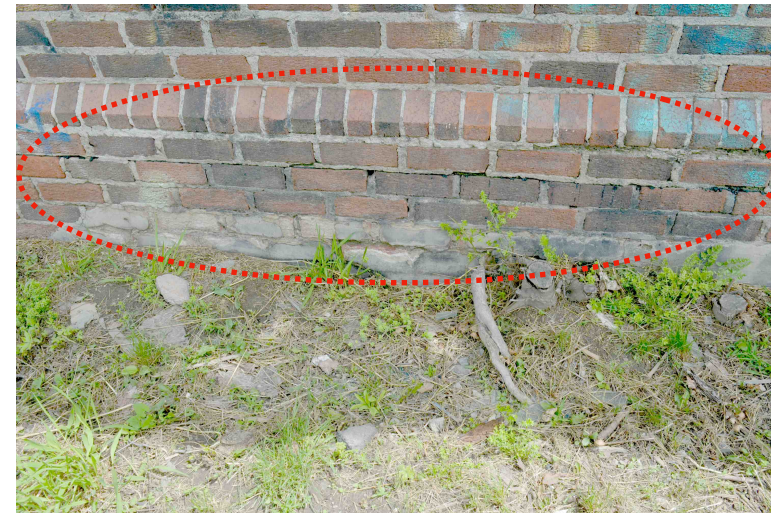
Old repairs to damaged foundation on west side .

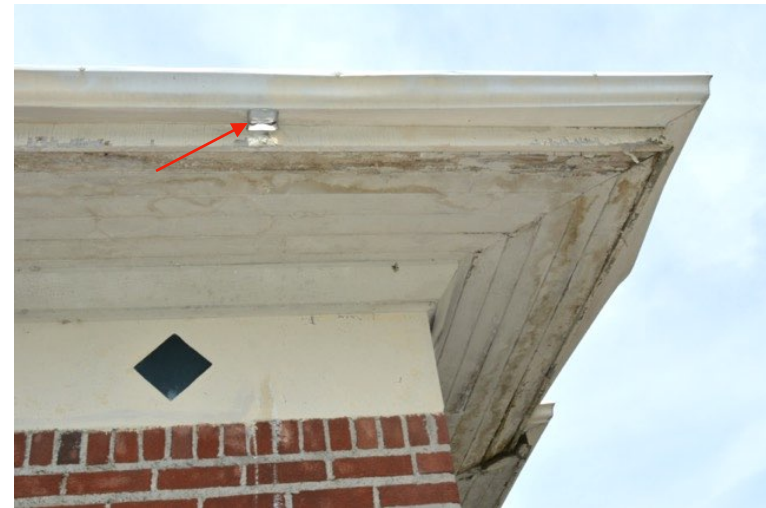
Missing rain water leaders typical.

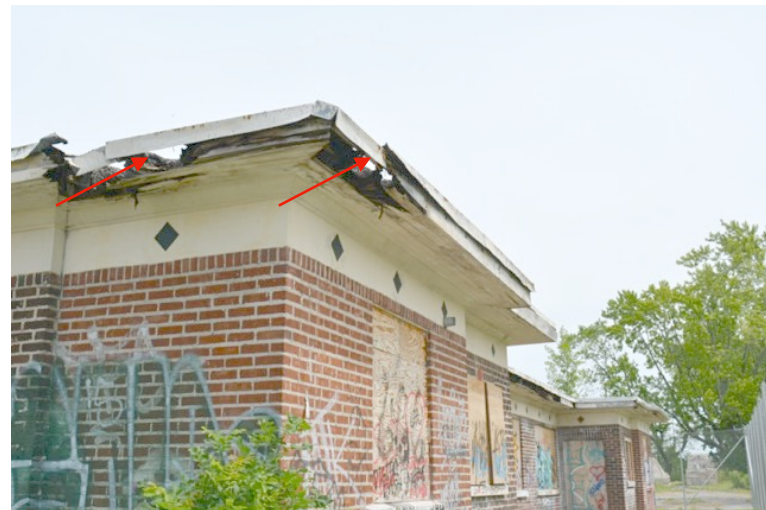
Torn flashings, missing gutter.

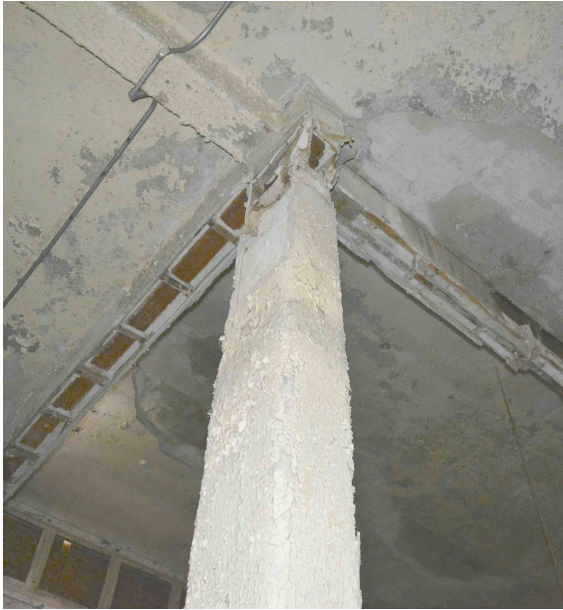
Steel Column encased in clay tile and parging.

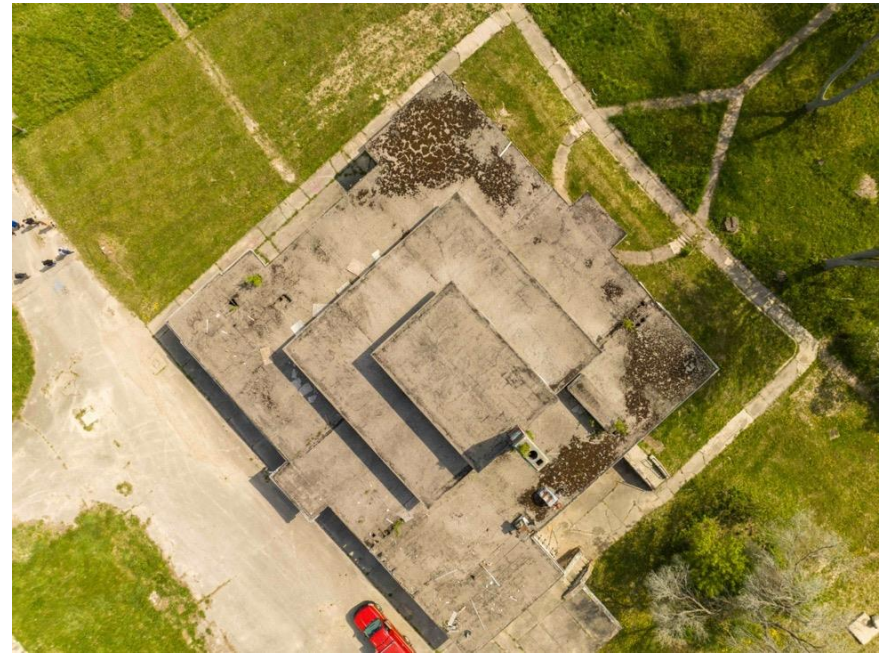
Roof Plan showing soiling at west side

- Remove vegetation from the roof of the building.
- The roofing must be replaced as it has reached the end of its life. Remove existing roof membrane, all legacy mechanical and plumbing penetration through roof.

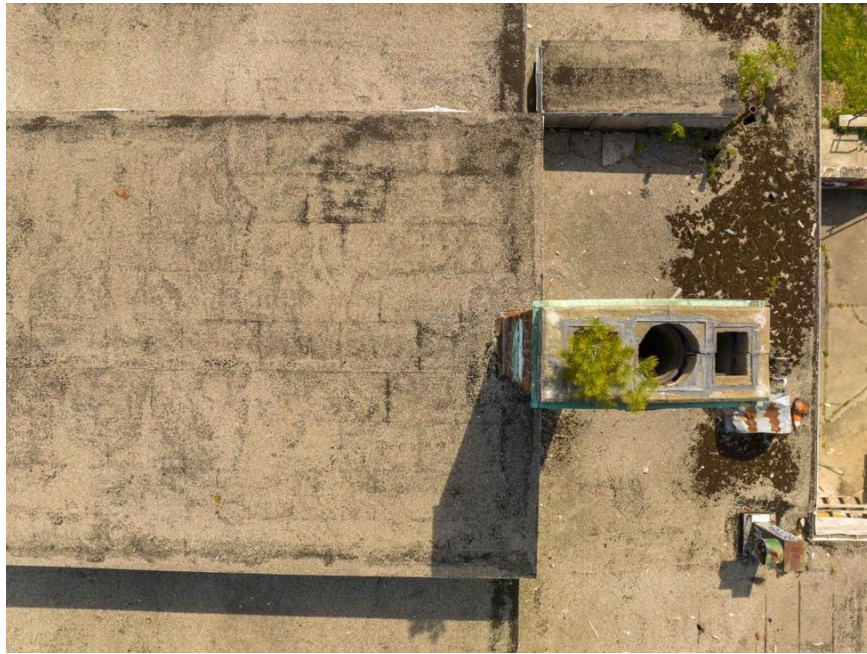
Roof Plan and chimney

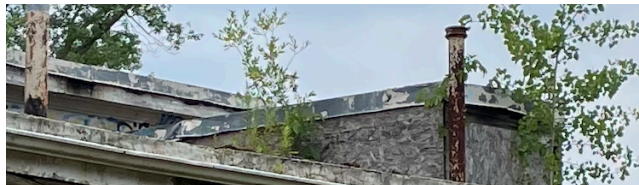
Small cupola in boarded up condition in 2024

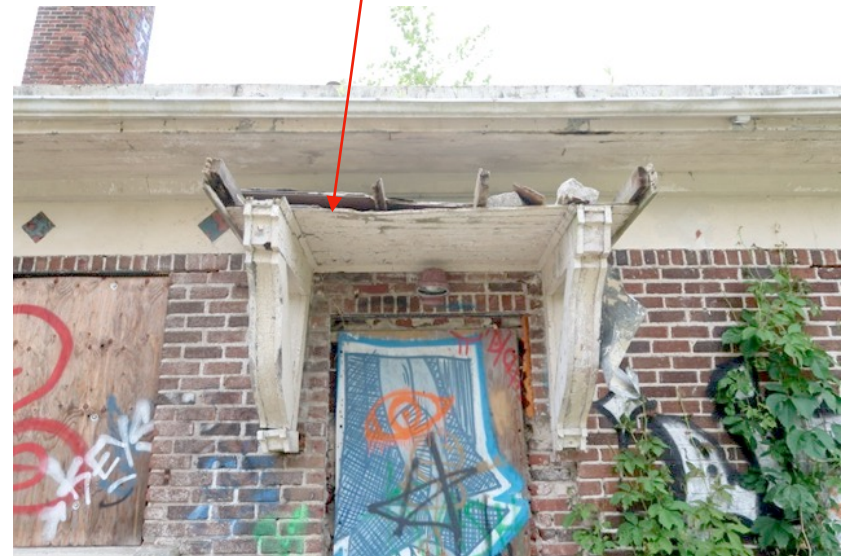
Remains of Canopy roof facing north.

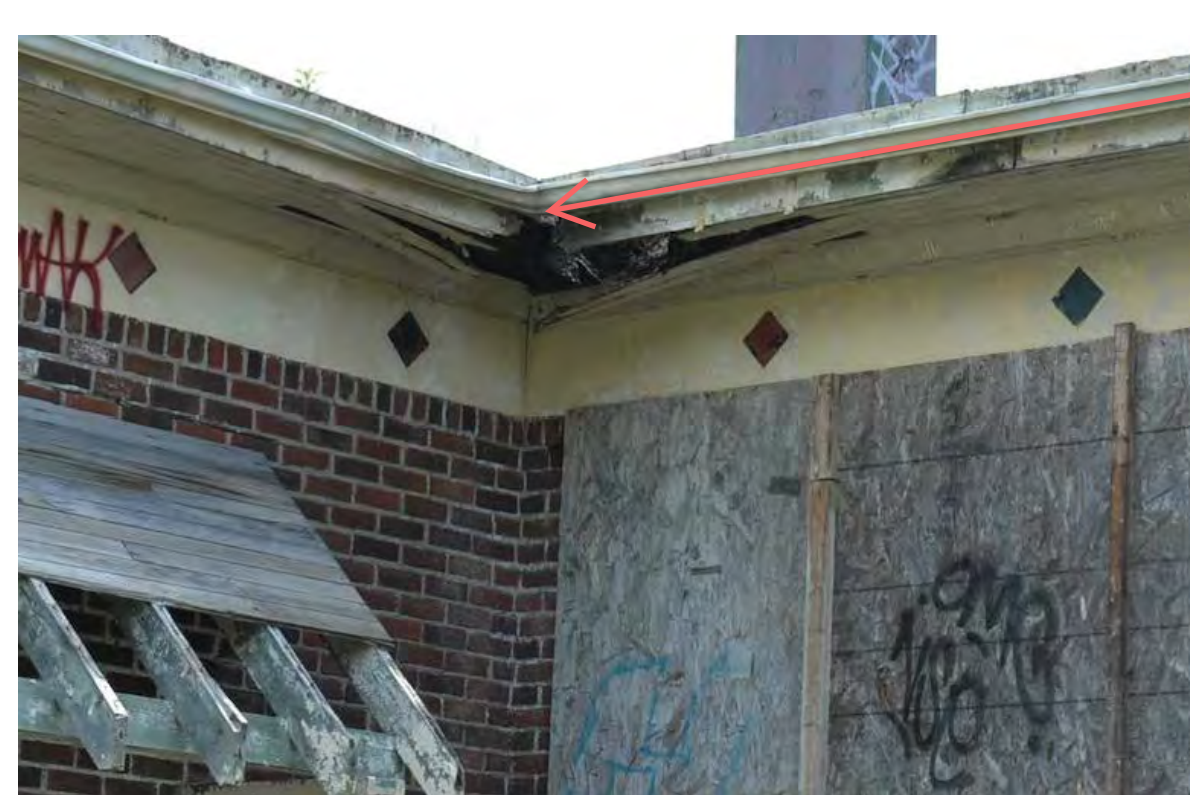
DETERIORATED FLASHING, FASCIA AND SOFFIT

FASCIA AND SOFFIT TO BE PATCHED

UPPER PLYWOOD WINDOW/DOORS PLUGS TO INCORPORATE VENTILATION GRILLE

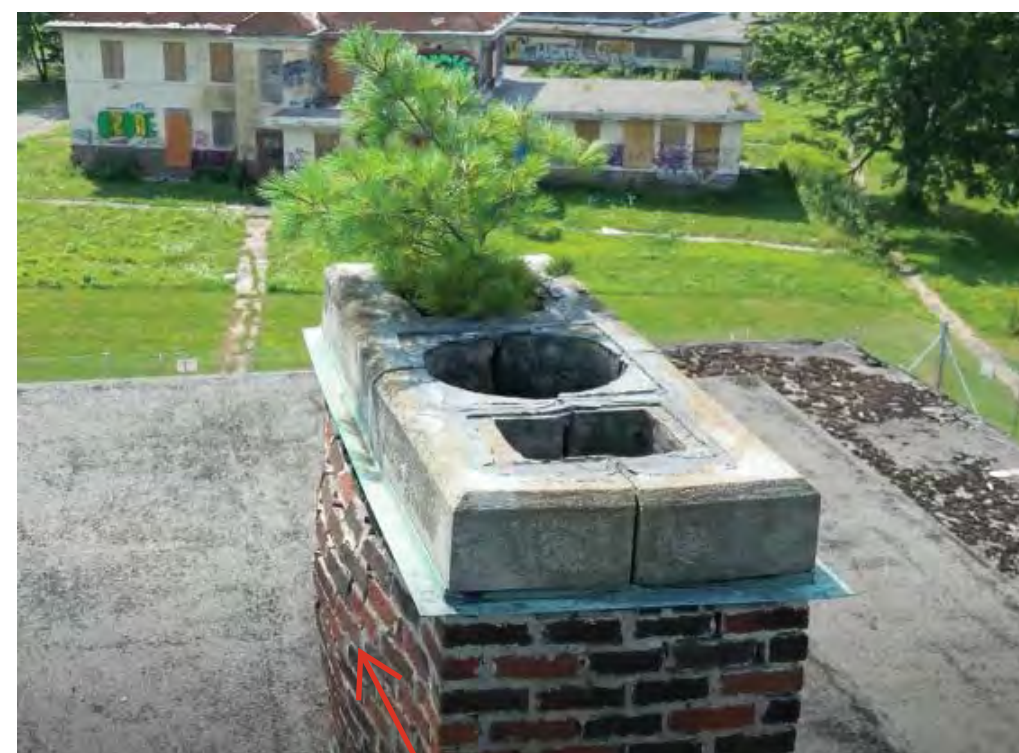
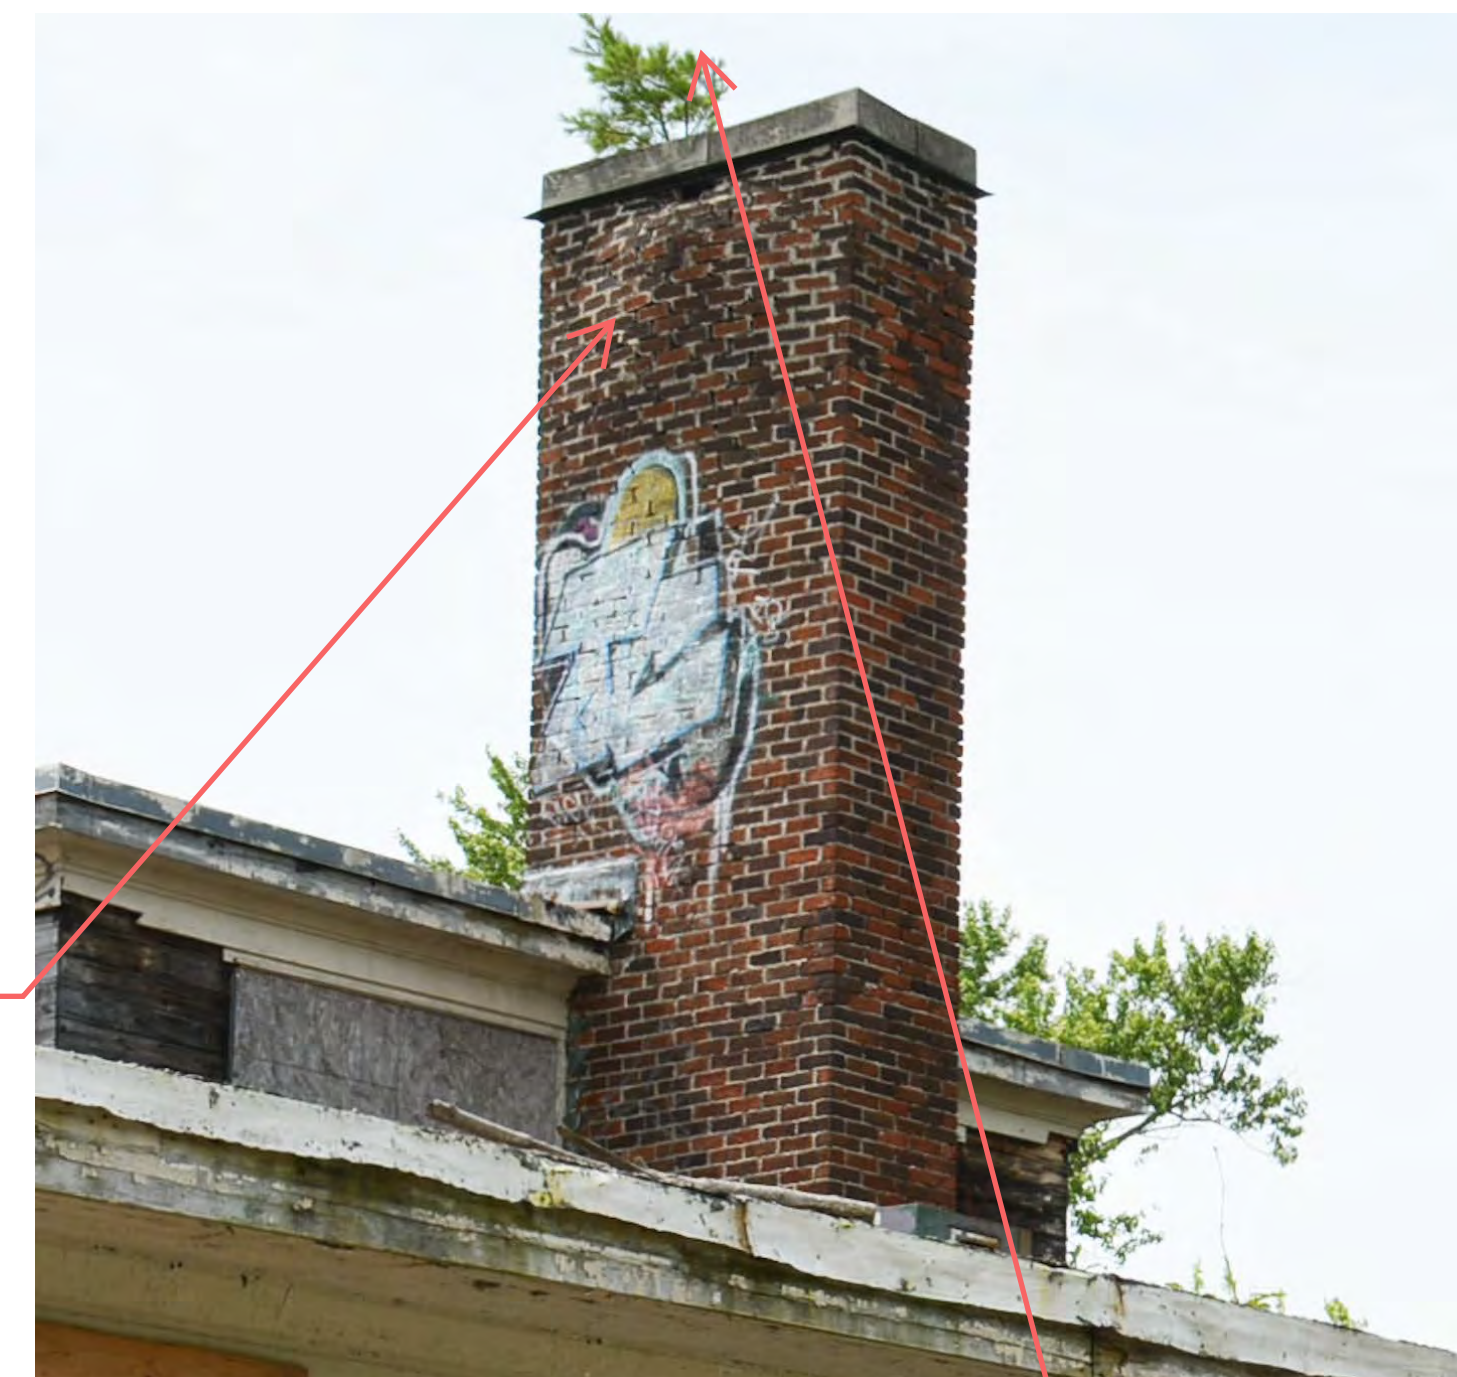
BULGING CHIMNEY AND VEGETATION GROWTH

BULGING CHIMNEY TO BE DISMANTLED AND REBUILT. STABILIZATION TO BE SPECIFIED BY STRUCTURAL ENGINEER

REMOVE ROOTS, TREES AND OTHER VEGETATION. BY ARBORIST CONSULTANT AND AUTHORITIES HAVING JURISDICTION

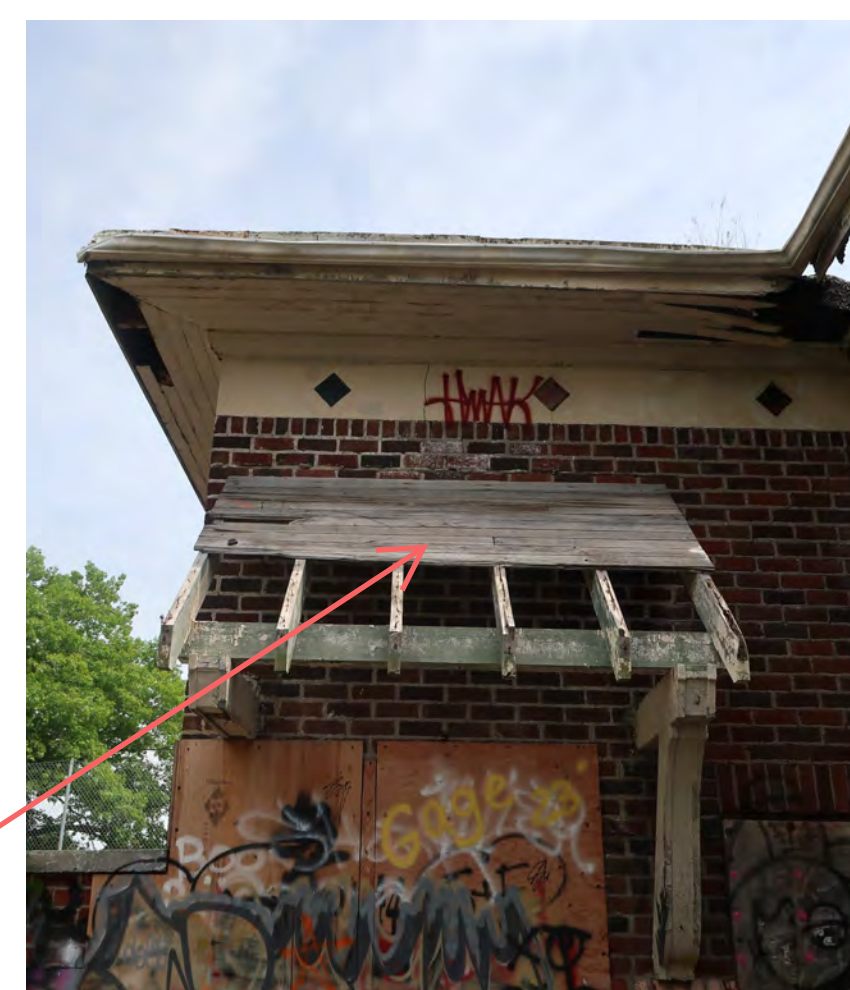
DETERIORATED CANOPY AND BRACKET

DETERIORATED CANOPY AND BRACKETS TO BE REMOVED AND STORED

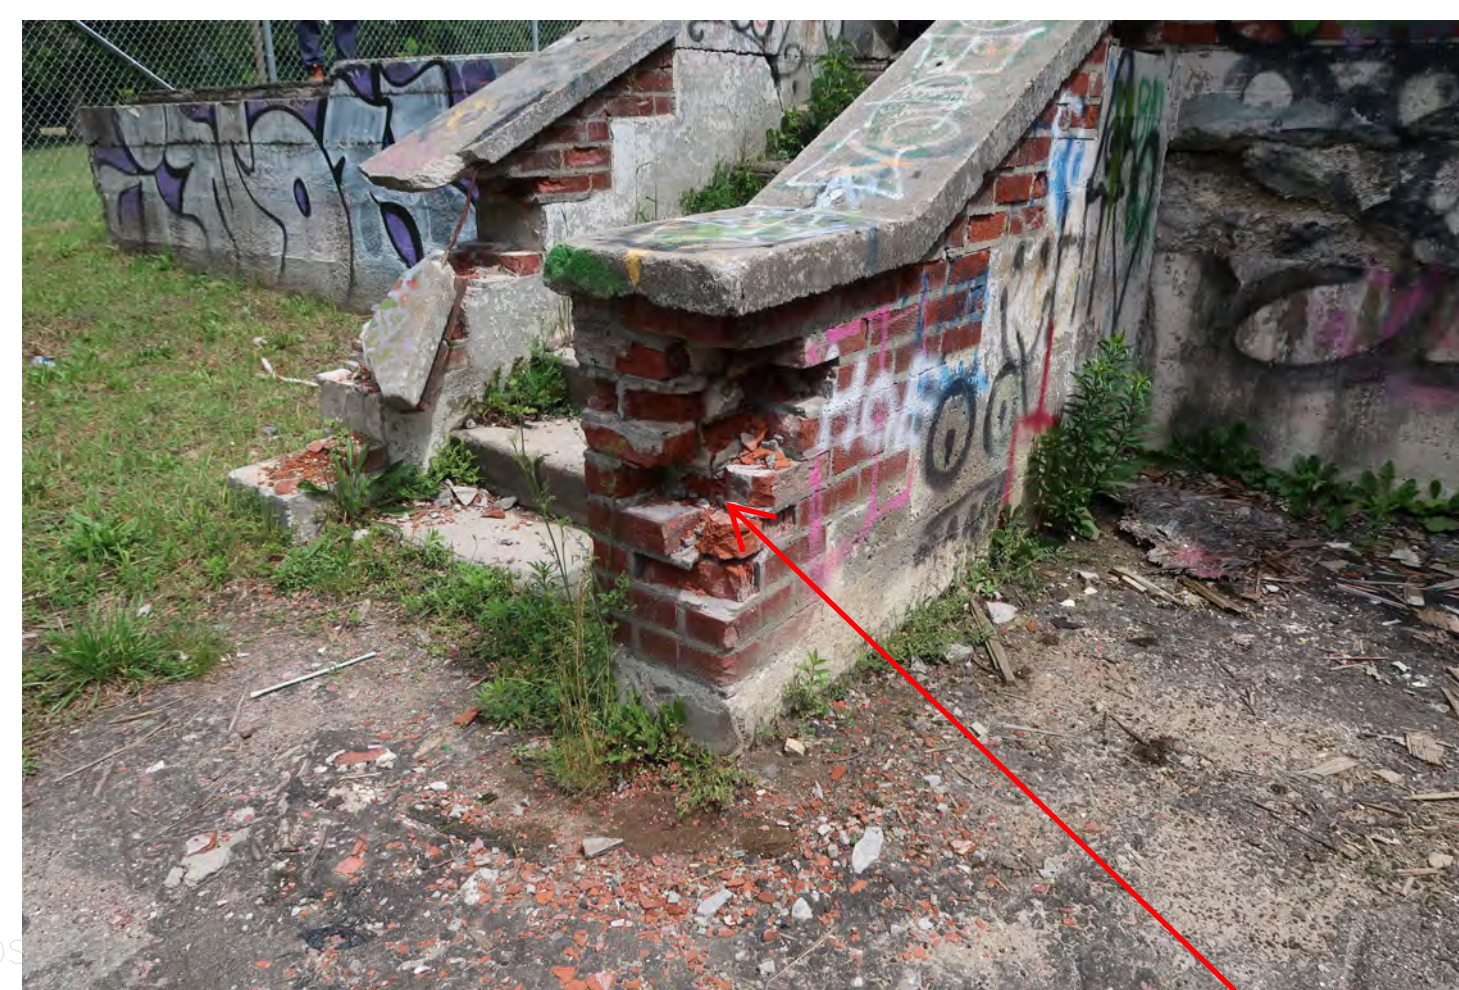
DETERIORATED EXTERIOR STAIRS

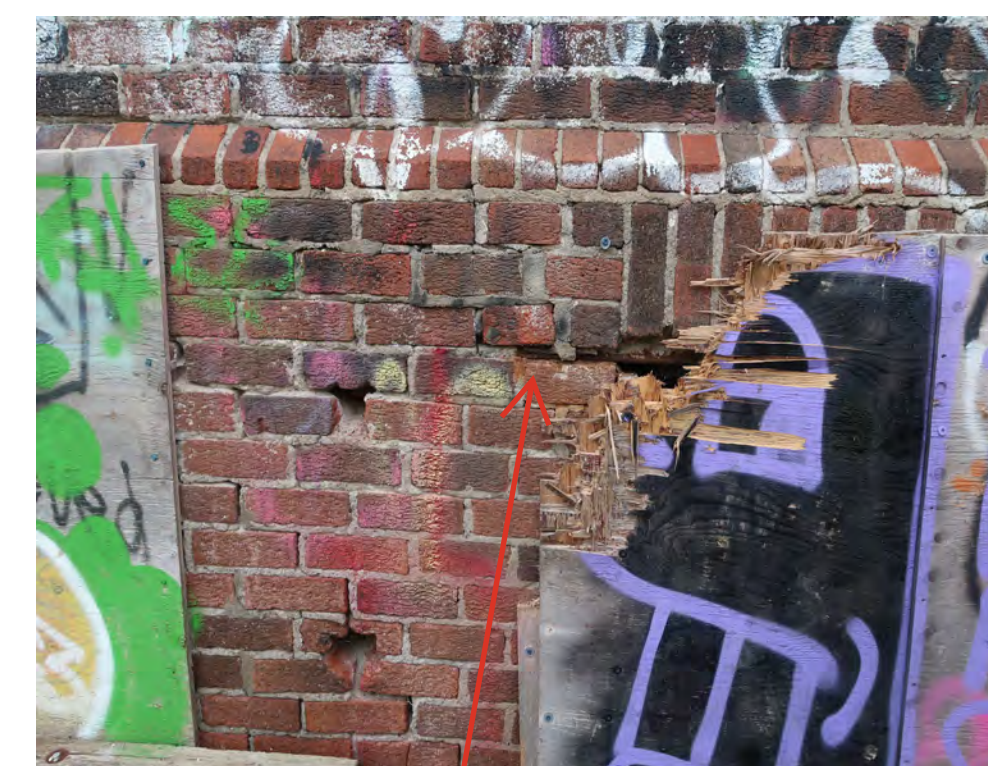
HOLES IN BRICKS

MASONRY REPAIRS

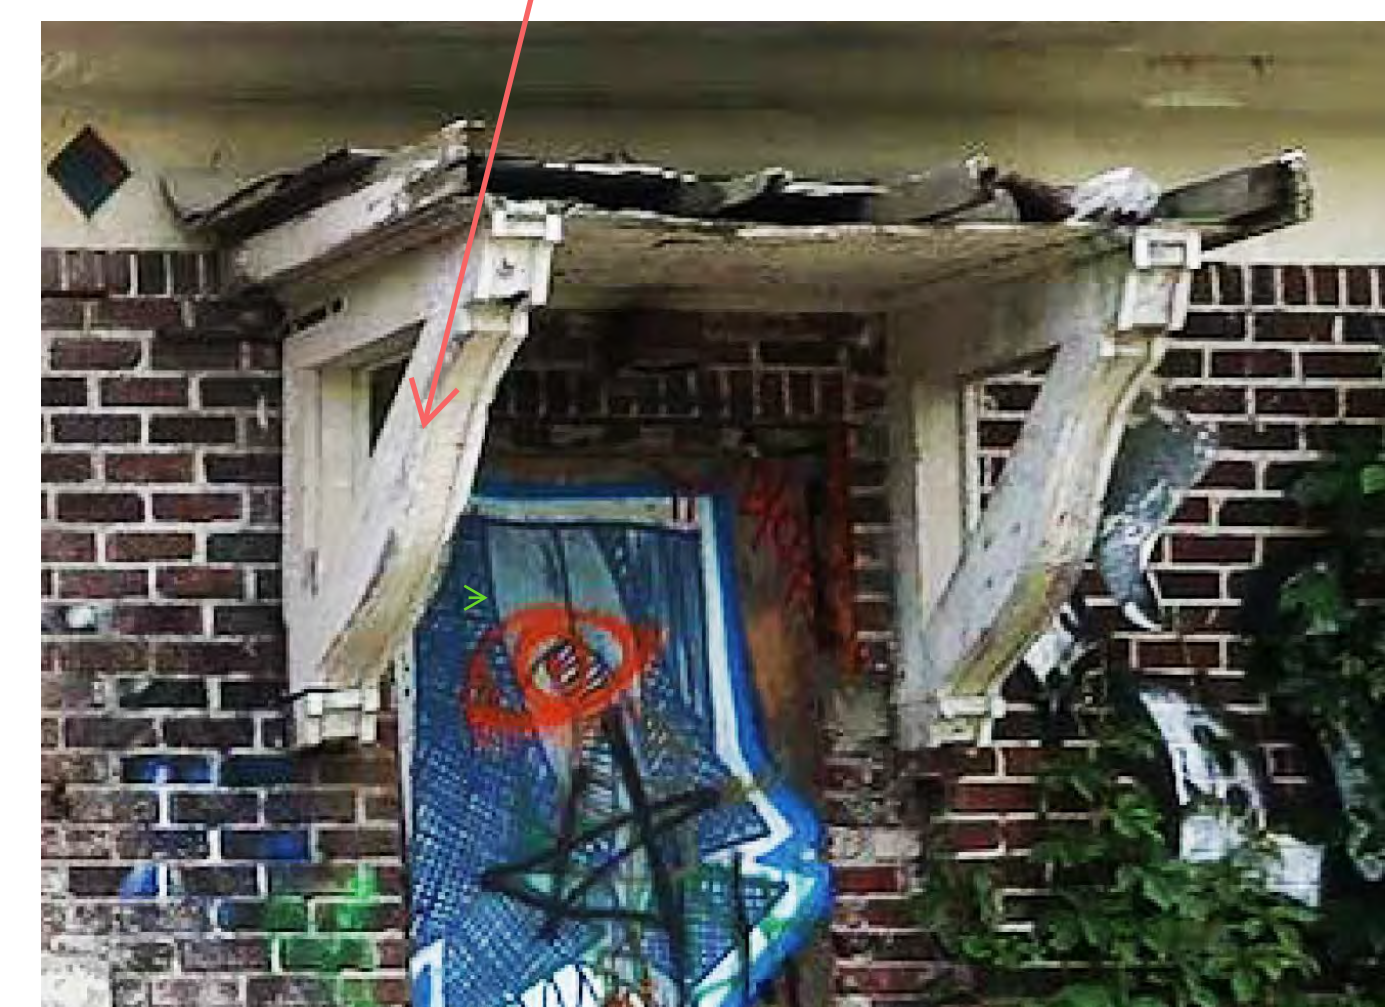
DETERIORATED CANOPY

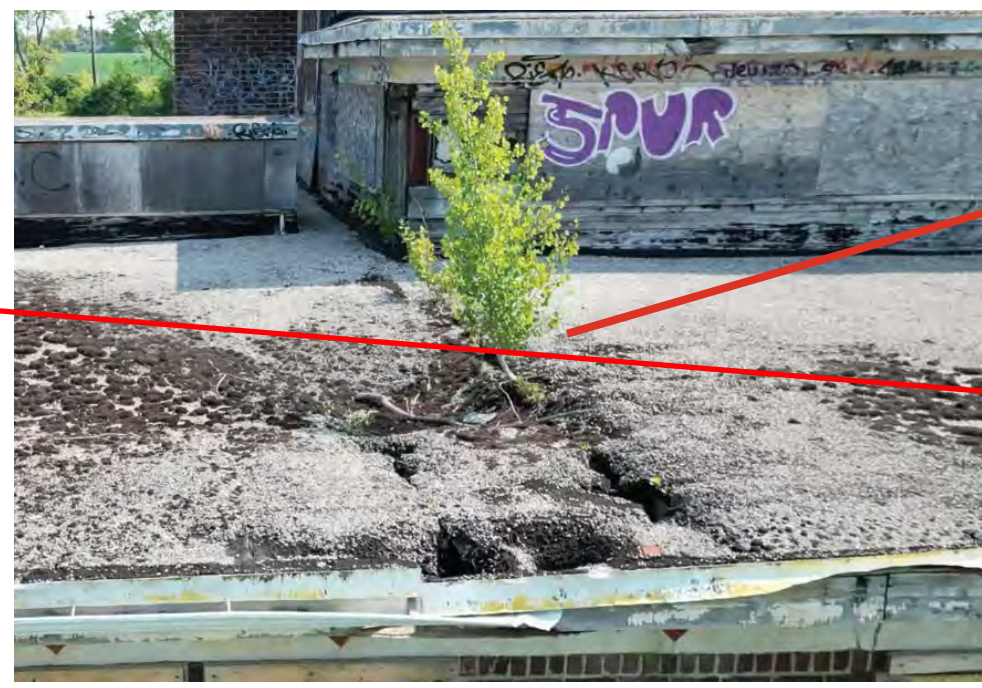
DETERIORATED ROOF CAVING IN AND BIOLOGICAL GROWTH

DO LOCALIZED REPAIRS TO ALL THREE LEVELS OF EXISTING ROOF WOOD PLANKS WITH 3/4" PLYWOOD SHEATHING. ESTIMATED 40% OF ROOF. REMOVE EXISTING ROOF MEMBRANE AND ANY VEGETATION, ALL LEGACY MECH & PLUMBING PENETRATION THROUGH ROOF. PATCH FASCIA BOARD, REMOVE DETERIORATED FLASHING AND GUTTERS THROUGHOUT AND INSTALL NEW FLASHING, GUTTERS, AND RWL'S. INSTALL 5 YEAR TEMPORARY ROOF MEMBRANE ON ENTIRE ROOF

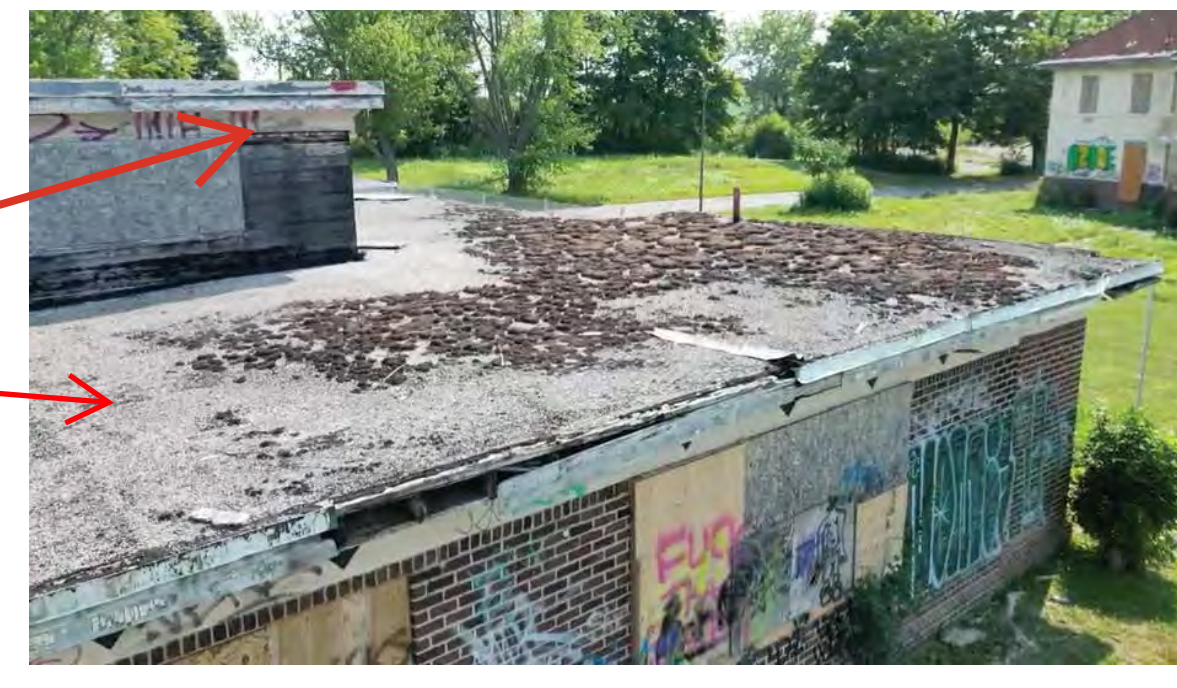
DETERIORATED ROOF SHOWING SOIL AND BIOLOGICAL GROWTH

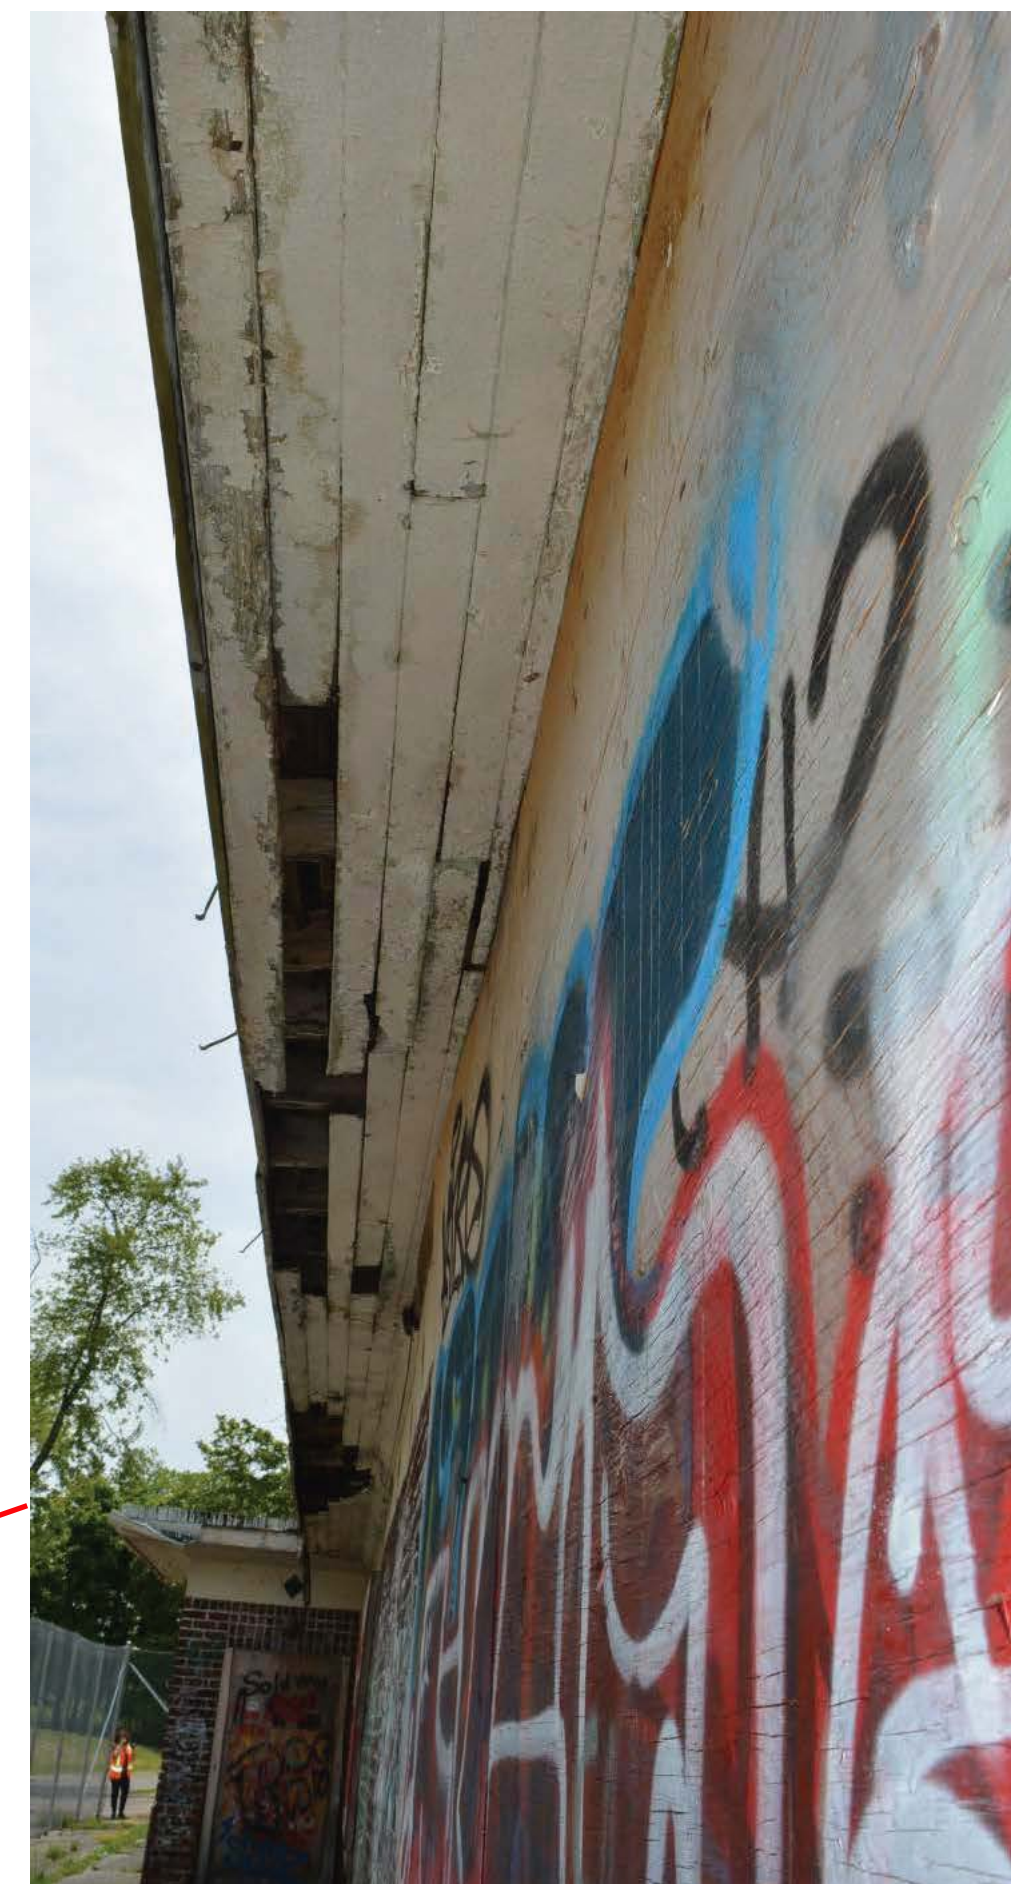
HEAVILY DAMAGED SOFFIT
