Re: Budget Decision on the Cafeteria Building at Camp 30

Prepared by GBCA

Goldsmith Borgal & Company Ltd Architects

3.1 CONDITION REVIEW - CAFETERIA/DINING HALL

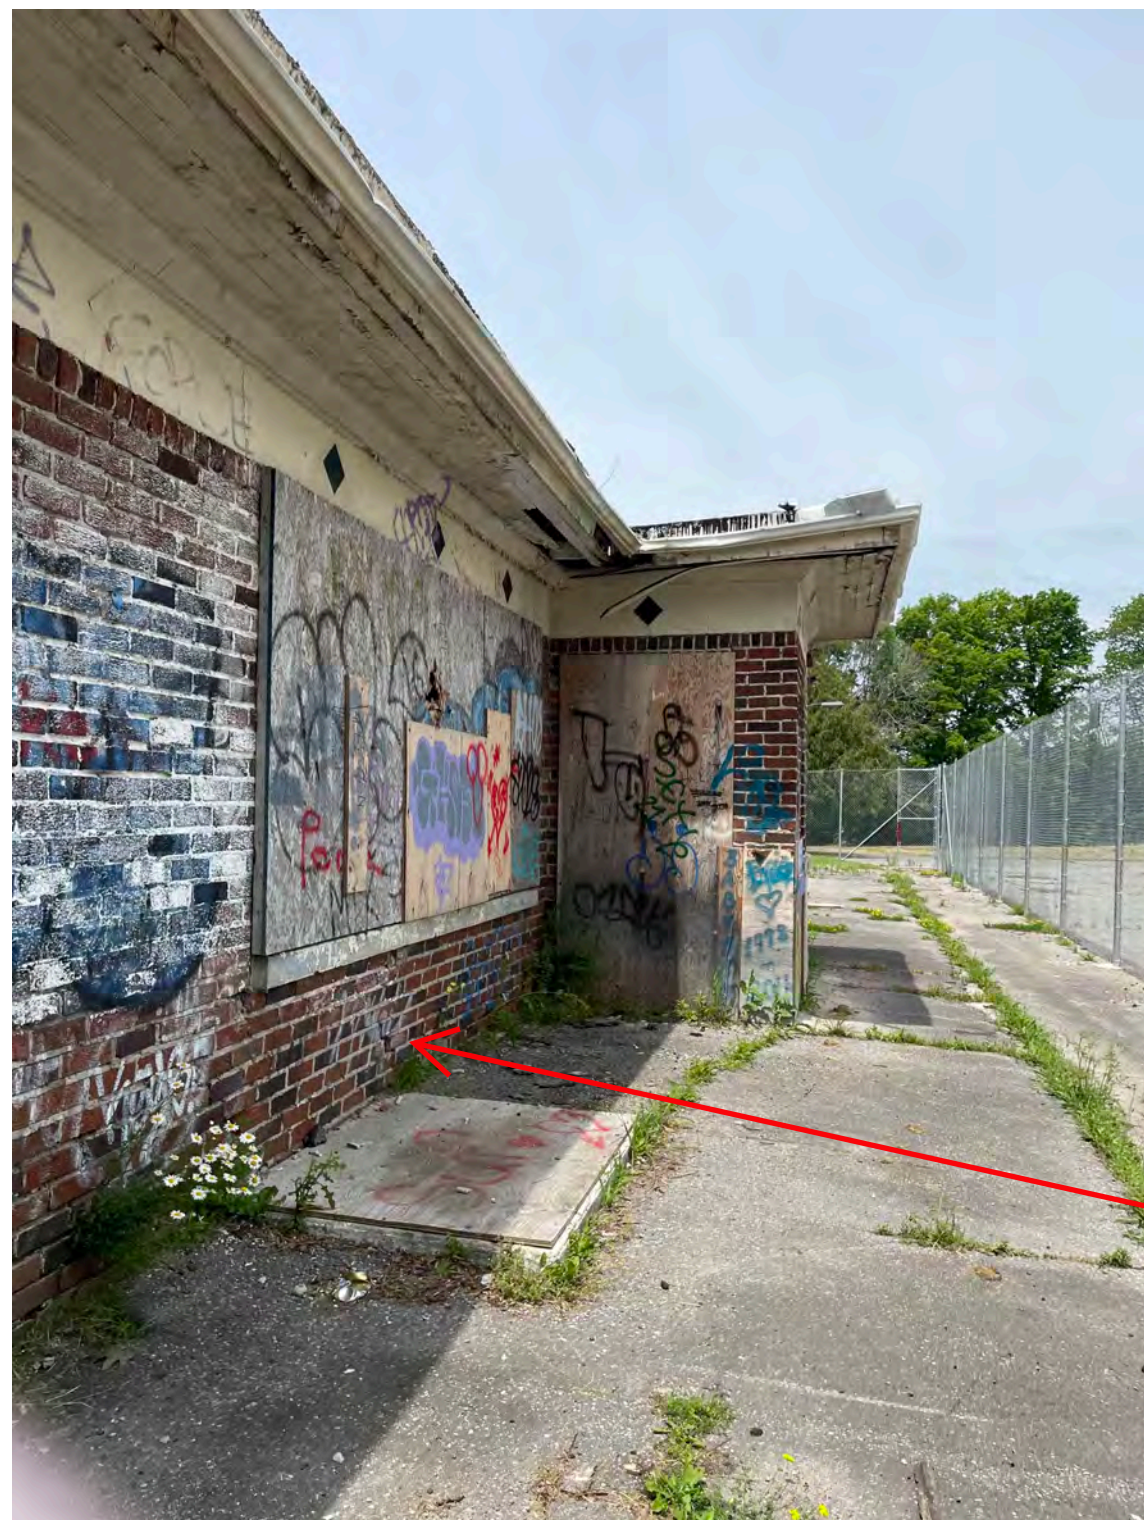
LEANING BRICK WALL

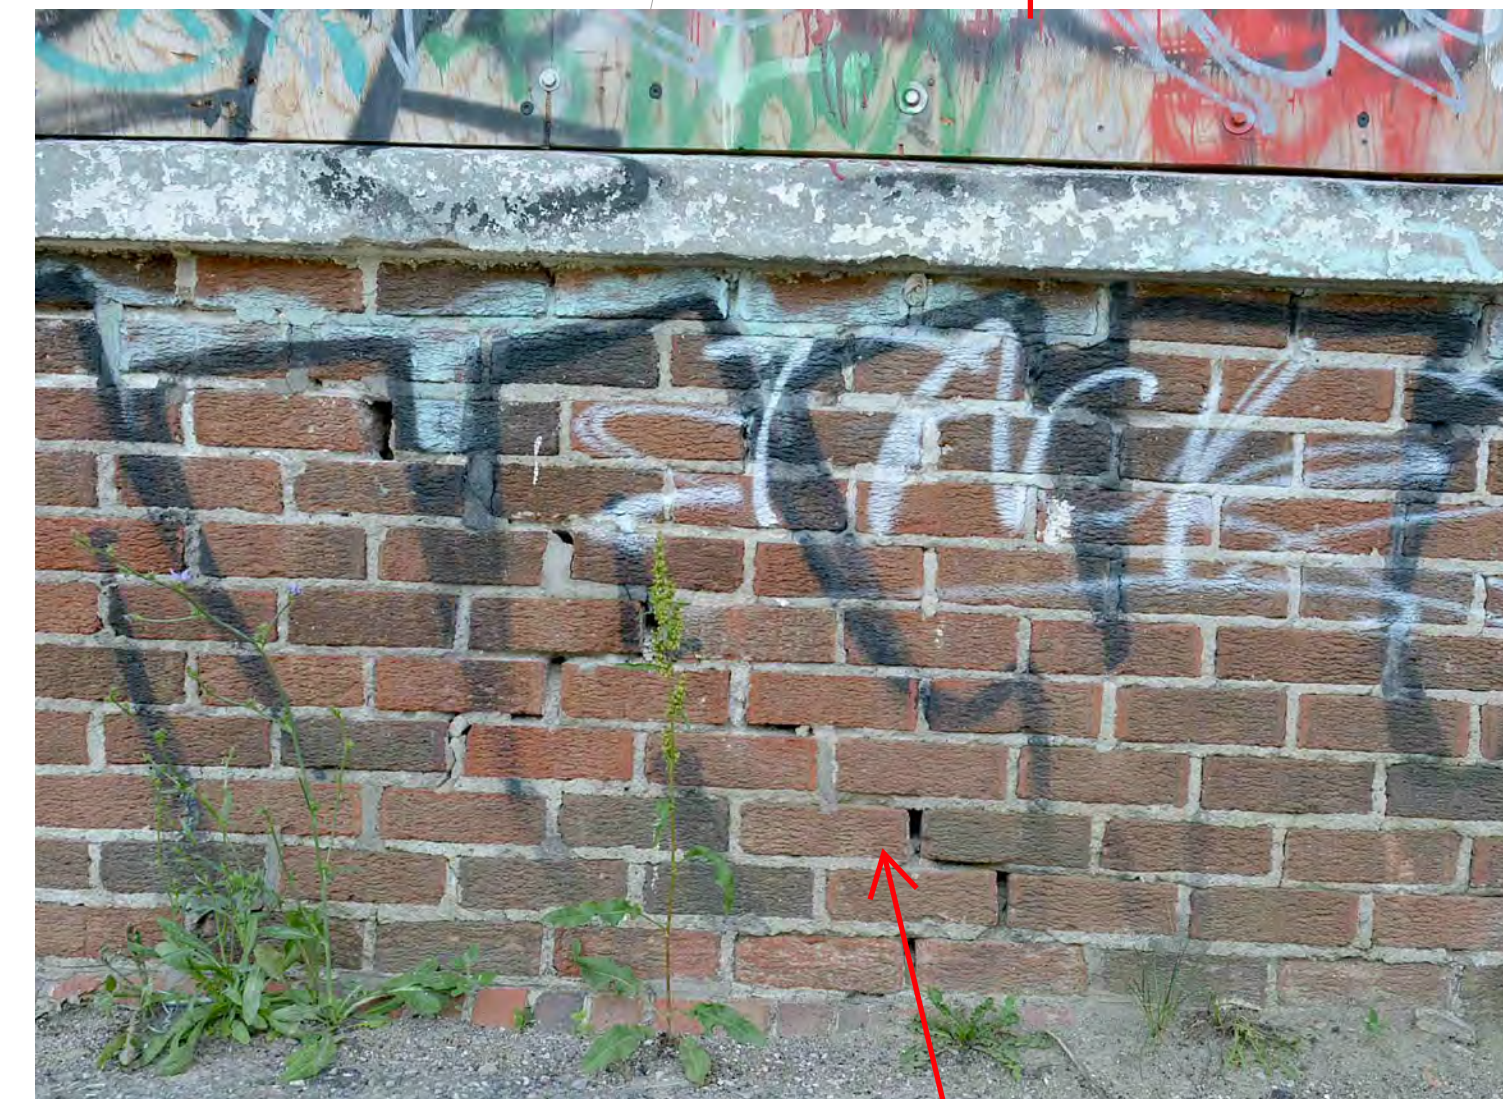
DETERIORATED MORTAR JOINTS

MASONRY REPAIRS. ESTIMATED 35%

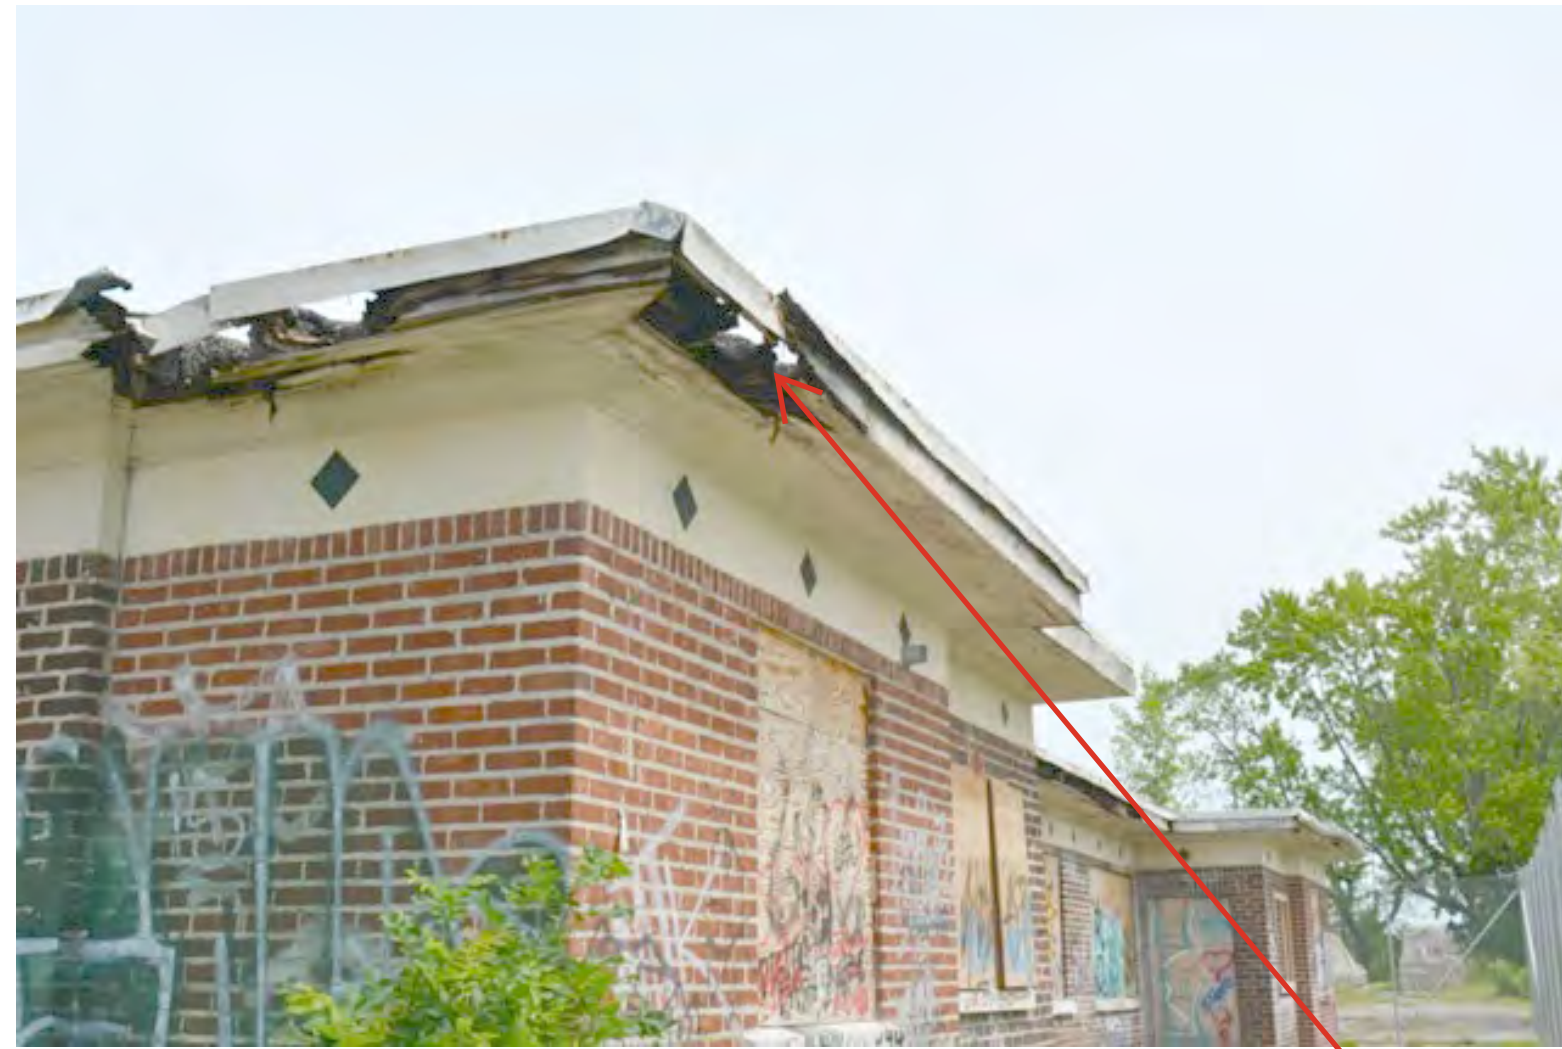
ROOF STRUCTURE HEAVILY DETERIORATED AT EDGE. FASCIA AND SOFFIT SEVERELY DETERIORATED AND DAMAGED. NO GUTTERS

PATCH FASCIA BOARDS AND REMOVE DETERIORATED FLASHING AND GUTTERS THROUGHOUT

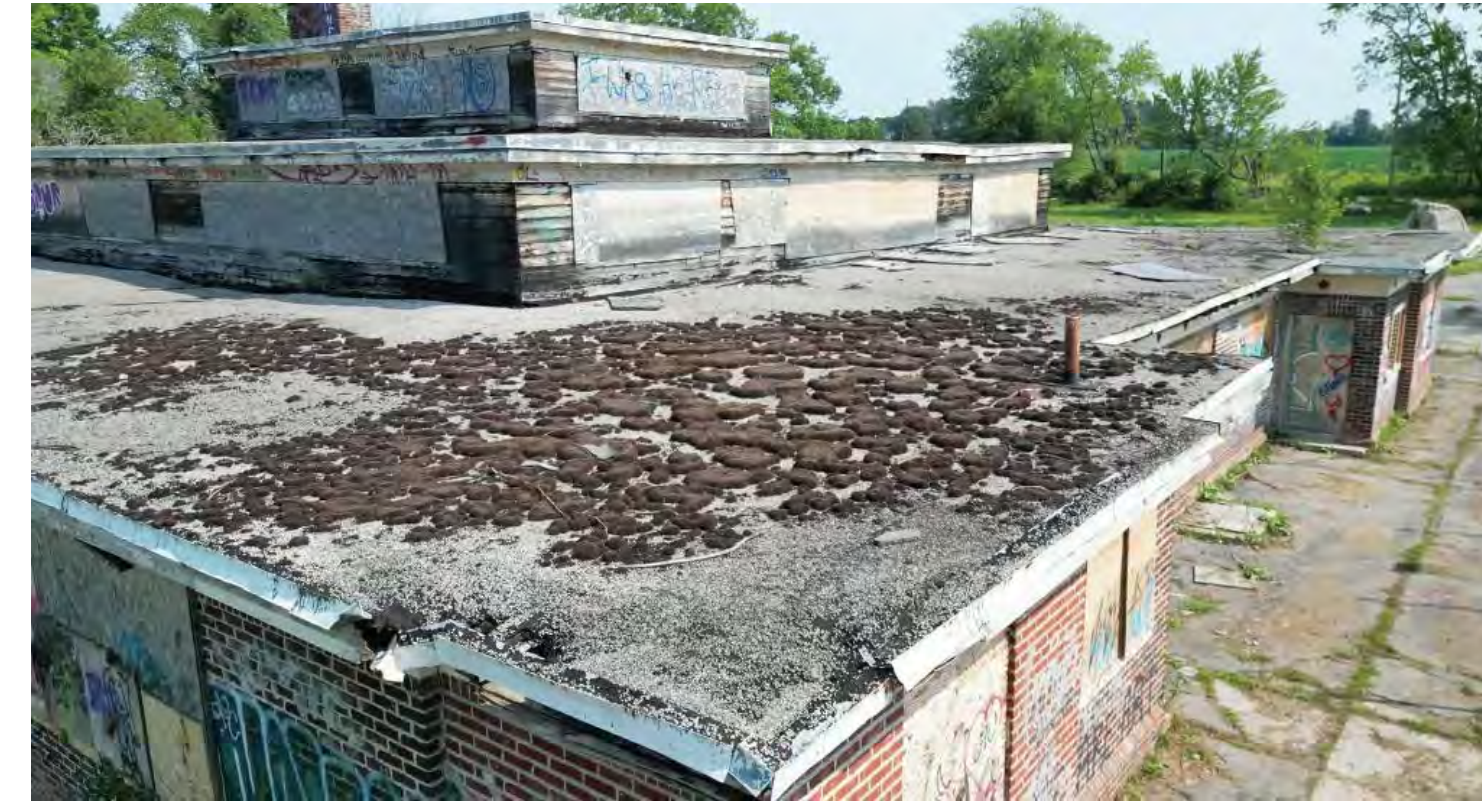
TRIPPLE HEIGHT ROOF FORM SHOWING ABSENCE OF GUTTERS DETERIORATED FLASHING AND ROOF

UPPER PLYWOOD WINDOW/DOOR PLUGS TO INCORPORATE VENTILATION GRILLES

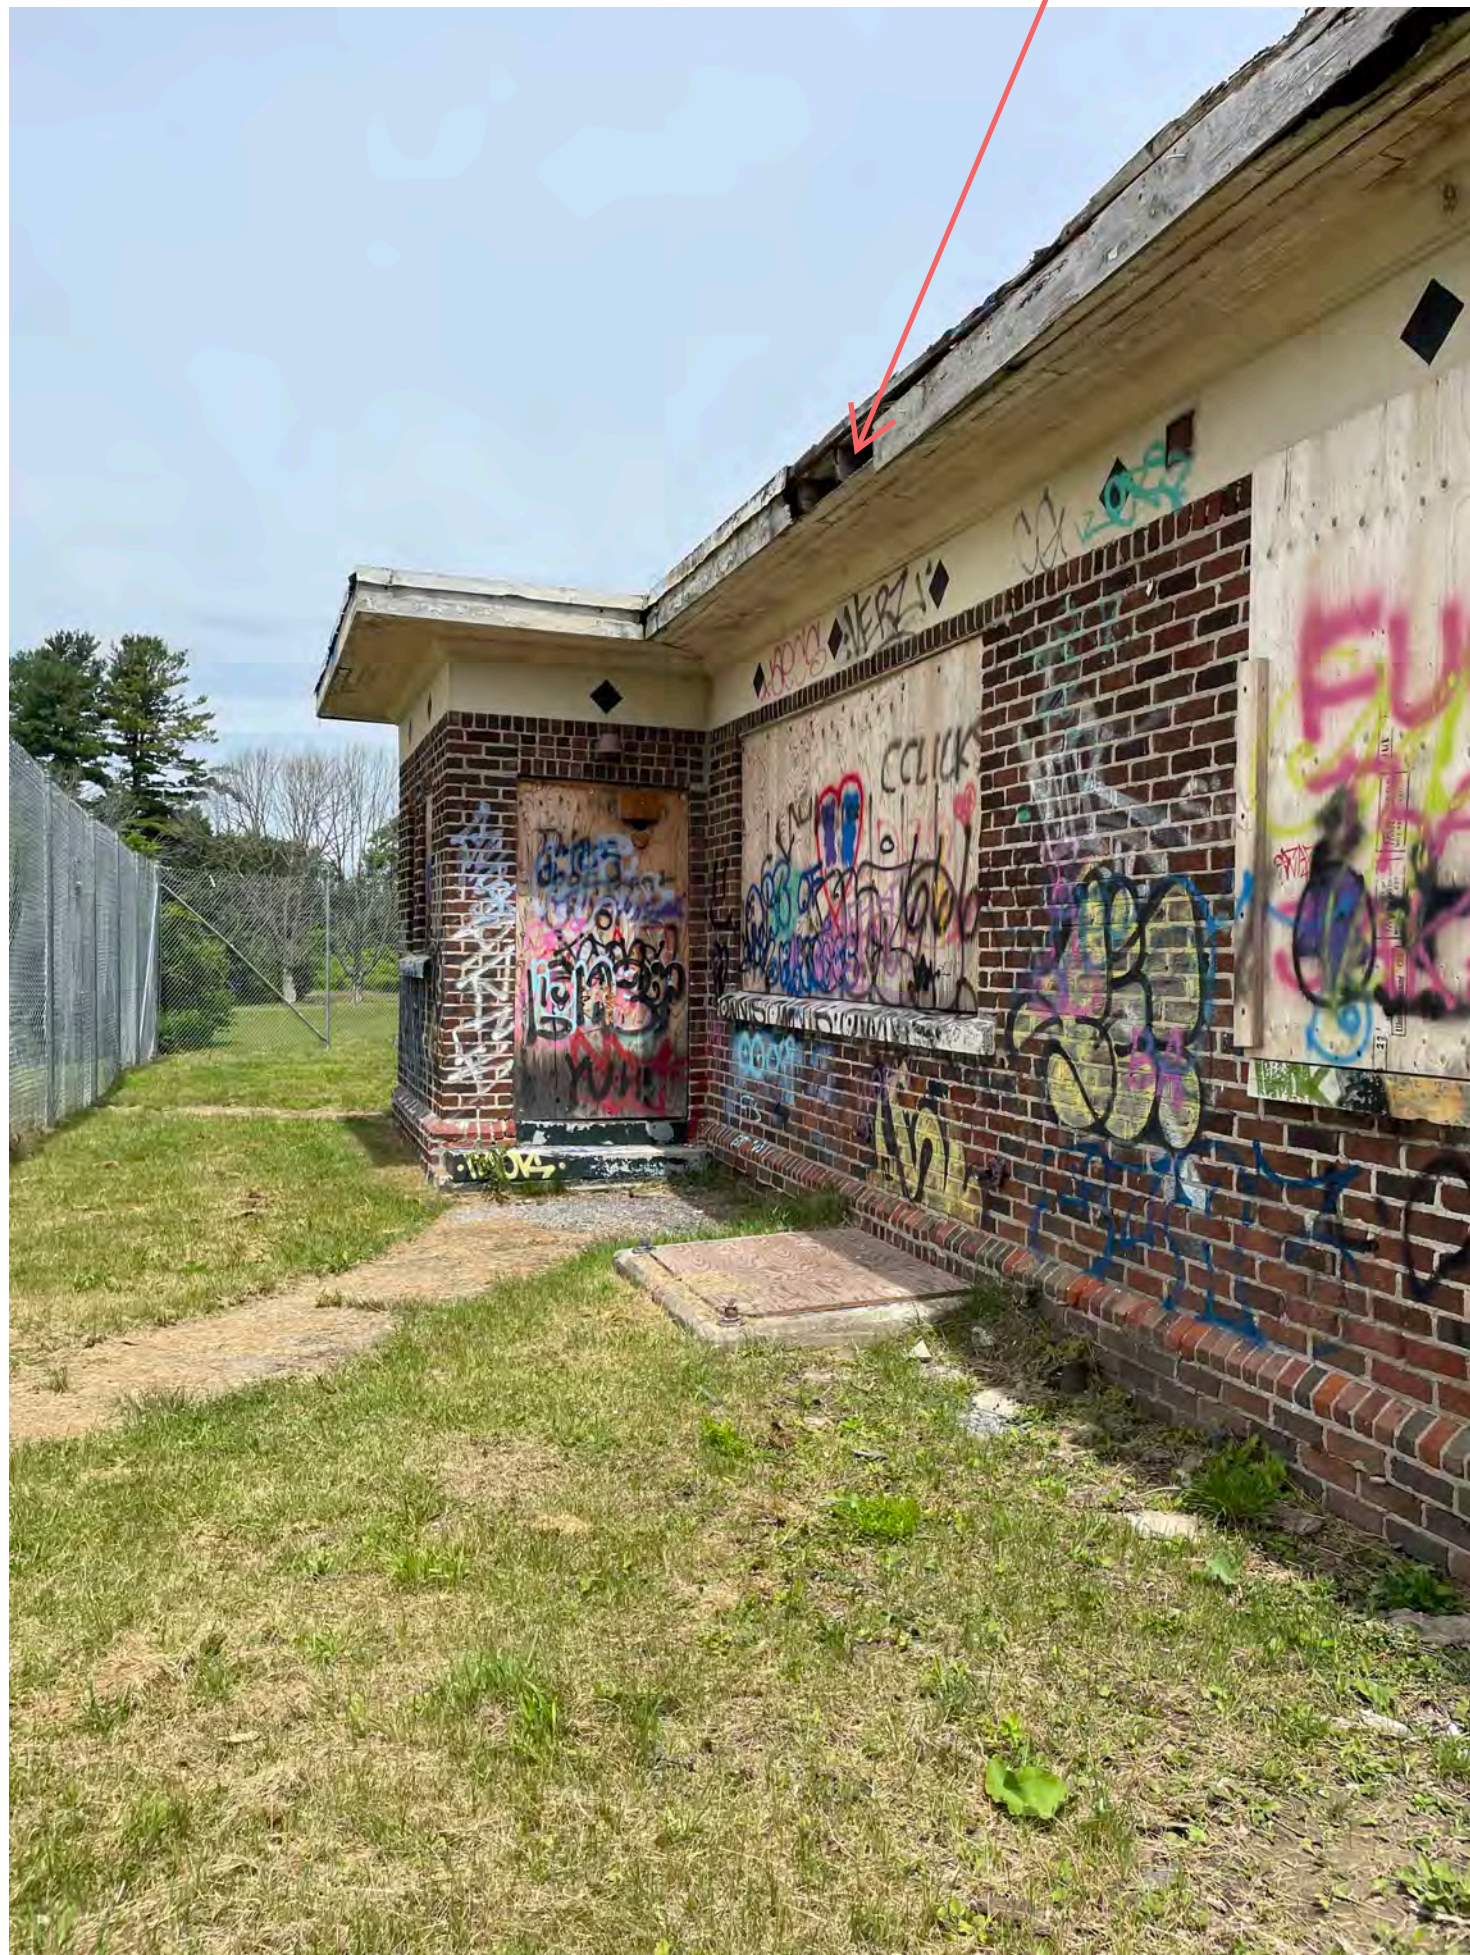
ELEVATION SHOWING VANDALISM

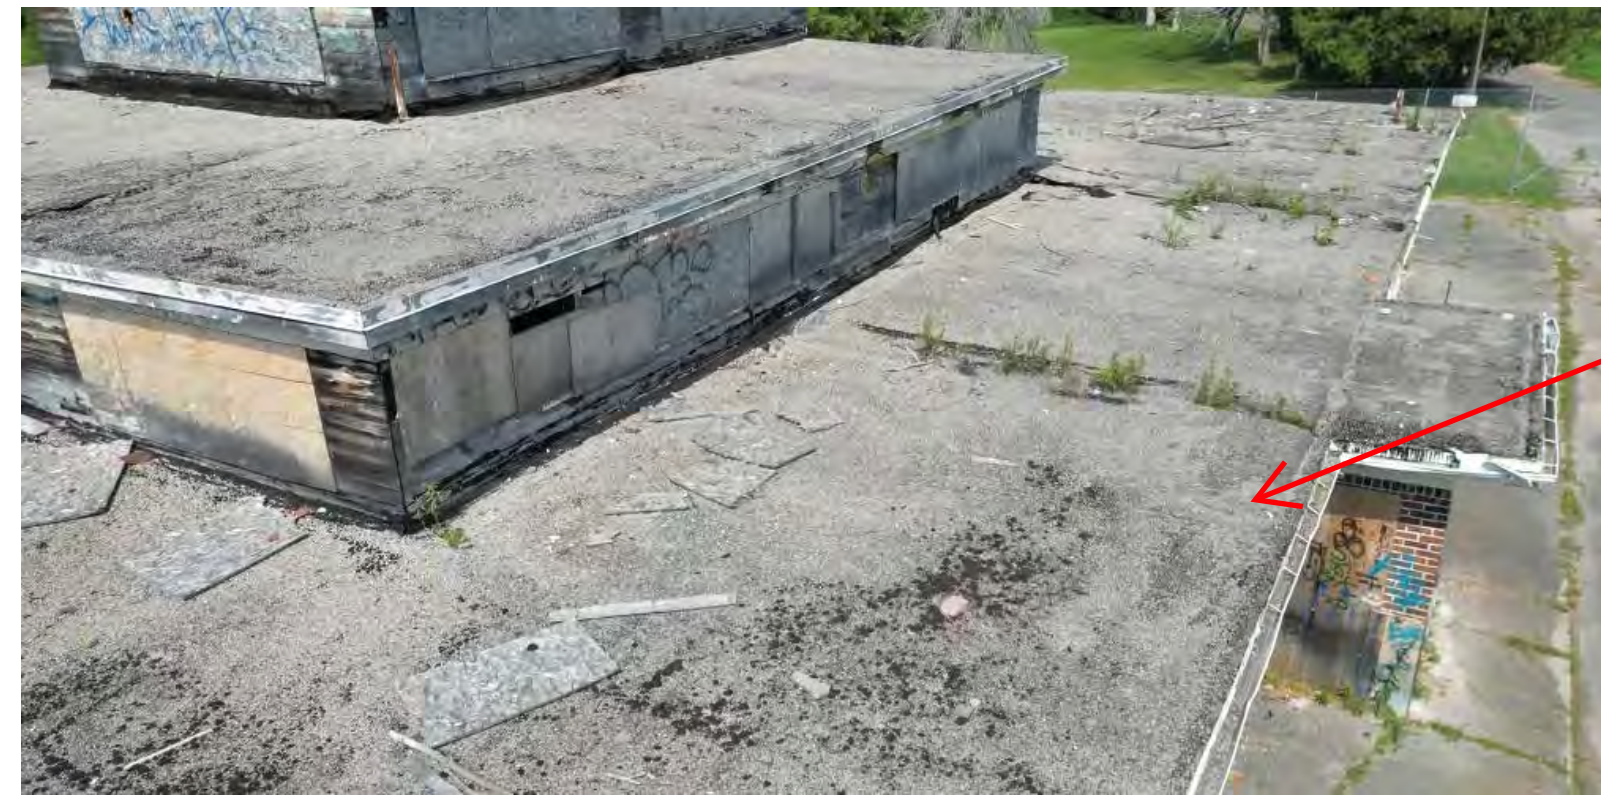
DETERIORATED ROOF AND BIOLOGICAL GROWTH

DO LOCALIZED REPAIRS TO ALL THREE LEVELS OF EXISTING ROOF WOOD PLANKS WITH 3/4" PLYWOOD SHEATHING. ESTIMATED 40% OF ROOF. REMOVE EXISTING ROOF MEMBRANE AND ANY VEGETATION, ALL LEGACY MECH & PLUMBING PENETRATION THROUGH ROOF. PATCH FASCIA BOARD, REMOVE DETERIORATED FLASHING AND GUTTERS THROUGHOUT AND INSTALL NEW FLASHING, GUTTERS, AND RWL'S. INSTALL 5 YEAR TEMPORARY ROOF MEMBRANE ON ENTIRE ROOF

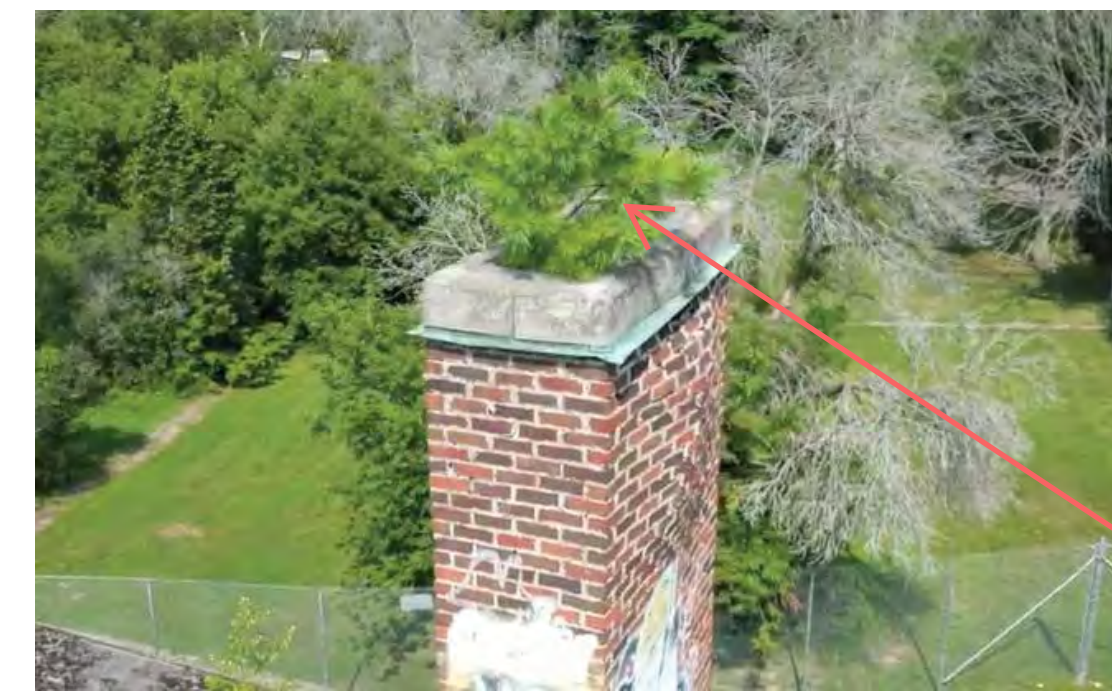
DETERIORATED CHIMNEY SHOWN SIGNS BULGING AND VEGETATION GROWTH FROM THE FLUE

REMOVE ROOTS, TREE AND OTHER VEGETATION

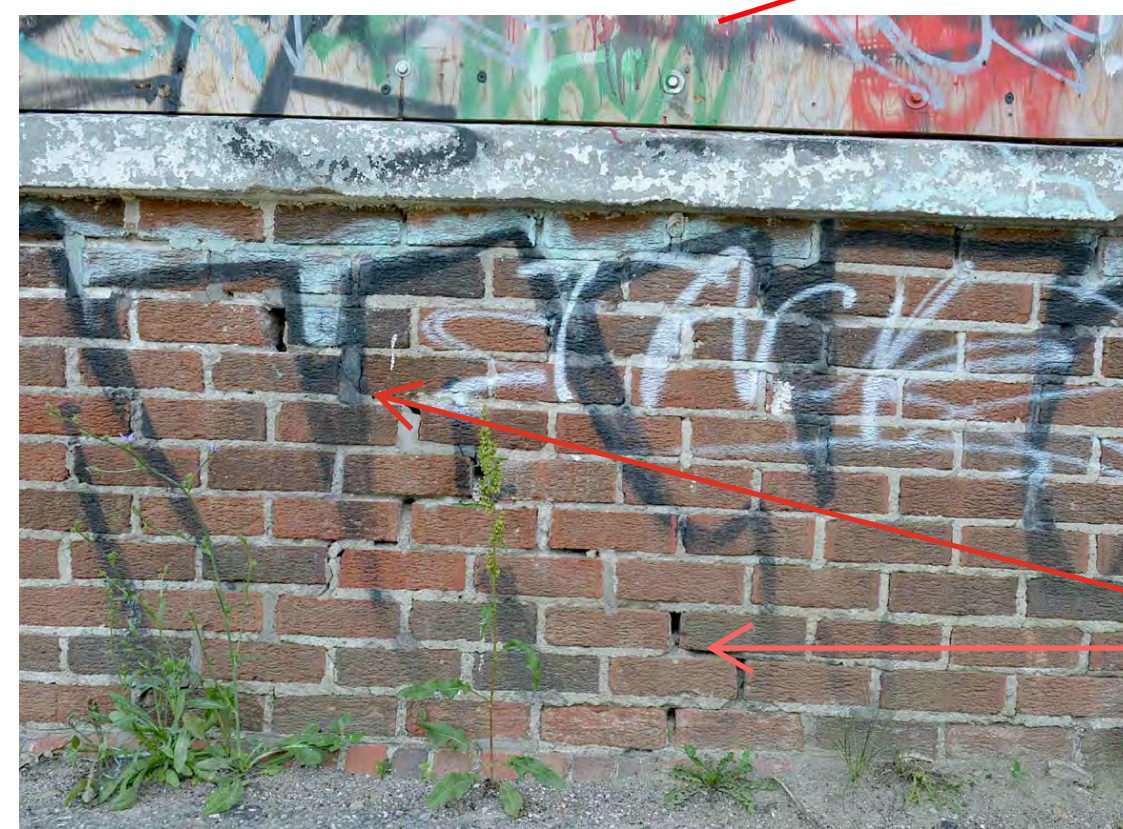
DETERIORATED MORTAR OINTS

MASONRY REPOINTING REPAIRS. ESTIMATED 35%
