Tree Inspection & Assessment of Red Oak, 21 Beech Street, Bowmanville, Ontario

September 22, 2020

Prepared for: Ken Mercer
Supervisor
Public Works Department
Municipality of Clarington
40 Temperance Street
Bowmanville, ON
L1C 3A6

Prepared by: Michael Richardson
Ontario Line Clearing & Tree Experts Inc.
7790 Telephone Rd
Cobourg, ON
K9A 4J7

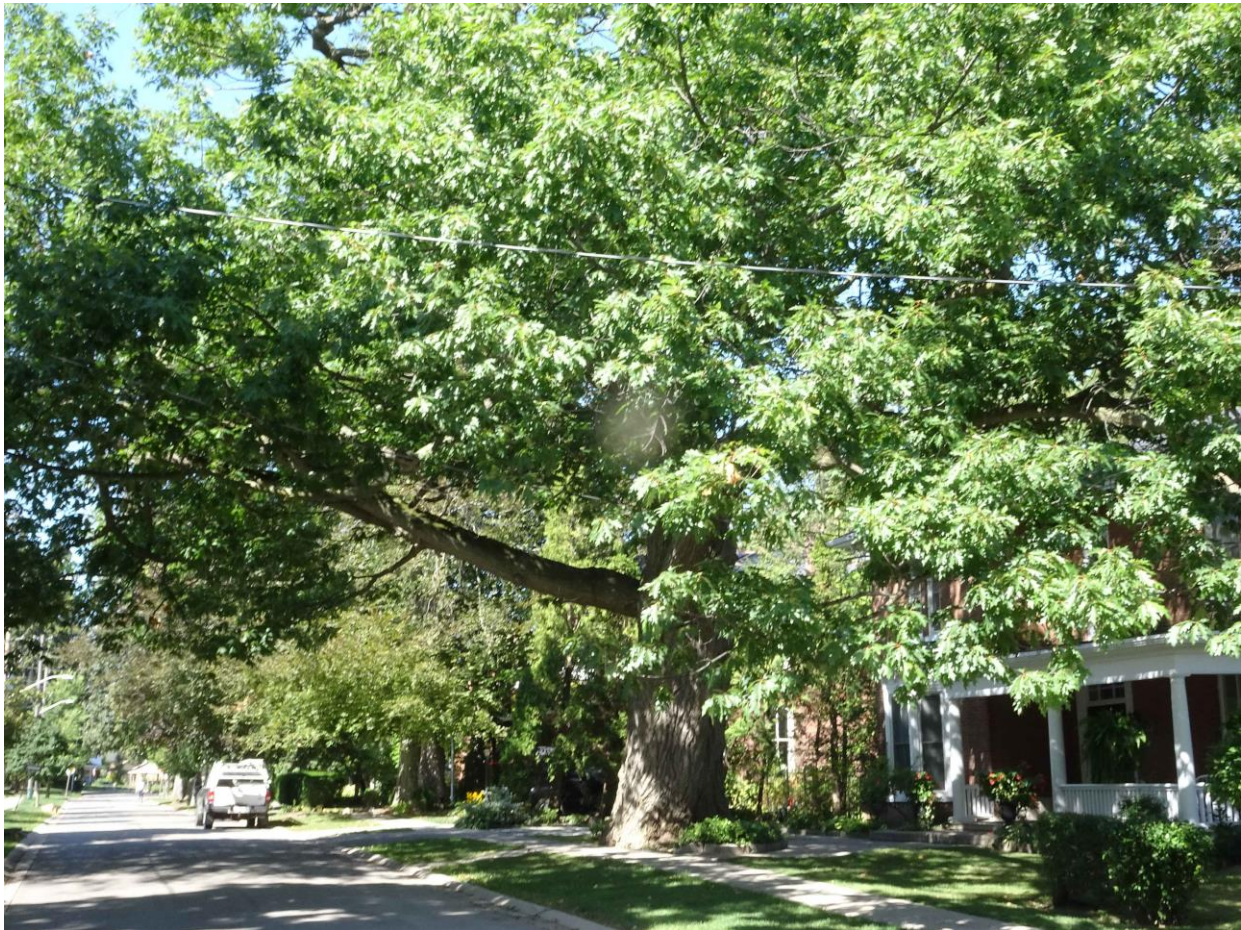
Photographs of Subject Tree

Location - in front yard between the sidewalk and the house at 21 Beech St. Lower limbs reach from the tree to the west side of road and from the tree to the house and the driveway to the south. The sidewalk has been adjusted to flow around the tree.

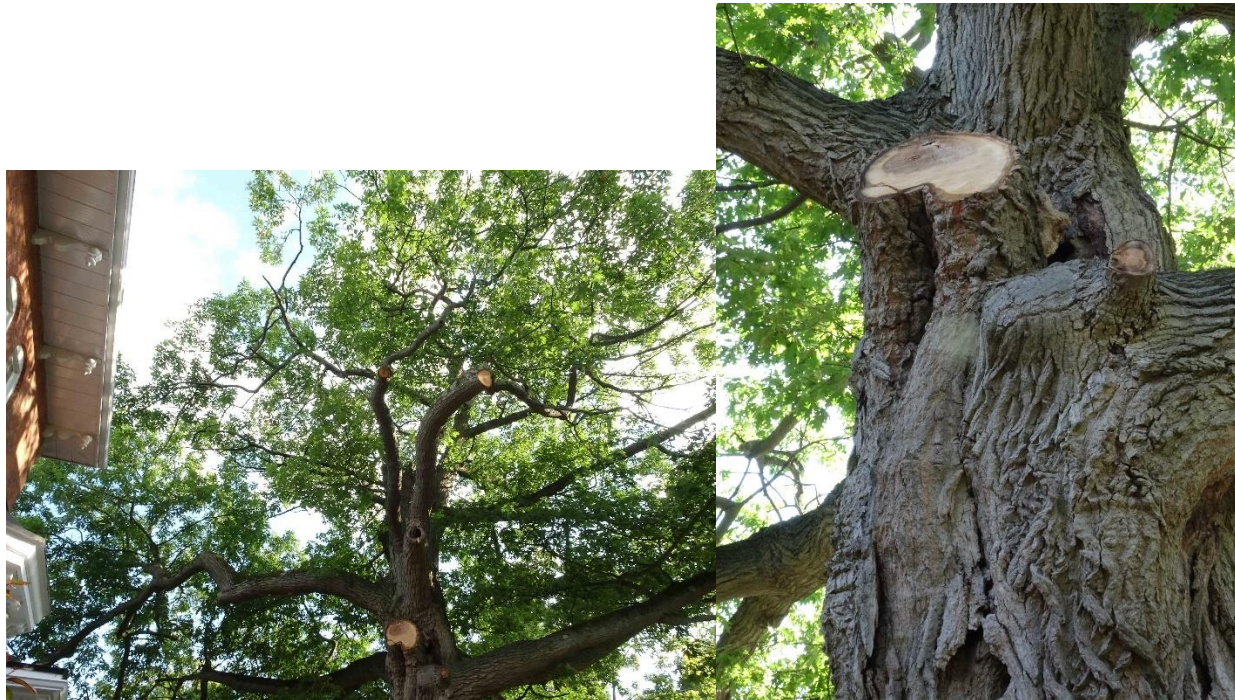
Photograph(s) of Noted Defects/Features

Presenting defects/features – a large limb on the north east corner of the tree has fractured this past summer and landed on the house. The broken branch union reveals a cavity centred in the stem.

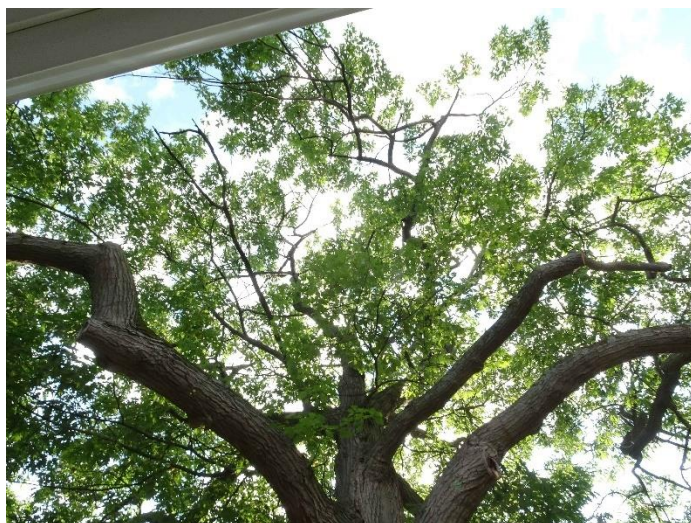
The crown has been heavily pruned in the past as evidenced by the large pruning wounds. The crown is in decline as many dead branches and thin areas exist.

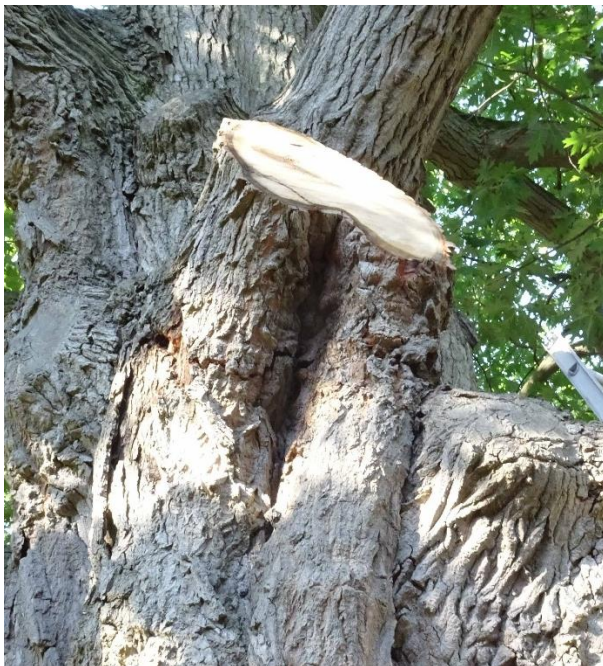
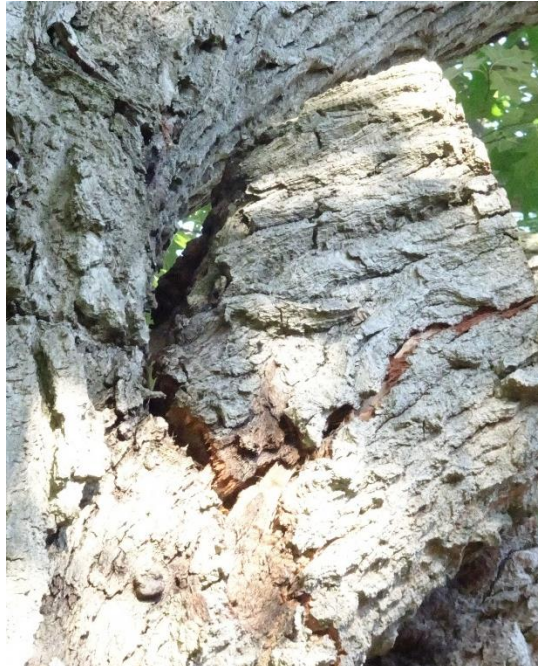
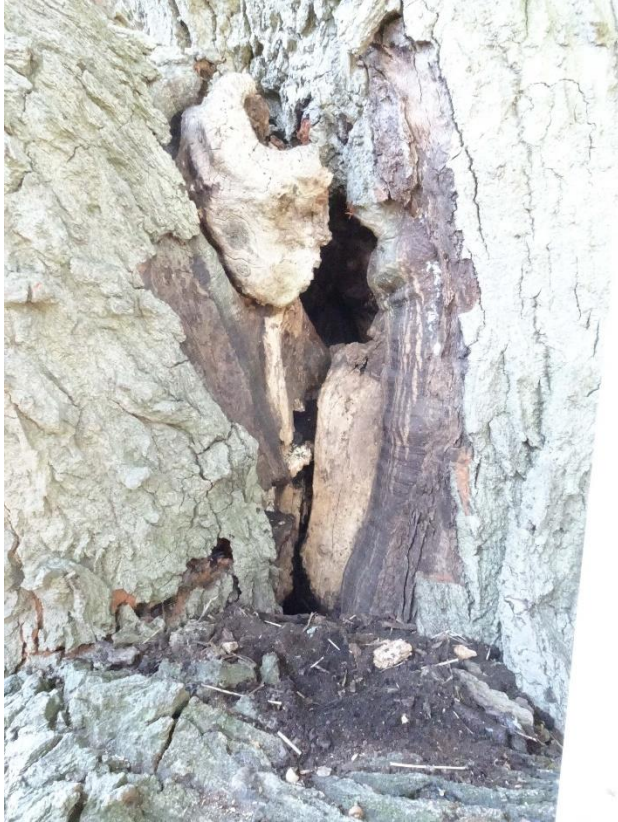
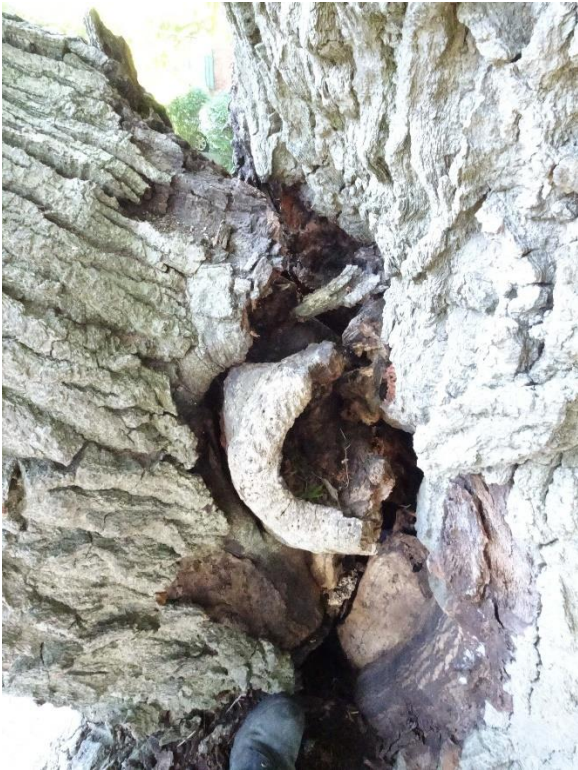
The failed limb fractured because there was no integration of the branch fibers into the trunk on the upper portion of the of limb combined with the weight applied to the long lever arm. This is a very common failure mode in large oaks. The cavity within the trunk played no role in the failure.

There are very well-formed growth ribs on the underside of the failed limb. The large growth ribs are pushing the limb up but the traditional tension mode of angiosperms was lost many years ago on this limb.

There is no connection between the limb and the trunk on the upper half of the limb. This is identified by included bark, the loss of the branch bark ridge. Near vertical apparent connection interface, and in the photo of the fracture the loss of toothpick like fibres above the fracture line.

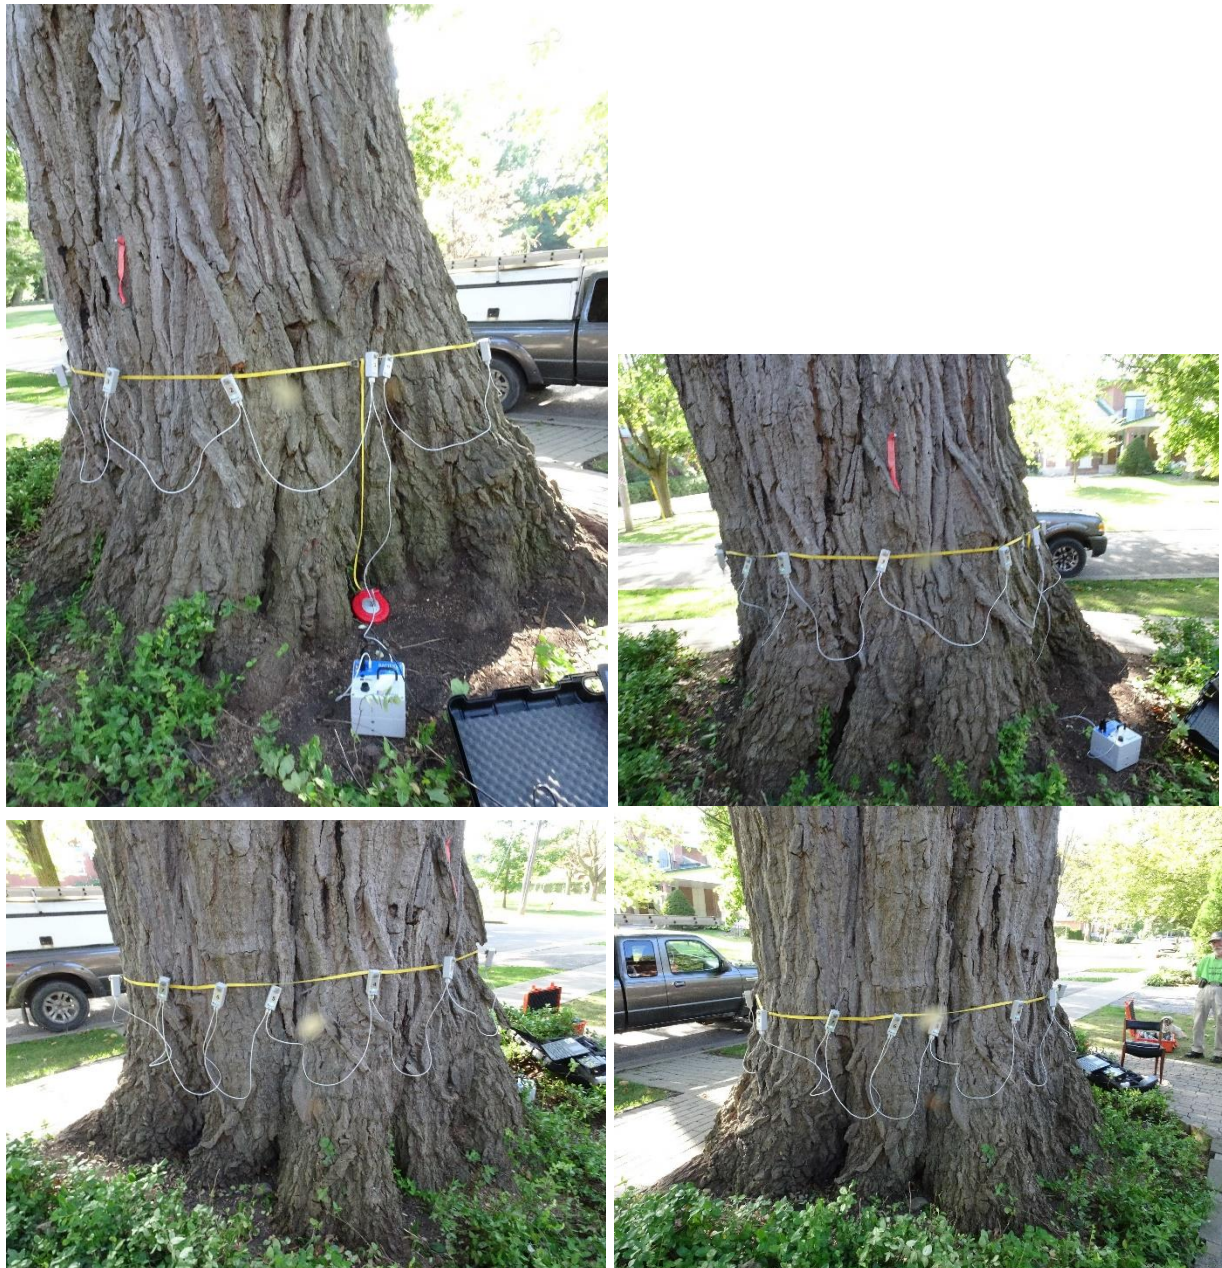
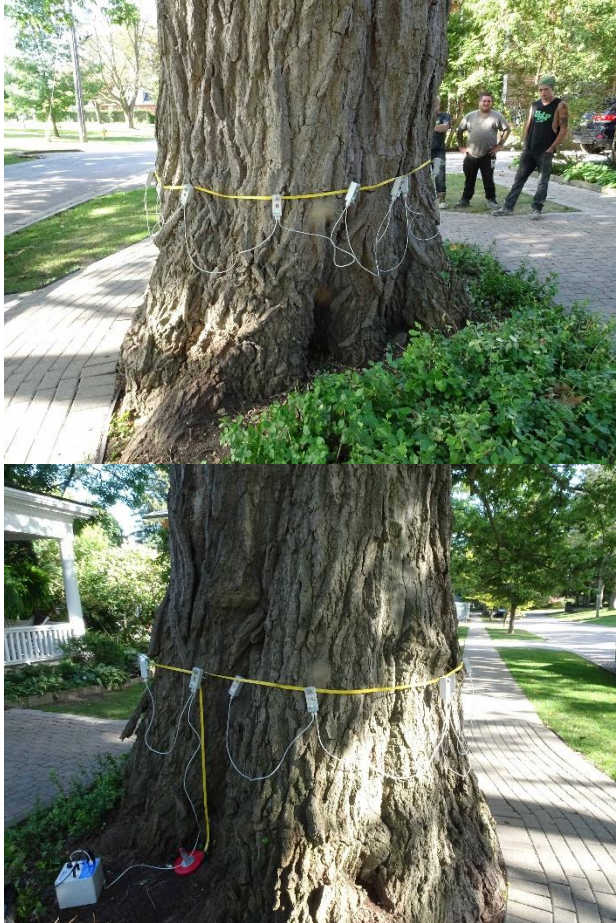
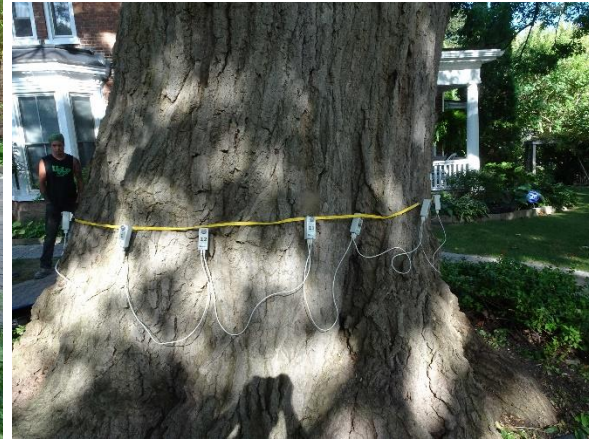
Photograph(s) of sensors installed on tree and cross-section height

The area of the trunk was inspected using Rinntech Arbotom® Sonic Tomography and Rinntech Resistograph®. The yellow tape and sensors indicate the level of the inspection. Measuring point 1 is to magnetic north.

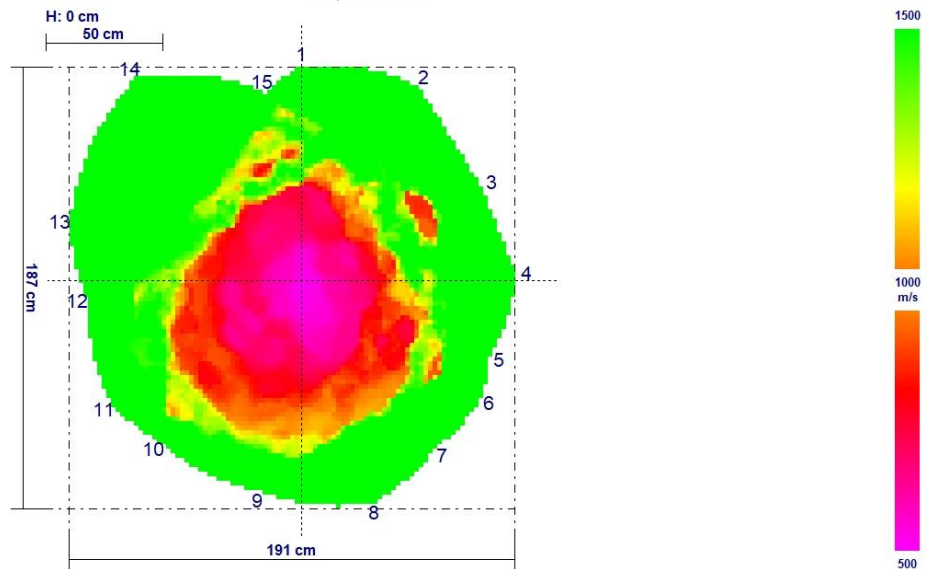
Tomogram of Cross-section Shown in Above Photograph

The tomogram shows loss of solid wood in the cross-section primarily progressing from the center (pith) area towards the edge. Green indicates solid wood while yellow indicates incipient decay and reds and purple complete loss of physical structure.

Central heartwood decay is expected and typical of large old oaks.

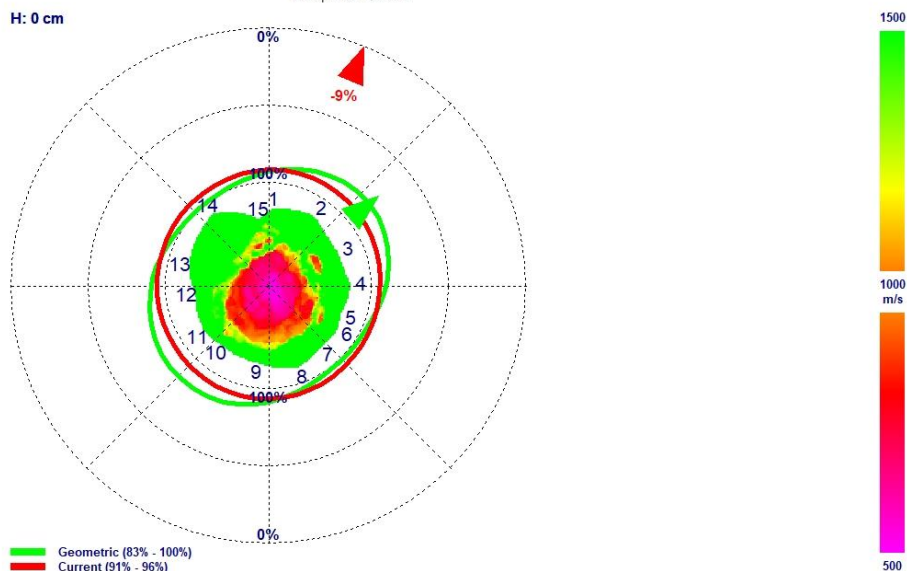
Tomogram with Mechanical Interpretation of Strength Loss

The second tomogram image indicates a maximum loss of 9% of the load carrying capacity of the cross-section as compared to the geometrically same cross-section with no decay.

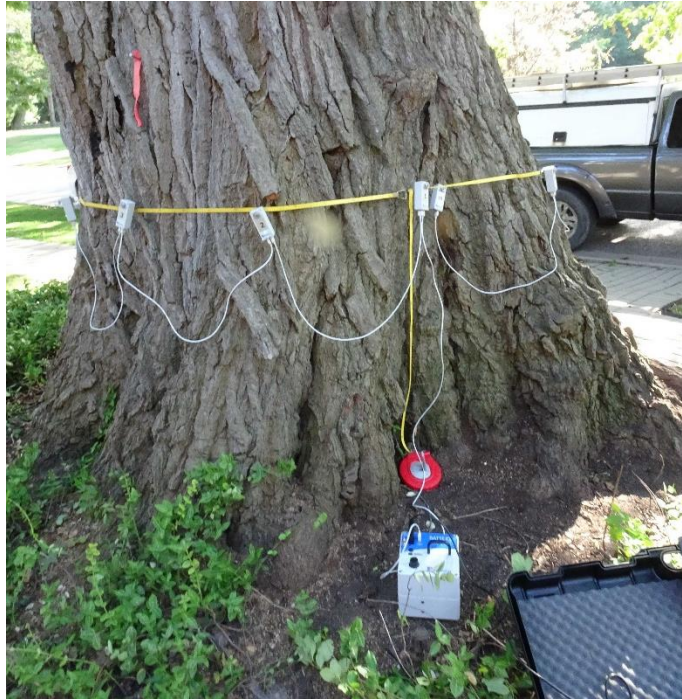
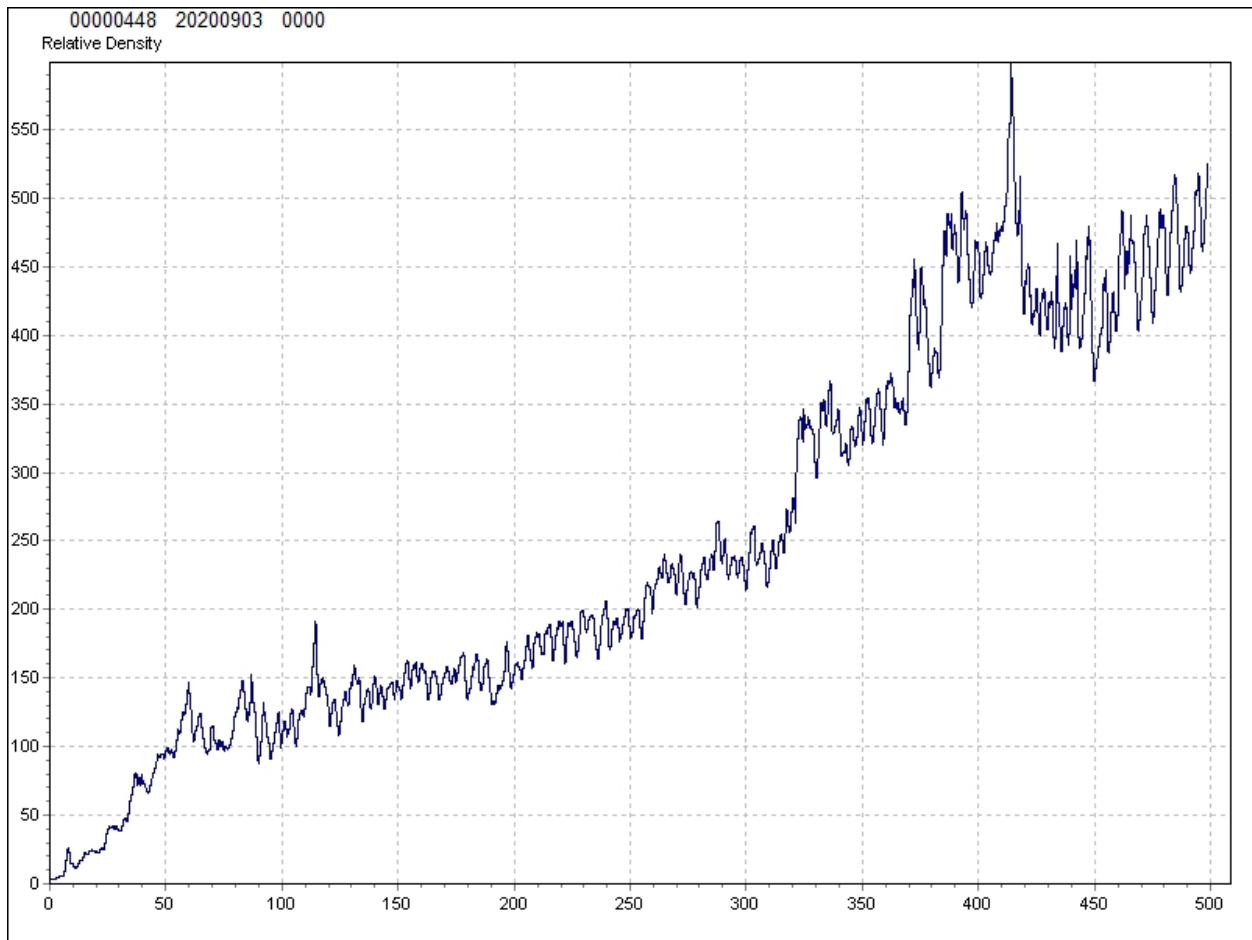
Resistance drilling confirms the decay is centrally located and there is a solid intact shell wall.

The tree was drilled on the east face at the top of the red ribbon. The wood was intact to a depth of 50 cm.

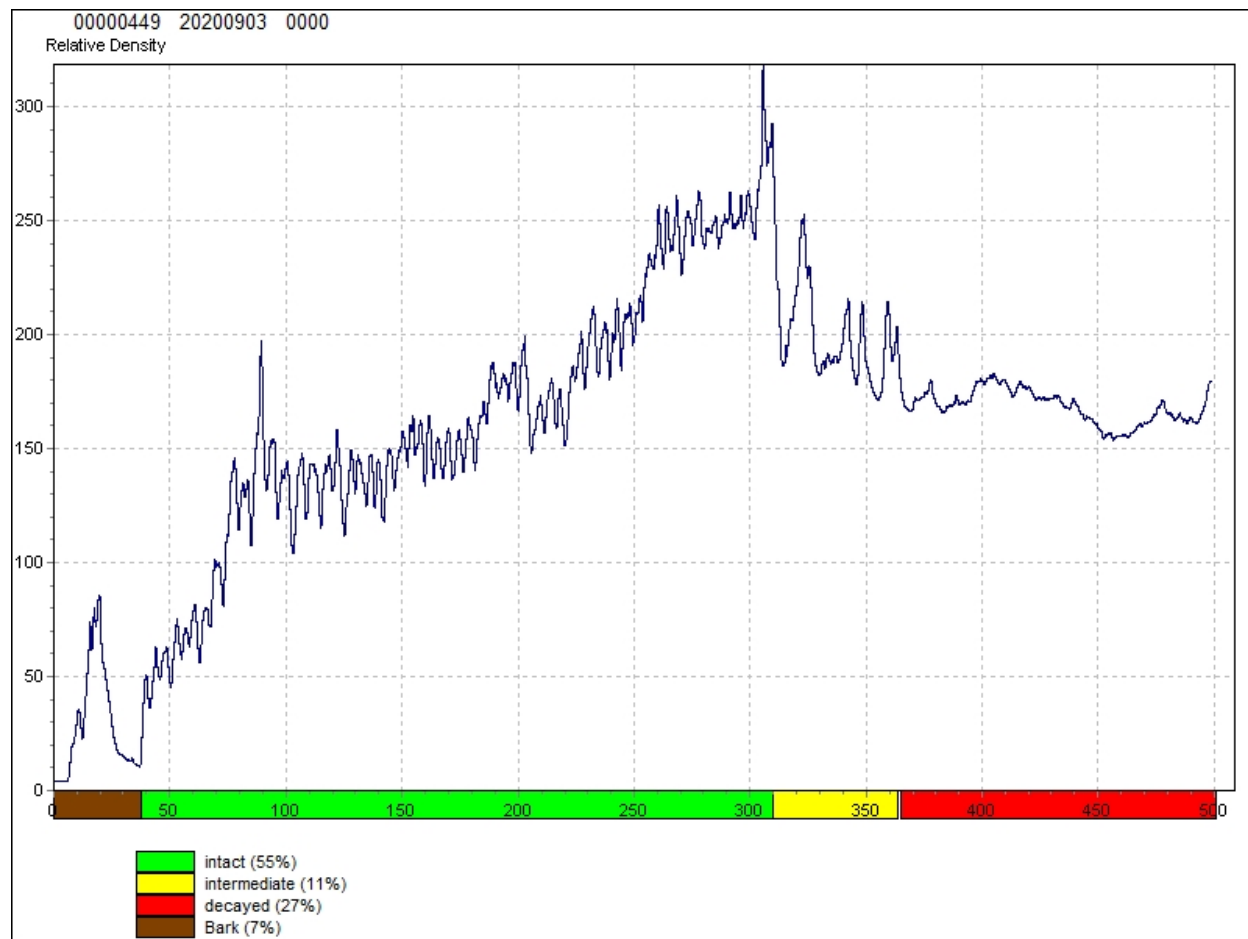
The tree was drilled at the southwest side near measuring point 10. This area was expected to have the thinnest shell-wall. There is approximately 27 cm of intact wood at this location.

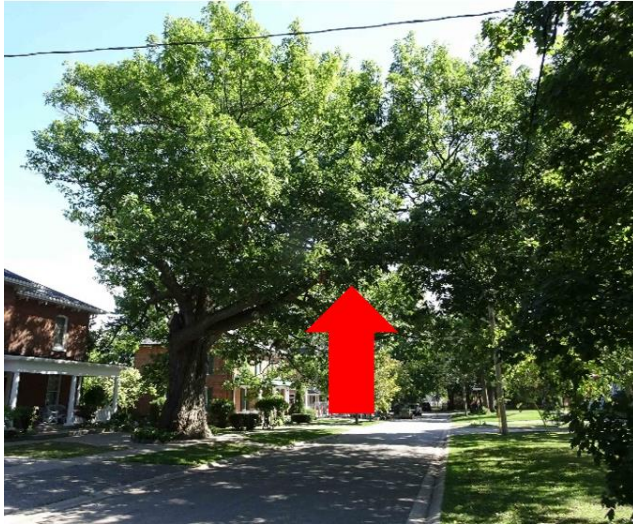
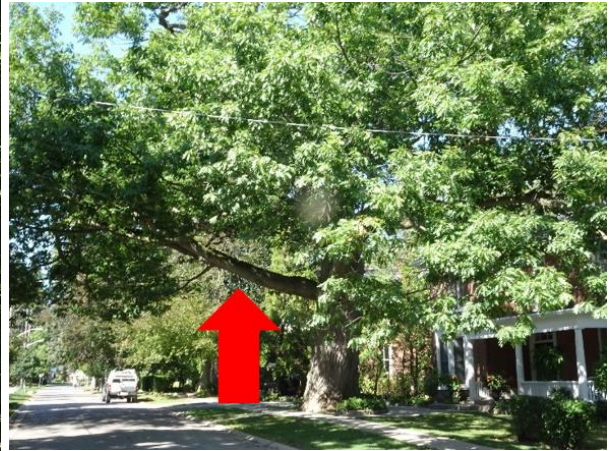
There is a large limb over the road that stretches across the road and intersects another tree. The limb is relatively horizontal with most of the leaves situated at the distal ends. There are very few branches and sprouts along the limb.

It is my opinion the likelihood of failure of the limb over the road in the next five years is probable, the likelihood of impacting someone on the sidewalk or a vehicle is medium, but the consequences of failure is severe resulting in the limb having a risk rating of moderate.

Option 2. It is my opinion that to retain the tree the two lower limbs must be mechanically supported and the upper crown supported as necessary. This work will require a complete inspection of tree to determine likely failure points, the loads they represent and the requirement of the support materials. Pruning, including dead-wooding and crown reduction must be specified based upon the need to maintain as much live canopy as possible.

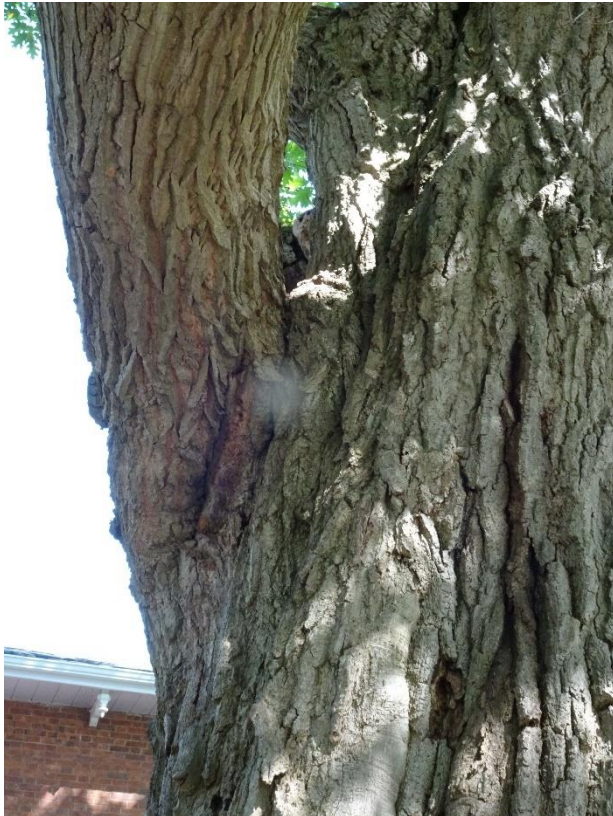
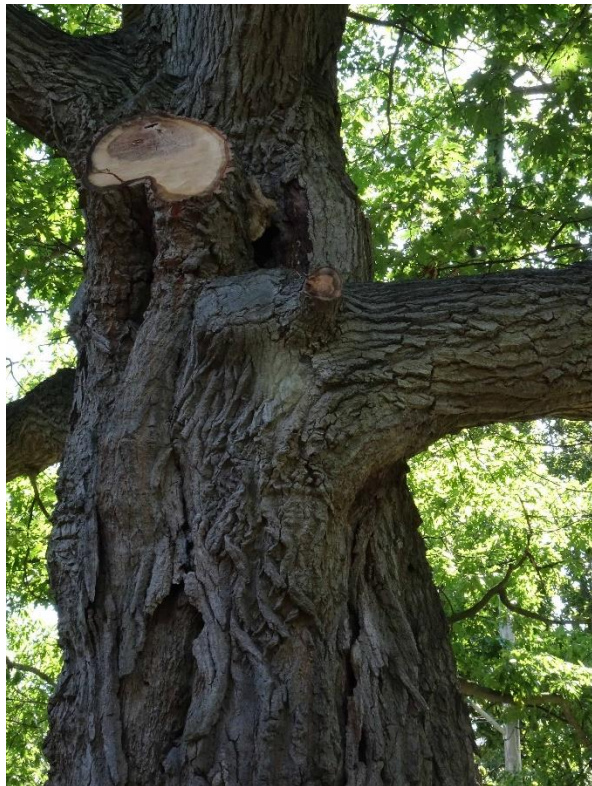
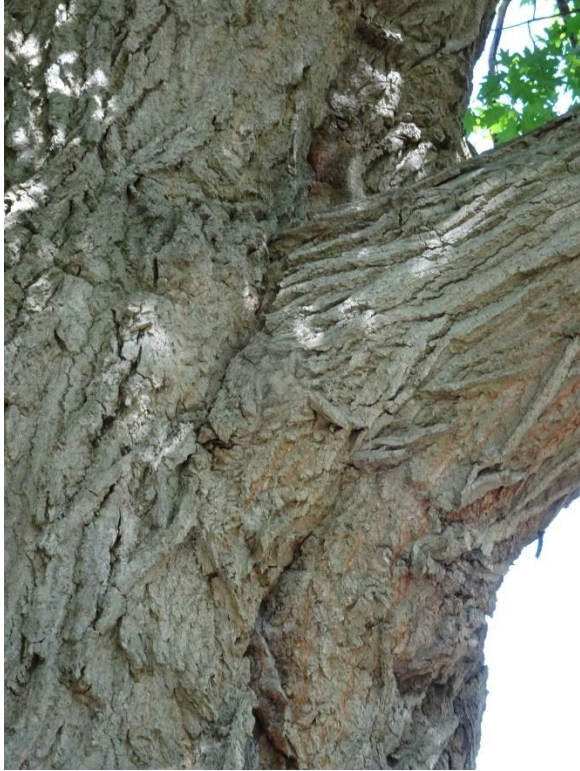
The limb is attached in much the same way as the failed limb. There is strongly included bark and nearly vertical apparent attachment where a blank branch ridge should occur.

It is my opinion that the two lower limbs will fail in the next five years. These limbs can fail at any time as the length of the lever arm, weight, and poor branch attachments all combine to make it likely the limb will fail do to gravity alone with no added dynamic forces.

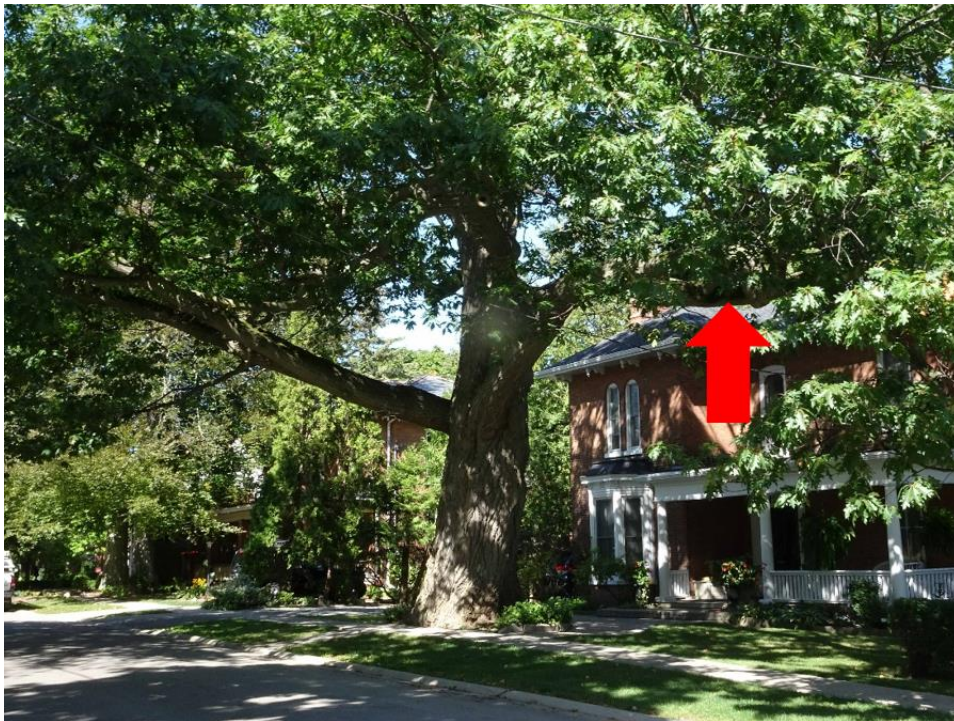
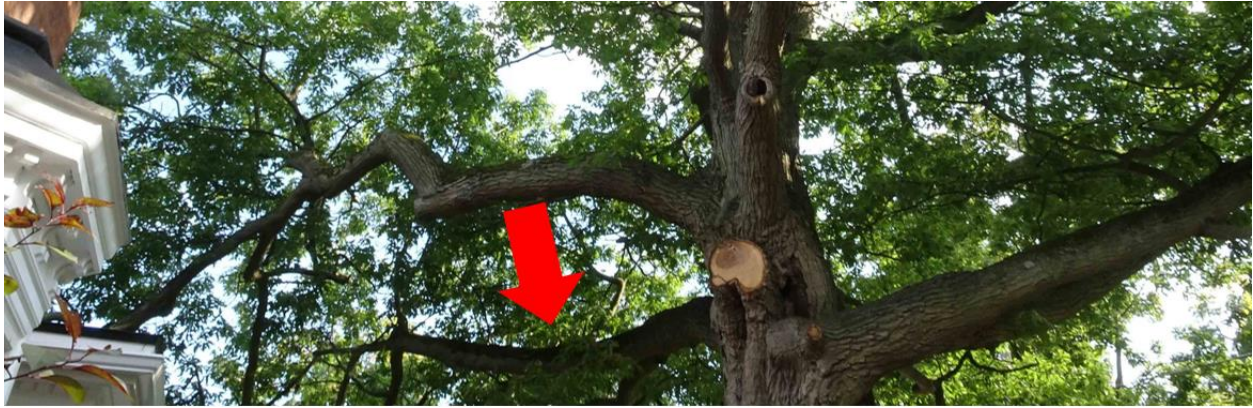
The other large lower limb stretches southward across the lawn and reaches the driveway of the house to the south.

It is my opinion the likelihood of failure of the southern limb in the next five years is probable, the likelihood of impacting someone on the sidewalk is low, but the consequences of failure is severe resulting in the limb having a risk rating of low.

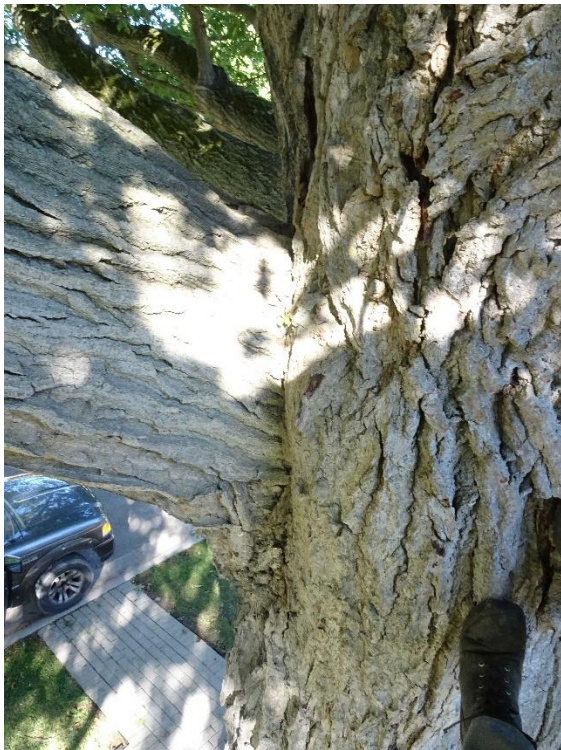
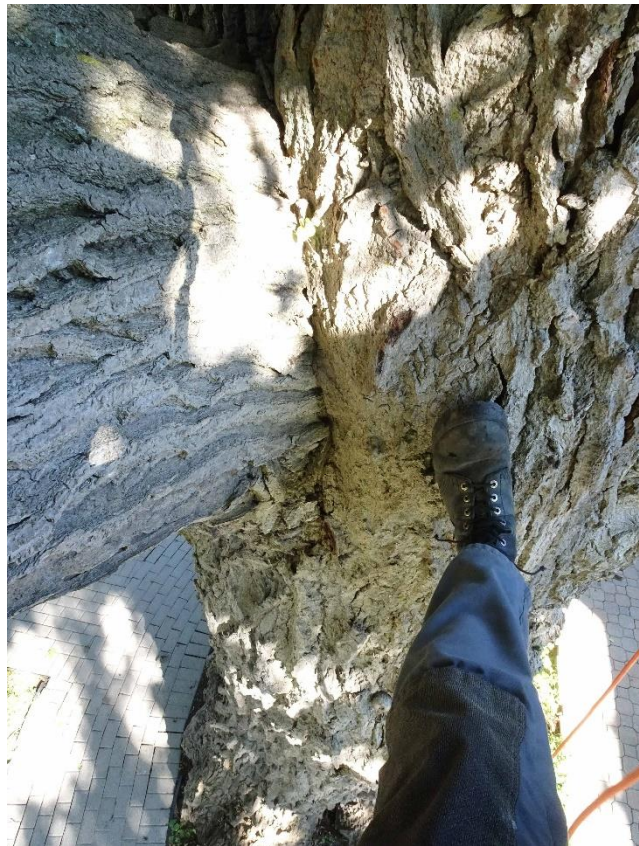
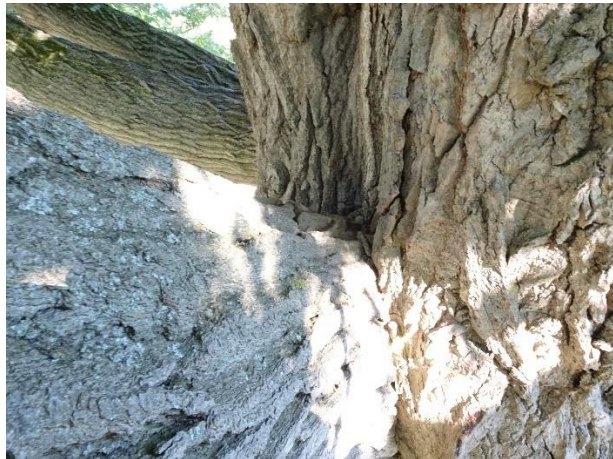
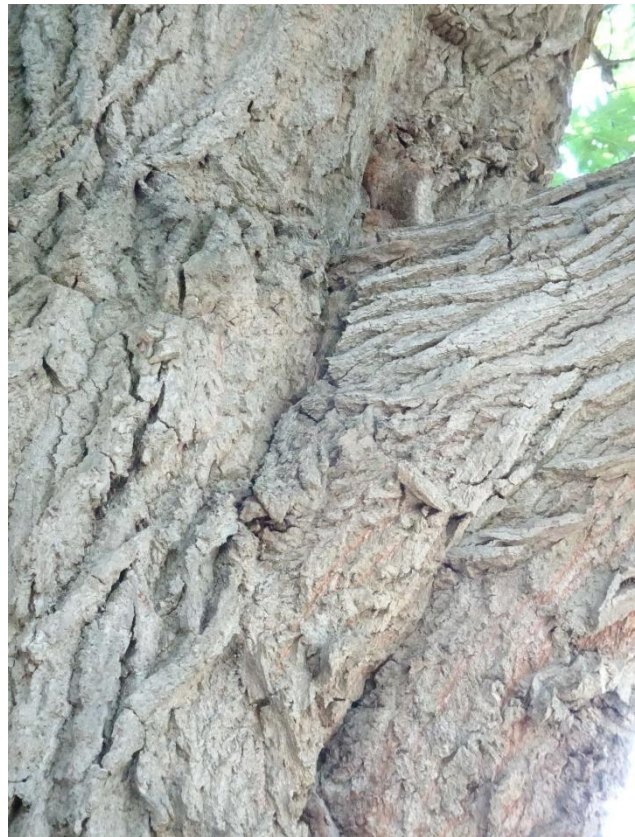
This south limb also has very similar branch attachment characteristics as the limb over the road.

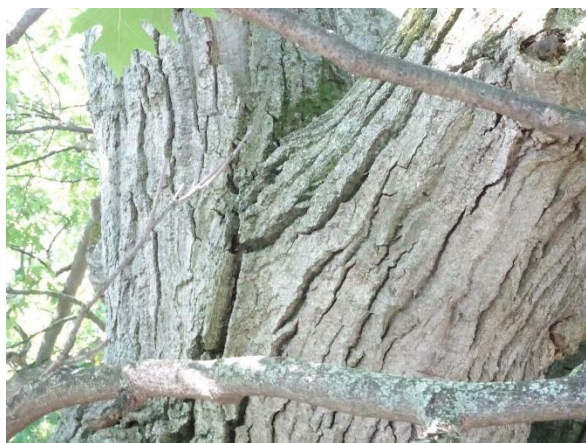
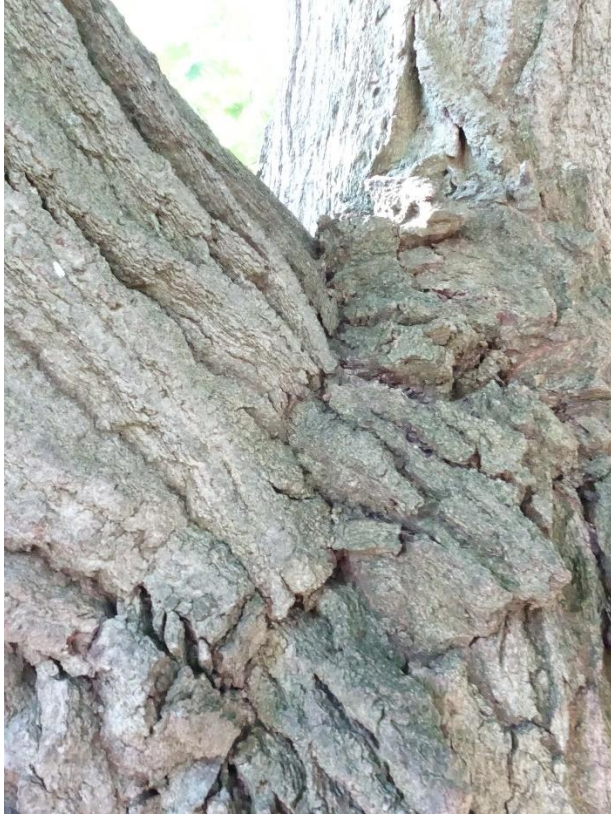
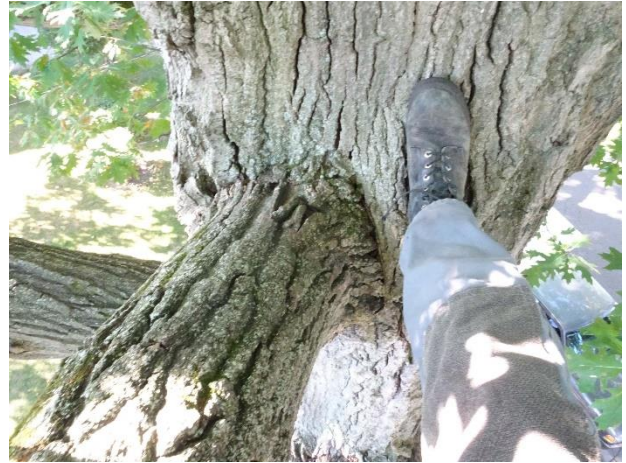
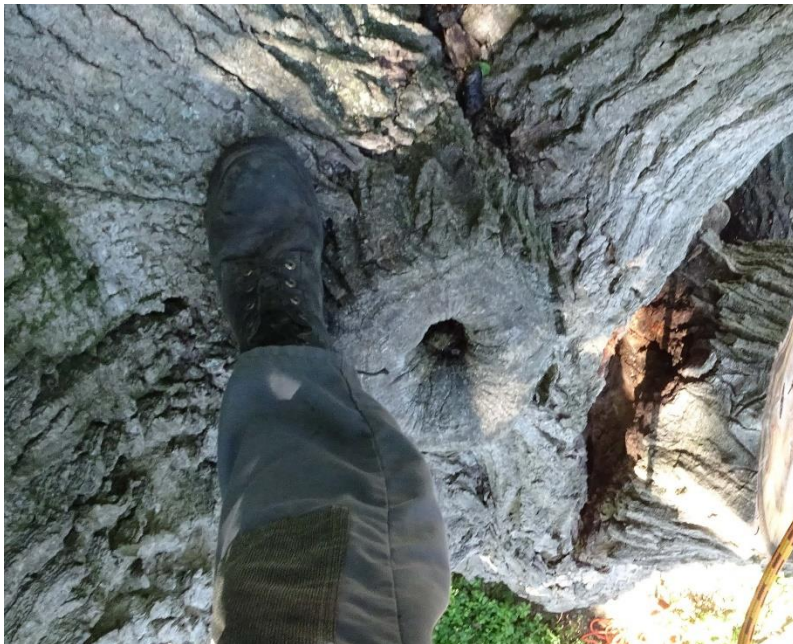
There are many other smaller limbs in the canopy with very similar poor branch attachments. Many of these can fail at any time.
