5/18/2021

Arborist report

21 Beech Ave, Bowmanville

Ruurd van de Ven, ISA BCMA

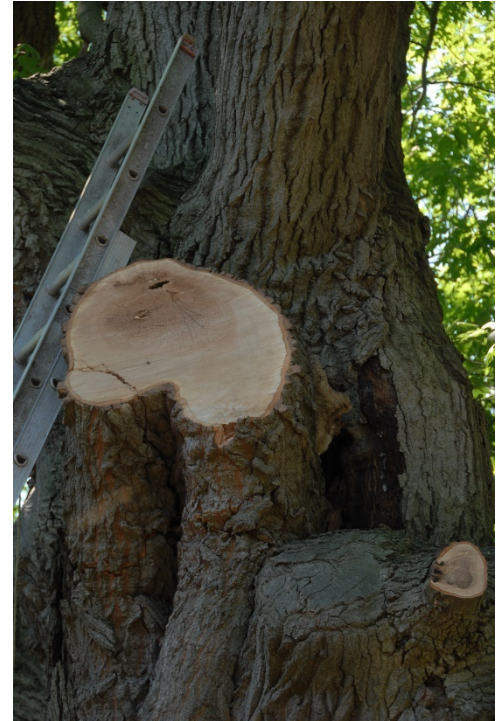
A large limb had broken off this tree on June 30, 2020, the limb that broke off left a wound on the trunk measuring 60 cm in diameter. This had broken away from the trunk leaving a 40 cm gap in behind. There was some decay in this gap. Two areas of reaction wood have formed at the underside of this limb (compression wood).

The photograph to the left shows the wounds as well as the two areas of reaction wood at the bottom of this limb.

failed. Here the compression wood was holding the branch in place until it ultimately failed. Not due to the limb failing but due to the branch union failing.

The failure of the limb over the house can be contributed to two main factors, poor attachment to the tree and excessive weight of the limb. Since this tree had not been maintained for many years, this condition was allowed to continue and over time a failure such as this will occur. Very old pruning wounds can be seen throughout the canopy. These large wounds indicate that when the tree was pruned last an attempt was made to reduce the canopy.

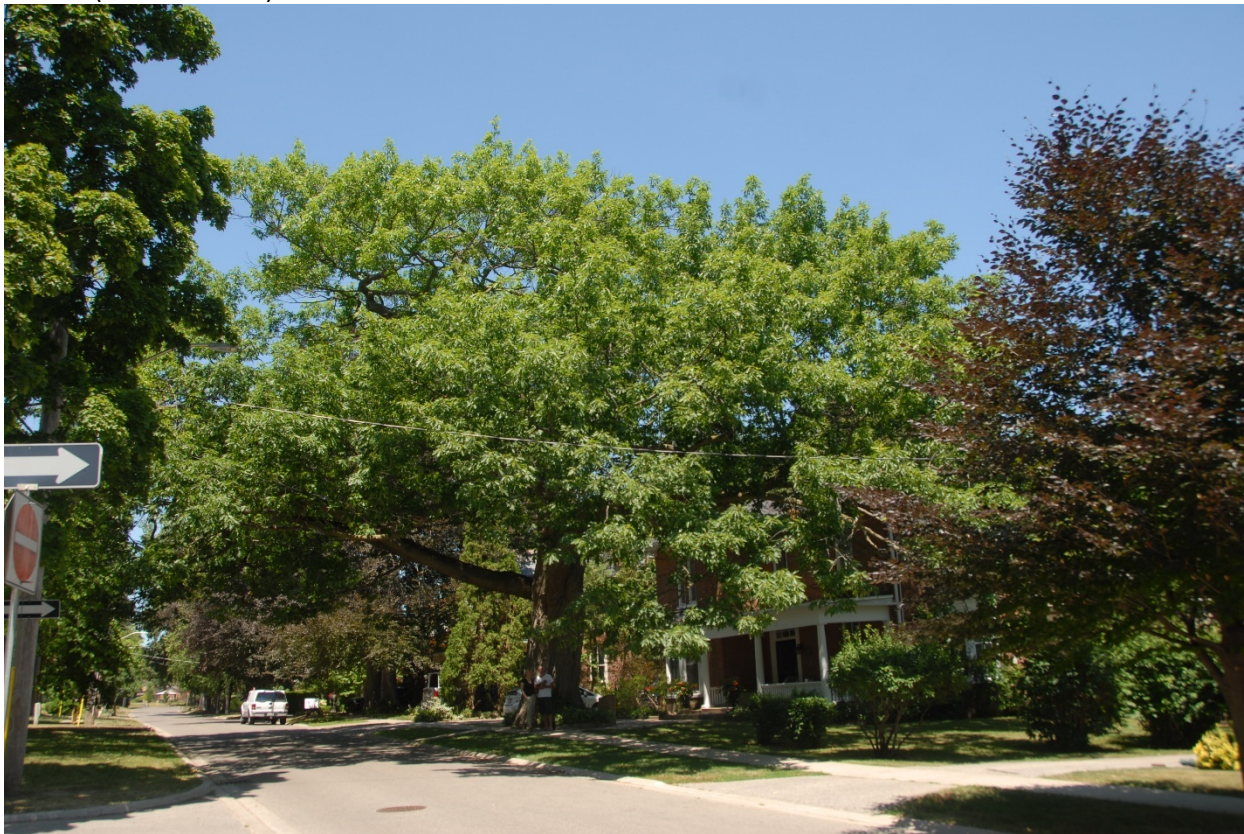
This tree is approximately 20 m tall and has a crown spread of about 50 m. This tree has some very long over extended limbs in the lower half of the tree. One limb is over the traveled portion of the road. This limb extends 24 m over the road and where the limb is attached to the tree it is 69 cm in diameter. This long limb over the road has an oval shape with a substantial amount of reaction wood on the top side of this branch (tension wood).

Angiosperms create reaction wood on top of branches away from the force that is working on it. In this case gravity is pulling the limbs down to the ground so the tree has formed tension wood on top of the branches to help hold them up. The cell structure in this portion of the limb is different and stronger than the rest of the cells and thus it helps in keeping the branches in place. This tree in addition to forming tension wood it has also developed some compression wood at the base of the limb that has

The risk assessment of this tree does indicate that in its current state this tree is a moderate risk of failure. If left unattended that large limb over the road will eventually fail and could potentially cause damage or injury.

Current risk situation: This tree if left unattended will probably fail in the next 5-7 years. This in combination with a severe likelihood of damage and/or injury results in a moderate risk for this tree.

This tree has some very large limbs that will need to be reduce in length to prevent failure of the limbs. One limb over the road is posing the highest risk currently. Reduction of this limb will result in the removal of about 10% of live tissue.

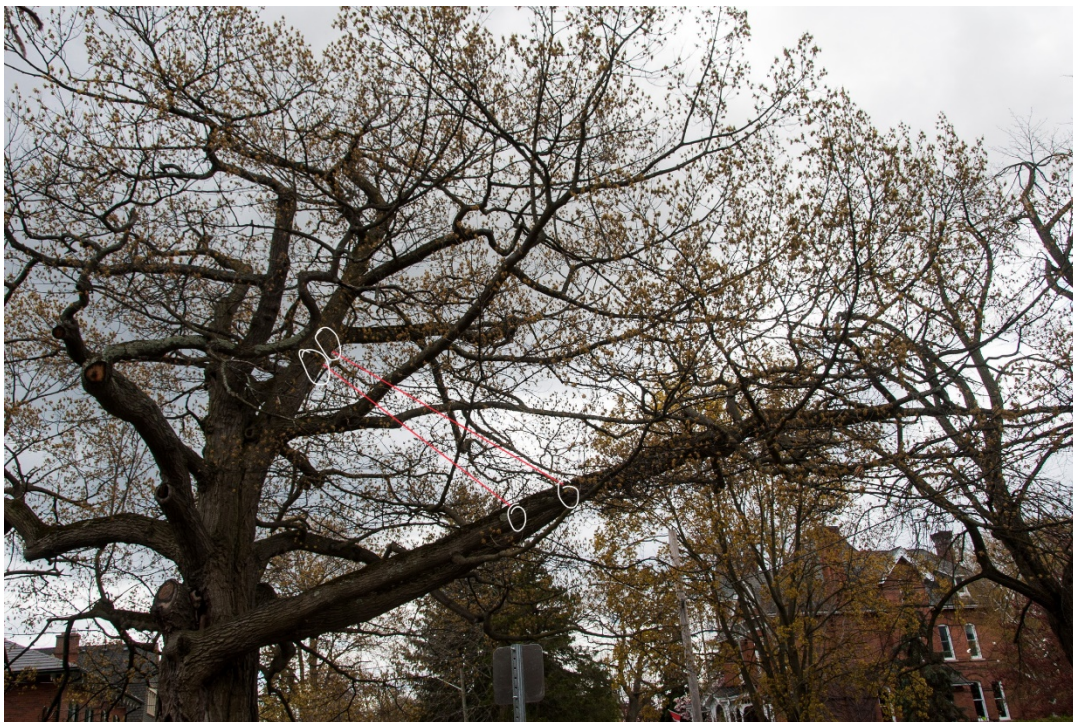
Objectives: This tree has some very long limbs that will benefit from the installation of a cabling system.

- The systems shall be installed to the ANSI A300 Standard (Part 3) supplemental support systems.
- The system shall employ through bolts and Amon eye nuts or eyebolts 5/8" in diameter
- The system shall employ Extra high strength cable 7/16" in diameter or Aircraft cable 1/2" in diameter.
- The system, shall be installed in the approximate location as indicated in the photograph. This location shall be confined on site in consultation with the consultant
