October 15, 2021

RE: Review of Arborist's Reports for 21 Beech Street, Bowmanville, Ontario

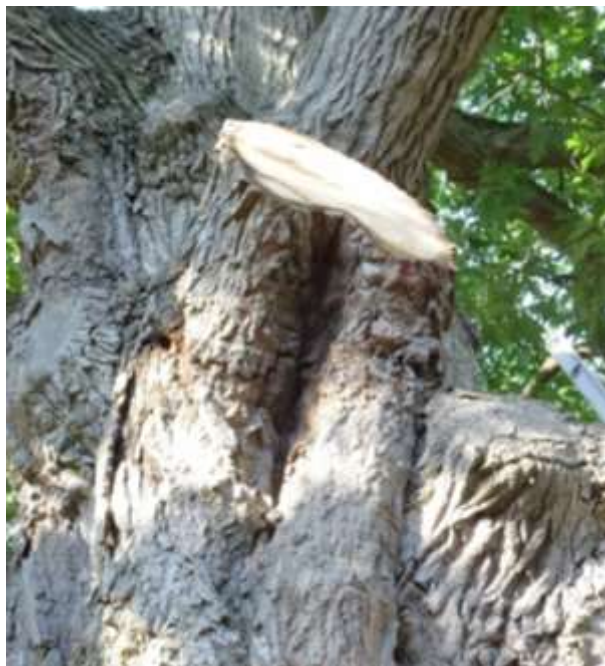
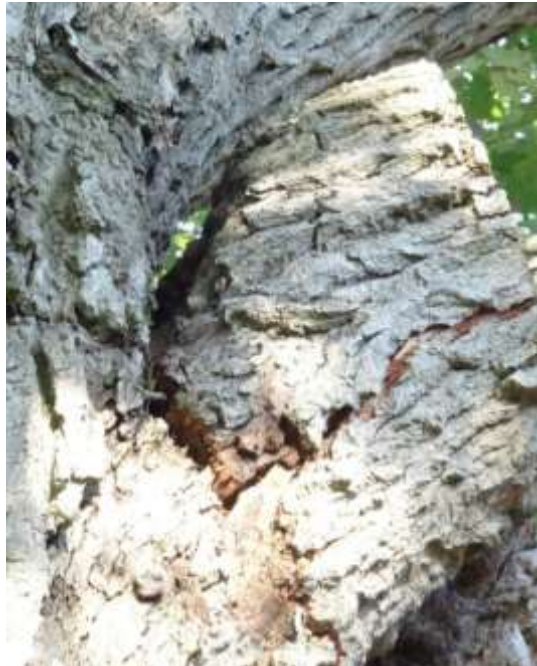
The failed limb fractured because there was no integration of the branch fibers into the trunk on the upper portion of the of limb combined with the weight applied to the long lever arm. This is a very common failure mode in large oaks. **The cavity within the trunk played no role in the failure.**

There are very well-formed growth ribs on the underside of the failed limb. The large growth ribs are pushing the limb up but the traditional tension mode of angiosperms was lost many years ago on this limb.

There is no connection between the limb and the trunk on the upper half of the limb. This is identified by included bark, the loss of the branch bark ridge. Near vertical apparent connection interface, and in the photo of the fracture the loss of toothpick like fibres above the fracture line.

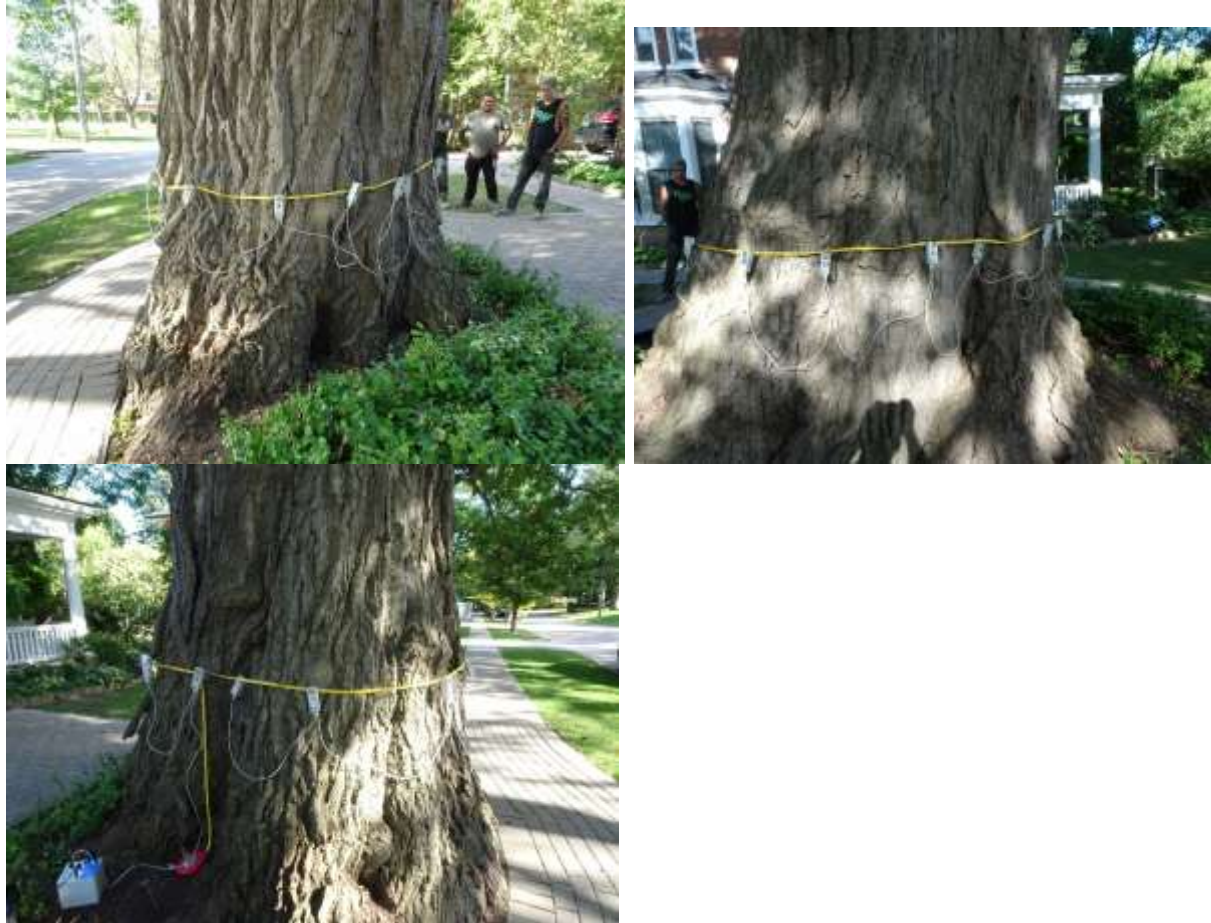
Tomogram of Cross-section Shown in Above Photograph

1. From Michael Richardson: The Tomogram Cross-section on page 10 shows an intact wall of live, solid wood and the Resistograph Drilling confirmed the same. This was done one metre above the ground but from my observations, I believe that this characterizes the entire trunk, up into the crown. Therefore, the structural stability of the trunk is not in question. Michael also mentions this on page 7 of his report when referring to the large limb that did fail. He said, "The cavity within the trunk played no role in the failure". I would agree with that statement.
2. Both reports indicate the current risk is with the two long, heavy limbs; one on the west side and one on the south side. I would agree. The union of the two limbs with the trunk both have included bark which creates weakness and the possibility of failure.
