MUNICIPALITY OF CLARINGTON

TRIAGE REPORT FOR
INSPECTION – RINK REFRIGERATION & PAD
ORONO ARENA & COMMUNITY CENTRE

2 PRINCESS STREET, ORONO, ON

SEPTEMBER 23, 2020

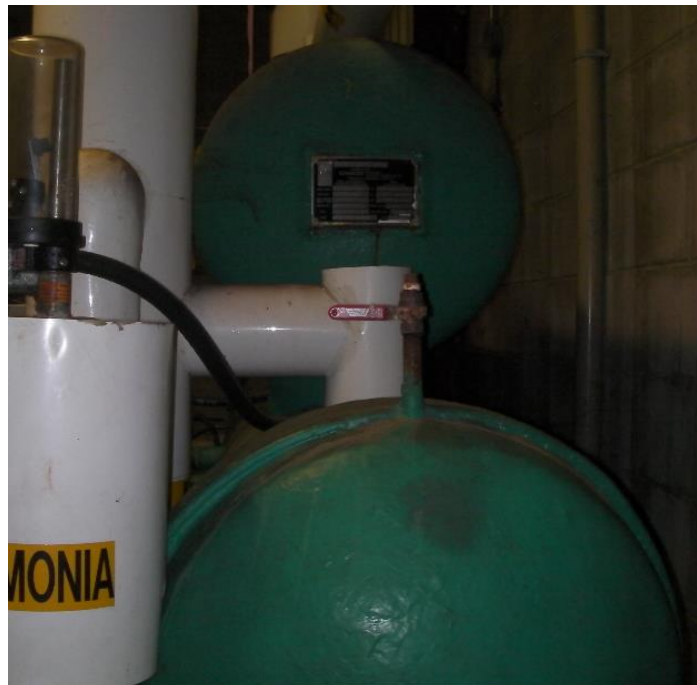
Figure 1: Chiller barrel and vessel.

- The chiller is very near the median end of life, and may be subject to failures in the near future. The chiller and attached surge drum are the primary ammonia storage vessels and given the hazardous nature of ammonia the chiller should not be allowed to operate near the median end of life.
- **Chiller failures are a serious risk to public health and safety because toxic refrigerant may leak. Replacement of the chiller should be considered as soon as possible¹.**
- Inspection of the chiller is due in January 2021 for insurance purposes.
- Chiller relief valves need to be replaced by June, 2023. This is a critical safety component.
- While the chiller and surge drum are covered in an insulating layer that limits direct inspection, exposed elements where piping connects shows significant signs of rusting. This suggests the potential for corrosion throughout the vessel.

Category	Recommended Action
Immediate Actions	<ul style="list-style-type: none"> • Have a brine analysis performed to check for ammonia contamination in brine as an early sign of chiller failure to mitigate danger to operators and users.
Short-Term Actions	<ul style="list-style-type: none"> • Have chiller and surge drum re-inspected by January 2021 for insurance purposes. • Replace chiller relief valves by June 2023 as required. • Perform ongoing monitoring of brine to test for potential chiller failure. Additional ongoing monitoring is recommended, including²: <ul style="list-style-type: none"> ○ Check for any increase in volume in the secondary refrigerant (brine) system. ○ Check for any unusual increase in pressure in the secondary refrigerant (brine) system. ○ Test the system heat exchange for leaks during the off season.
Capital Expenditure Planning	<ul style="list-style-type: none"> • Pursue opportunities to replace the chiller as soon as possible. <ul style="list-style-type: none"> ○ This is a significant health and safety risk. Replacing the chiller on its own or as part of a total refrigeration plant upgrade should be prioritized. Given the age of all of the equipment, a full plant replacement is recommended at this time.

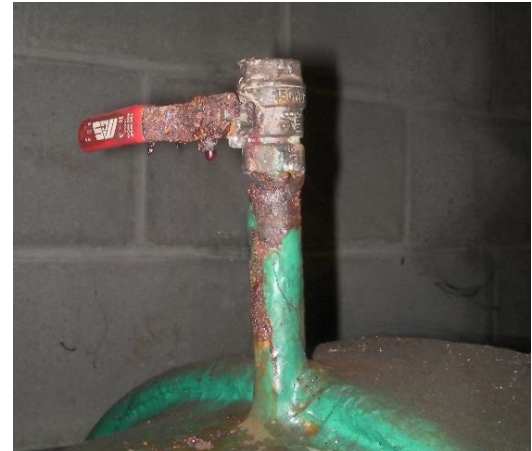
Figure 2: Signs of rusting on the chiller.

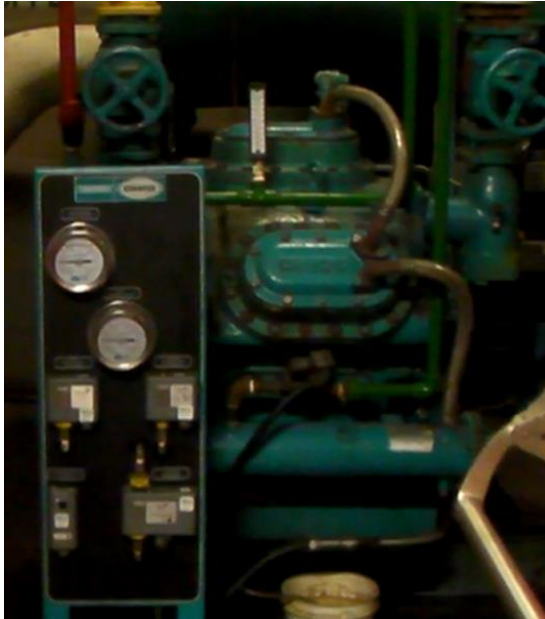
Figure 3: Compressor #1

- Both compressors are aged with signs of rust all over the unit.
- Both compressors are due to have reliefs replaced by April 2024.
- The compressors are nearing the end of the typical operating life for this type of equipment, beyond which it will become increasingly more expensive to maintain them.
- These compressors represent a significant safety risk, as they are compressing gaseous ammonia, a toxic, flammable refrigerant. Aging compressors pose a serious hazard to life and health.

³ There’s no nameplate attached to this compressor, but the equipment configuration matches with a Cimco C5-W06A.

- Though having multiple compressors allows for the system to continue operating at a limited capacity with only one compressor, these units are near the end of life and should be replaced. Plan for compressor replacements as soon as possible.

Category	Recommended Action
Immediate Actions	<ul style="list-style-type: none"> • Maintain routine maintenance procedures.
Short-Term Actions	<ul style="list-style-type: none"> • Replace compressor relief valves as needed. <ul style="list-style-type: none"> ○ Due for replacement April 2024..
Capital Expenditure Planning	<ul style="list-style-type: none"> • Pursue opportunities to replace the compressors as soon as possible. <ul style="list-style-type: none"> ○ Compressors are essential equipment for the refrigeration plant and ice cannot be maintained without them. Additionally, as the prime mover responsible for compressing ammonia mechanical issues with this equipment is a safety hazard. This equipment should be planned for replacement in conjunction with the chiller.

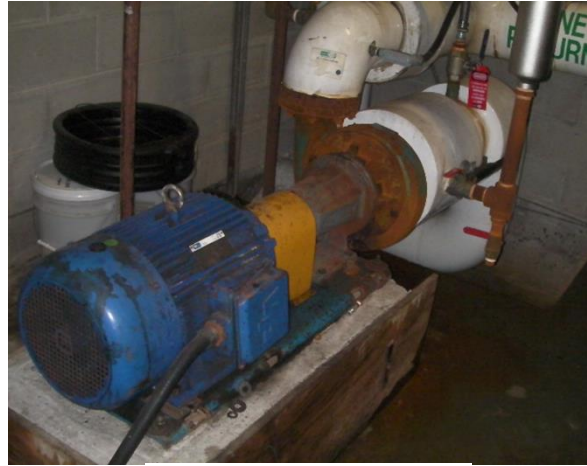
Figure 5: Cold Brine Pump

- The cold brine (secondary refrigerant) pump is showing serious signs of corrosion, with obvious rust all over the pump casing. The use of brine as a secondary refrigerant in the system may introduce greater stress on the equipment and reduce the overall service life.
- Brine as a secondary refrigerant requires regular maintenance and monitoring of corrosion inhibitors, and if this maintenance has not been carried out significant corrosion and damage to the pump interior is likely.
- Regular maintenance on the equipment should be maintained.
- The failure of this pump would disable the ice rink until a replacement could be installed.
- Plan for equipment replacement in 1 - 3 years. It is recommended that if the compressors and chillers are replaced, the brine pump be replaced as well for overall system longevity.

⁷ No data on the current age of this pump was available due to the conditions of the pump. Based on the advanced deterioration of the pump it is reasonable to assume that this pump is as at least as old as the chiller.

Category	Recommended Action
Immediate Actions	<ul style="list-style-type: none"> • Maintain routine maintenance procedures.
Short-Term Actions	
Capital Expenditure Planning	<ul style="list-style-type: none"> • Plan to replace cold brine pump in 1 to 3 years. <ul style="list-style-type: none"> ○ Brine pump should be replaced at the same time as large refrigeration plant overhaul if pursued. • Plan to replace condenser pump in 10 years.

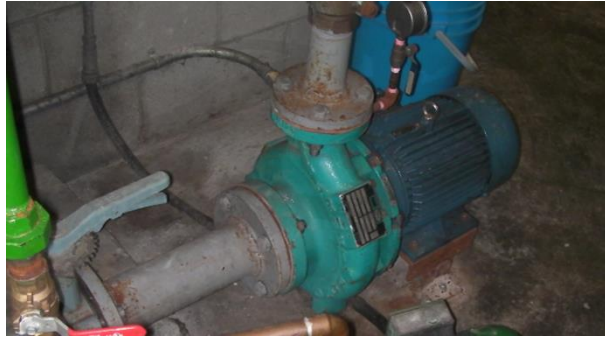
Figure 6: Condenser Pump

- The condenser pump shows some signs of wear on the outer casing particularly near pipe couplings, though any issues with the impeller or interior casing could not be assessed.
- Based on the age and visual inspection of the equipment, it should be planned to replace this pump within 10 years or when the refrigeration plant is upgraded.
- Failure of this pump may limit the ability of the refrigeration plant to operate in high outdoor temperatures during the shoulder seasons, and will increase overall energy consumption and operating costs.

⁹ The age of this pump was not available, however based on the condition of the pump compared to other equipment in the room it is likely that it has been replaced. Based on the condition of the pump it is estimated that it has roughly ten years of service life remaining.

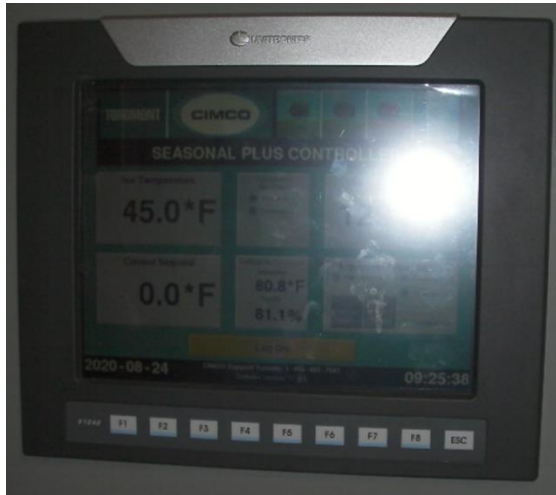
Figure 7: Primary Control Panel

- The primary control system is a proprietary Cimco system that includes limited controls for seasonal adjustments and basic staging options.
- This control system is used to provide floating head control by adjusting the discharge pressure of the compressors only, and is not a full refrigeration plant automation system.
- The control system is proprietary and locked, restricting edits and the ability to change sequences.
- The backup control unit is an industry standard Honeywell T775.
- Control systems have no definitive service life and can be used for long periods of time, however improvements to controls technology provide energy savings so periodic upgrades are recommended.
- Control sensors should be recalibrated to ensure accuracy for controls.

Category	Recommended Action
Immediate Actions	<ul style="list-style-type: none"> • Maintain routine maintenance procedures.
Short-Term Actions	<ul style="list-style-type: none"> • Recalibrate all sensors to ensure accuracy in controls.
Capital Expenditure Planning	<ul style="list-style-type: none"> • Plan to replace the control system when the refrigeration plant is overhauled. <ul style="list-style-type: none"> ○ I.B. Storey Inc. recommends open source control systems when upgrading to ensure that the hardware and software can be updated indefinitely to match improvements in control technology and add new features to the plant. This control system should control the entire refrigeration system.

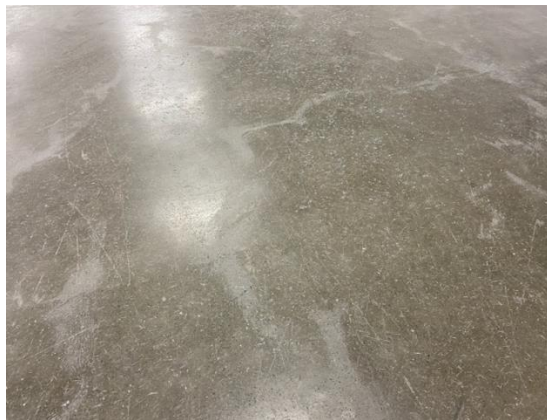
Figure 9: Scuff marks and scrapes throughout the ice rink floor

- Scuffs and surface abrasions were observed on the concrete, along with general wear and tear.
 - A large scuff mark was noted as well, and may be a result of hosting events on the floor in the off season.
- The rink cold floor piping was not accessible, so an assessment of its condition could not be made.
 - The cold brine supply system should be monitored for dropping fluid levels which indicate a leak in the cold floor.
- As the floor is original to the building, the probability of internal piping failure is high. It is recommended that the floor system be replaced as soon as possible.

Category	Recommended Action
Immediate Actions	<ul style="list-style-type: none">• Maintain routine maintenance procedures and check ice rink cold brine feeder system regularly to catch any potential leaks.
Short-Term Actions	<ul style="list-style-type: none">• Consider a rugged cover to place over the concrete surface during off-season activities to prevent ongoing damage to concrete.
Capital Expenditure Planning	<ul style="list-style-type: none">• Plan to replace the ice rink concrete and piping as soon as possible.<ul style="list-style-type: none">○ I.B. Storey Inc. recommends new ice rink floors be installed with fusion welded HDPE piping to remove the need for ongoing clamp maintenance and provide corrosion resistant piping.

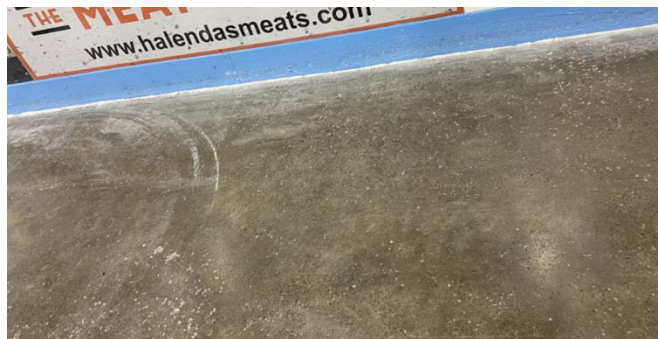
Figure 10: Large scrapes found on the rink floor

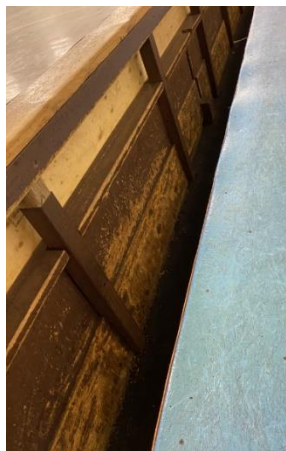
- Boards and glass are aging, with some plexiglass scuffing, as well as distorted wood tops and cracking around the players bench.
- Some corrosion of the metal frame is noted on the metal around the doorways into the rink zone.
- Portions of the wooden boards show signs of being replaced recently, but serious wear can be seen near foot level in places.
- Board facings show significant waviness, likely as a result of moisture issues with the wooden components underneath.

Figure 12: Scuffing and wood damage near foot level.

Category	Recommended Action
Immediate Actions	
Short-Term Actions	<ul style="list-style-type: none"> • Consider replacing portions of wooden boards that show significant wear near foot level.
Capital Expenditure Planning	<ul style="list-style-type: none"> • Plan to replace the ice rink boards and glass at the same time as the floor replacement. <ul style="list-style-type: none"> ○ I.B. Storey Inc. recommends a modern board system with an aluminum frame to resist metal corrosion and provide flexibility for safety, along with a soft protective plastic piece along the caprail before the glass to prevent player injury and curved terminations for enhanced safety.

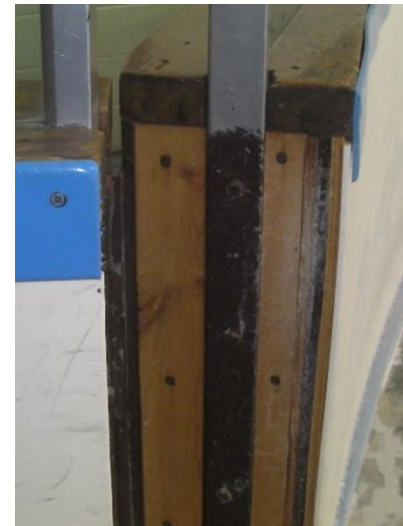
Figure 13: Signs of metal rusting at door interfaces.

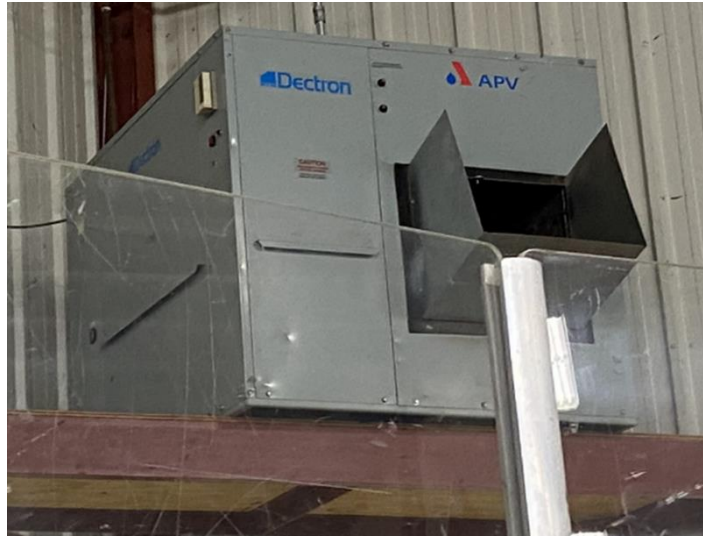
Figure 15: Mechanical dehumidifier in rink zone

- No information on the age of the two dehumidifier units is available and the units were not accessible. Based on a visual inspection they seem to be in reasonable condition.
- The location of these units makes for an operational and maintenance hazard, and makes maintenance difficult.
- It is recommended that these units be integrated into a central automation system to provide proper control and monitoring.

Category	Recommended Action
Immediate Actions	<ul style="list-style-type: none">• Inspect the dehumidifiers to ensure that both units are working properly.• Continue regular maintenance on the units.
Short-Term Actions	
Capital Expenditure Planning	<ul style="list-style-type: none">• Plan to integrate the existing units into a central automation system in order to provide better monitoring and control of zone humidity.

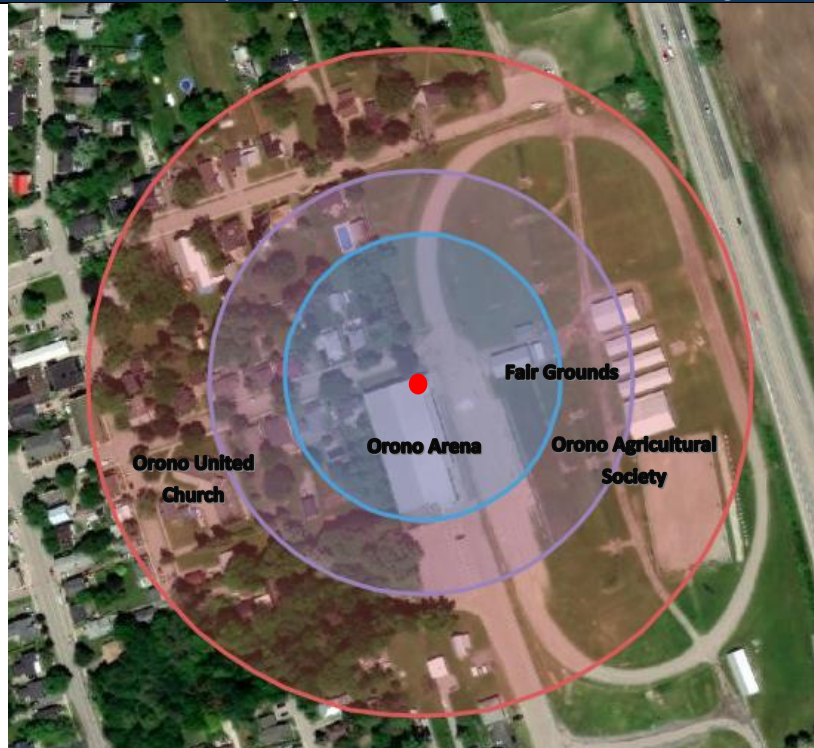
Figure 16: Health and safety danger ranges for visualization and decision-making.

- IDLH range does not factor in wind distribution and refrigerant charges have been estimated as no detailed signage is available. These ranges are presented for visualization and decision-making purposes only.

- The existing refrigeration plant range, shown in red, covers nearly 50 residential properties, Orono United Church, Orono Agricultural Society, fair grounds, and an antique market.

- Low charge plant (60% reduction), shown above in purple, would result in roughly 30 properties being removed from the immediately dangerous to life and health range but would still impact the fair grounds and private residences.

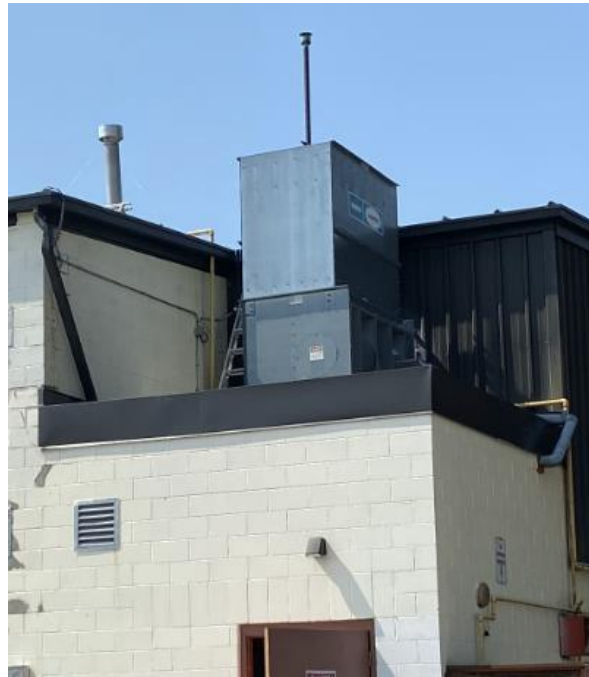
6.1.3 b)	Equipment that is not accessible from floor level shall be installed so that it can be safely reached by a permanently installed staircase(s) or ladder(s) with a platform(s) and railings meeting the workplace safety requirements; or by a mobile device(s) for lifting personnel to the equipment.	<ul style="list-style-type: none"> Evaporative condenser installed on the roof has no permanently installed staircase or ladder for access.

6.1.3 c)	(c) Roof- and mezzanine-mounted equipment shall be set back 3 m (10 ft) from any edge where a fall hazard exists, except under the conditions specified in Item (d). If the workplace safety requirements of the jurisdiction of installation impose a greater setback, those requirements shall apply.	<ul style="list-style-type: none"> Evaporative condenser is installed near the edge of the roof

CRITICAL B52-18 NON-COMPLIANT ITEMS		
Section	Description	Notes
6.1.3 d)	(d) Where roof- and mezzanine-mounted equipment cannot be set back as specified in Item (c), railings and fall-arrest system attachment points shall be provided in accordance with the workplace safety requirements of the jurisdiction of installation.	<ul style="list-style-type: none"> No railings or fall-arrest system installed though the equipment is placed next to the edge.

6.1.3 Evaporative condenser installed on the roof has no permanently accessible ladder, is near the edge, and has no railing

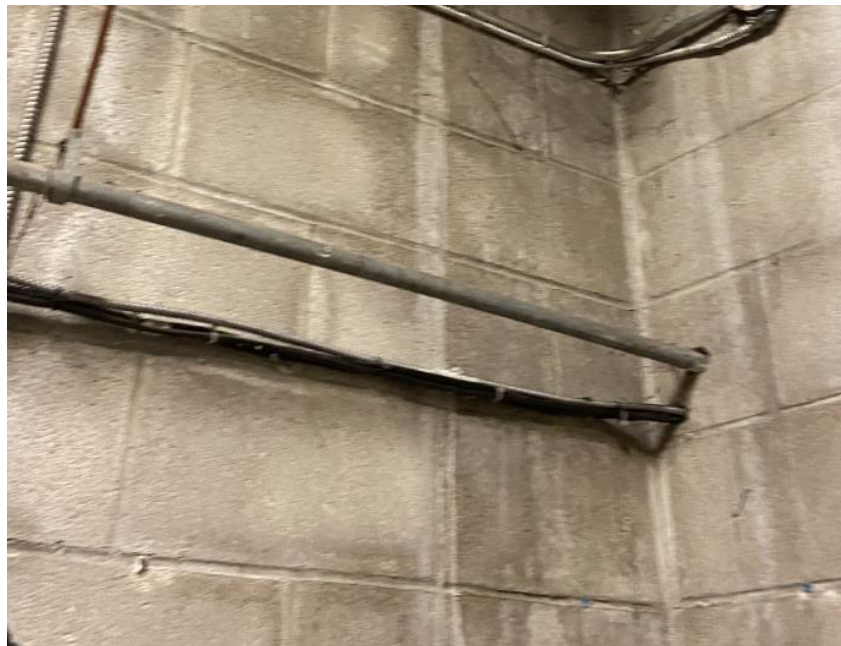
6.3 f)	All pipes piercing the interior walls, ceiling, or floor shall be tightly sealed to the walls, ceiling, or floor through which they pass.	<ul style="list-style-type: none"> Sprinklers and conduit that pass through the wall are not properly sealed.

6.3 f) Pipes passing through walls and ceiling not properly sealed

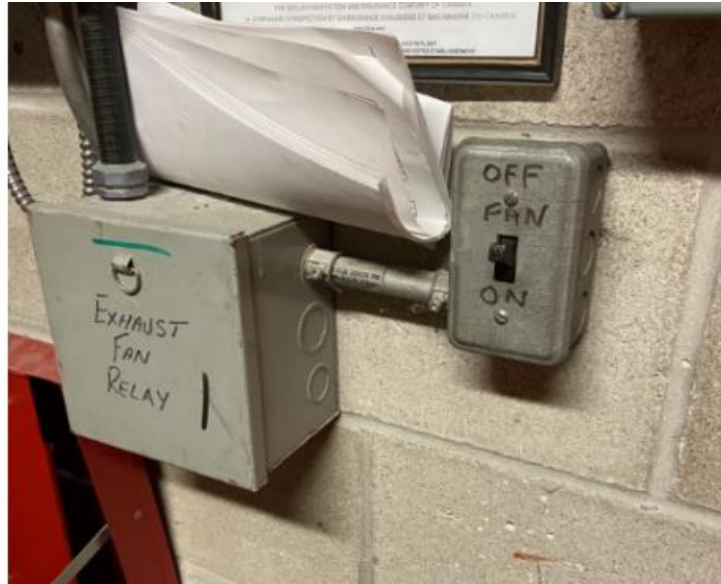
6.2.5.4	Fan switches are installed inside and outside of the machinery room. Switches outside the room shall start but not stop fans.	<ul style="list-style-type: none"> Switch outside of the room can turn the exhaust fan on and off.

6.2.5.4 Switch outside the mechanical room is capable of turning exhaust fans OFF, should be ON only

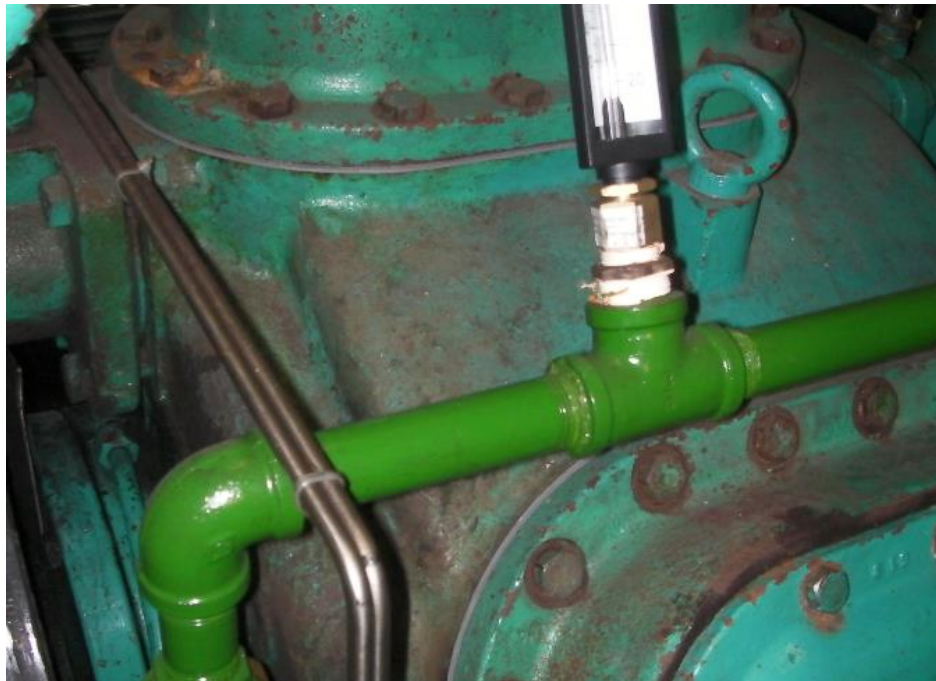
5.11.2	<p>Equipment signs that indicate the following:</p> <ul style="list-style-type: none"> (a) manufacturer's name; (b) manufacturer's nationally registered trademark; (c) identification number; (d) test pressures; (e) refrigerant type. 	<ul style="list-style-type: none"> • Compressor #1 does not have a nameplate.

5.11.2 Compressor is missing a nameplate to show relevant data

5.11.2	Equipment signs that indicate the following: (a) manufacturer's name; (b) manufacturer's nationally registered trademark; (c) identification number; (d) test pressures; (e) refrigerant type.	X	Compressor missing relevant signage.
