MUNICIPALITY OF CLARINGTON

*TRIAGE REPORT FOR*  
INSPECTION – RINK REFRIGERATION & PAD  
NEWCASTLE MEMORIAL ARENA

103 CAROLINE ST. W, NEWCASTLE, ON

SEPTEMBER 23, 2020

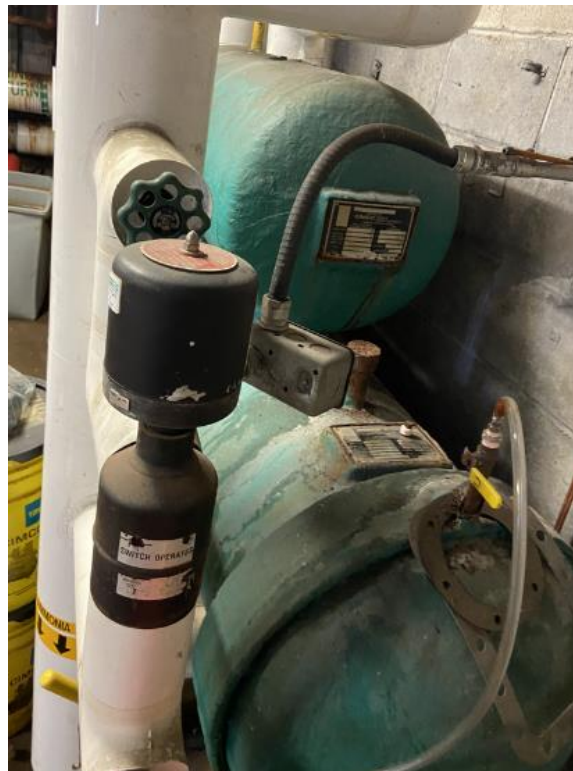
Figure 1: Chiller barrel and vessel.

- The chiller is very near the median end of life, and may be subject to failures in the near future. The chiller and attached surge drum are the primary ammonia storage vessels and given the hazardous nature of ammonia the chiller should not be allowed to operate near the median end of life.

- **Chiller failures are a serious risk to public health and safety because toxic refrigerant may leak. Replacement of the chiller should be considered as soon as possible<sup>1</sup>.**

- Documentation on site shows inspection for this equipment was due in March, 2019. This inspection should be completed, or proper documentation should be posted.

- Chiller relief valves need to be replaced by November 21, 2021. **This is a critical safety component.**
- Chiller components show signs of significant rusting on connections where insulation is not present. This indicates significant wear on the metal components, increasing the potential risk of failure.

Category	Recommended Action
Immediate Actions	<ul style="list-style-type: none"> <li>• Have a brine analysis performed to check for ammonia contamination in brine as an early sign of chiller failure.</li> <li>• Have chiller and surge drum re-inspected for insurance purposes and to detect potential leaks.</li> </ul>
Short-Term Actions	<ul style="list-style-type: none"> <li>• Replace chiller relief valves by November 2021.</li> <li>• Perform ongoing monitoring of brine to test for potential chiller failure. Additional ongoing monitoring is recommended, including<sup>2</sup>:                             <ul style="list-style-type: none"> <li>○ Check for any increase in volume in the secondary refrigerant (brine) system.</li> <li>○ Check for any unusual increase in pressure in the secondary refrigerant (brine) system.</li> <li>○ Test the system heat exchange for leaks during the off season.</li> </ul> </li> </ul>

Capital Expenditure Planning	<ul style="list-style-type: none"> <li>• Pursue opportunities to replace the chiller as soon as possible.                             <ul style="list-style-type: none"> <li>○ <b>This is a significant health and safety risk. Replacing the chiller on its own or as part of a total refrigeration plant upgrade should be prioritized. Given the age of all of the equipment, a full plant replacement is recommended at this time.</b></li> </ul> </li> </ul>

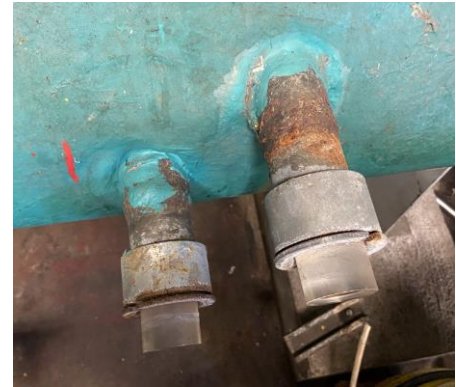
Figure 2: Signs of rusting on the chiller sight glass ports.

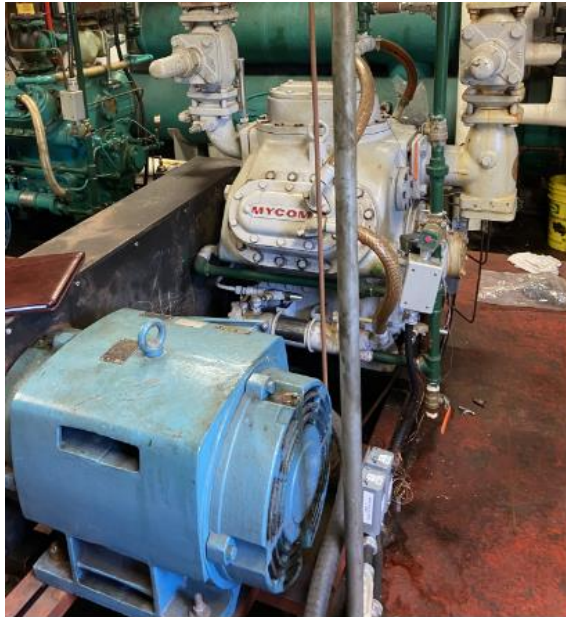
Figure 3: Compressor #1

- Both compressors look to be aged with some light signs of wear and tear on the outer casing.
- Compressor #1 is verified to be from 2010, making it half way through its expected service life.

- Compressor #1 is due to have reliefs replaced by February, 2024 while compressor #2 is due earlier by September, 2022.
- The motor on compressor #2 failed on start up in 2011, and was replaced at that time.

Category	Recommended Action
Immediate Actions	<ul style="list-style-type: none"> <li>• Maintain routine maintenance procedures.</li> </ul>
Short-Term Actions	<ul style="list-style-type: none"> <li>• Replace compressor relief valves as needed.                             <ul style="list-style-type: none"> <li>○ February 2024 for Compressor #1.</li> <li>○ September 2022 for Compressor #2.</li> </ul> </li> </ul>
Capital Expenditure Planning	<ul style="list-style-type: none"> <li>• Pursue opportunities to replace the compressors as soon as possible.                             <ul style="list-style-type: none"> <li>○ <b>Compressors are essential equipment for the refrigeration plant and ice cannot be maintained without them. Additionally, as the prime mover responsible for compressing ammonia mechanical issues with this equipment is a safety hazard. This equipment should be planned for replacement in conjunction with the chiller.</b></li> </ul> </li> </ul>

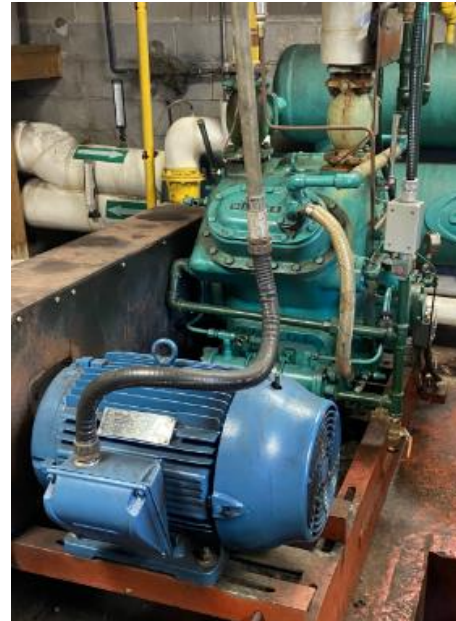
Figure 4: Compressor #2

- Compressor #2 represent a significant safety risk, as it is compressing gaseous ammonia, a toxic, flammable refrigerant. Aging compressors pose a serious hazard to life and health.

- Though having multiple compressors allows for the system to continue operating at a limited capacity with only one compressor, these units are near the end of life and should be replaced. Plan for compressor replacements as soon as possible.

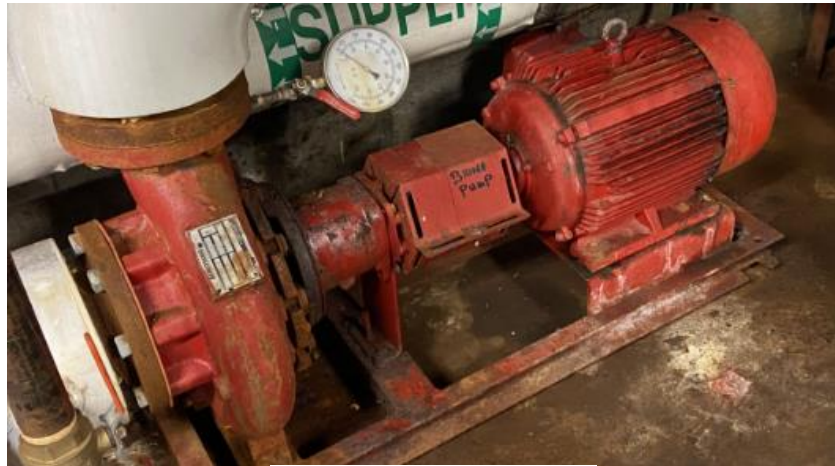
Figure 5: Cold Brine Pump

- The cold brine (secondary refrigerant) pump is showing signs of corrosion. The use of brine in the system may introduce greater stress on the equipment and reduce the overall service life.
- Brine as a secondary refrigerant requires regular maintenance and monitoring of corrosion inhibitors, and if this maintenance has not been carried out significant corrosion and damage to the pump interior is likely.
- Regular maintenance on the equipment should be maintained.
- The failure of this pump would disable the ice rink until a replacement could be installed.
- Plan for equipment replacement in 5 years. It is recommended that if the compressors and chillers are replaced, the brine pump be replaced as well for overall system longevity.

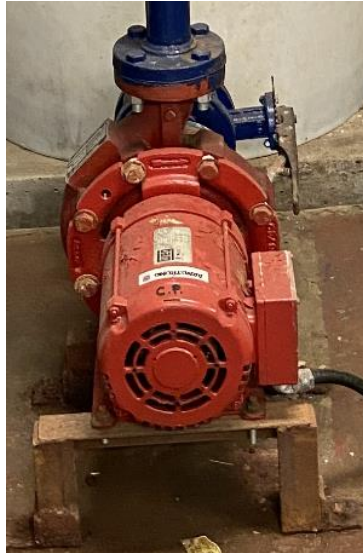
Figure 6: Condenser Pump

- The condenser pump shows little signs of wear on the outer casing, though any issues with the impeller or interior casing could not be assessed without disassembly.
- Based on the age of the equipment, it should be planned to replace this pump within 1 to 3 years.
- Failure of this pump may limit the ability of the refrigeration plant to operate in high outdoor temperatures during the shoulder seasons, and will increase overall energy consumption and operating costs.

Category	Recommended Action
Immediate Actions	<ul style="list-style-type: none"> <li>• Maintain routine maintenance procedures.</li> </ul>
Short-Term Actions	
Capital Expenditure Planning	<ul style="list-style-type: none"> <li>• Plan to replace cold brine pump in 5 years.                             <ul style="list-style-type: none"> <li>○ Brine pump should be replaced at the same time as large refrigeration plant overhaul if pursued.</li> </ul> </li> <li>• Plan to replace condenser pump in 1 to 3 years.</li> </ul>

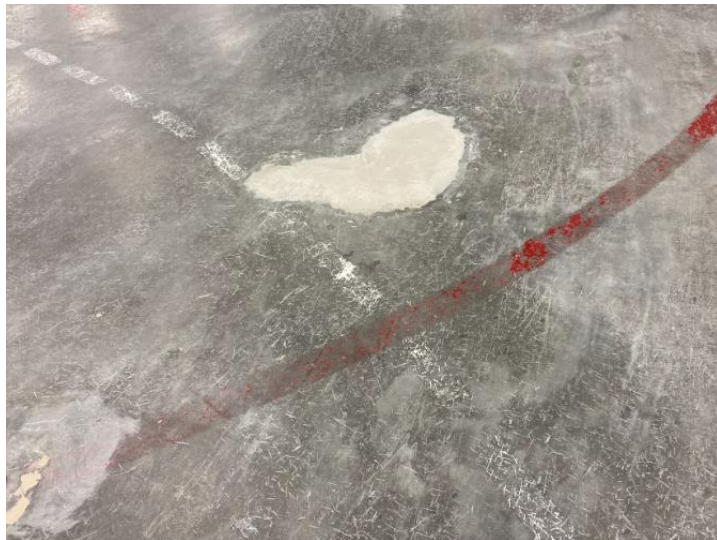
Figure 9: Ice rink floor showing serious signs of wear

- Serious wear and tear has been noted over the ice rink surface with signs of patching to deal with issues.
- The cold floor piping uses a clamped design for the piping connections, common in older ice rinks.
  - Header clamps should be checked annually for damage and repaired as needed.
- Cold floor header piping was under repair during the site inspection, showing signs of failure.
- Rink cold floor piping shows signs of rust and decay, and insulation is missing in the header trench which negatively affects performance.
- This floor has reached its end of life and should be replaced as soon as possible.

Category	Recommended Action
Immediate Actions	<ul style="list-style-type: none"> <li>• Maintain routine maintenance procedures and check ice rink header clamps annually.</li> </ul>
Short-Term Actions	<ul style="list-style-type: none"> <li>• Consider a rugged cover to place over the concrete surface during off-season activities to prevent ongoing damage to concrete.</li> </ul>
Capital Expenditure Planning	<ul style="list-style-type: none"> <li>• Plan to replace the ice rink concrete and piping as soon as possible.                             <ul style="list-style-type: none"> <li>○ <b>I.B. Storey Inc. recommends new ice rink floors be installed with fusion welded HDPE piping to remove the need for ongoing clamp maintenance and provide corrosion resistant piping.</b></li> </ul> </li> </ul>

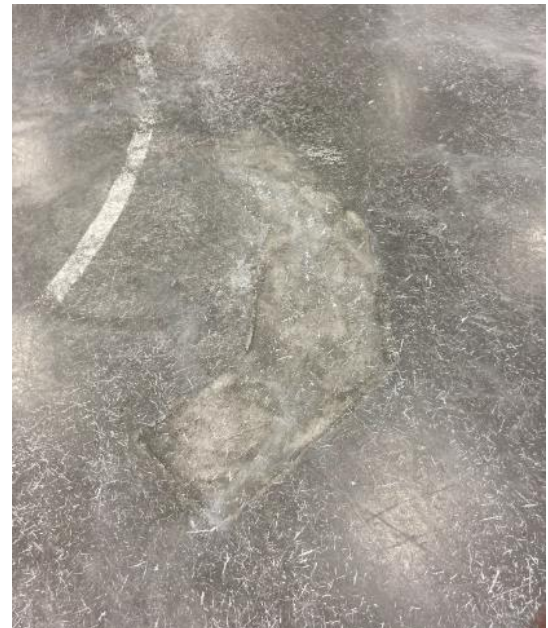
Figure 10: Scrapes and divots noted over ice rink floor surface

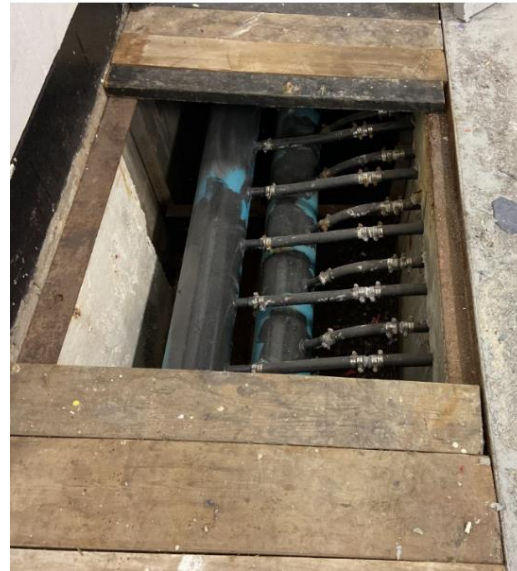
Figure 11: Clamped ice rink header with missing insulation in trench

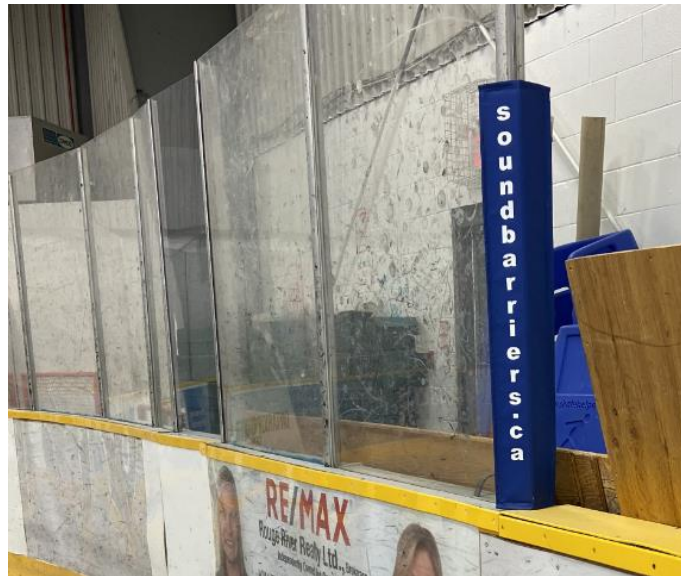
Figure 12: Ice rink boards and glass

- Boards and glass are aging, with serious plexiglass scuffing and board rippling issues.
- Significant corrosion is noted on the metal around the doorways into the rink zone. Cracked and distorted boards can also be seen.
- Upper and front board facings show significant waviness, likely as a result of moisture issues with the wooden components underneath.
- Cracks and splits in the boards were observed at floor level, showing ongoing wear and tear.

Category	Recommended Action
Immediate Actions	
Shot-Term Actions	
Capital Expenditure Planning	<ul style="list-style-type: none"> <li>• Plan to replace the ice rink boards and glass at the same time as the floor replacement, as soon as possible.                             <ul style="list-style-type: none"> <li>○ <b>I.B. Storey Inc. recommends a modern board system with an aluminum frame to resist metal corrosion and provide flexibility for safety, along with a soft protective plastic piece along the caprail before the glass to prevent player injury and curved terminations for enhanced safety.</b></li> </ul> </li> </ul>

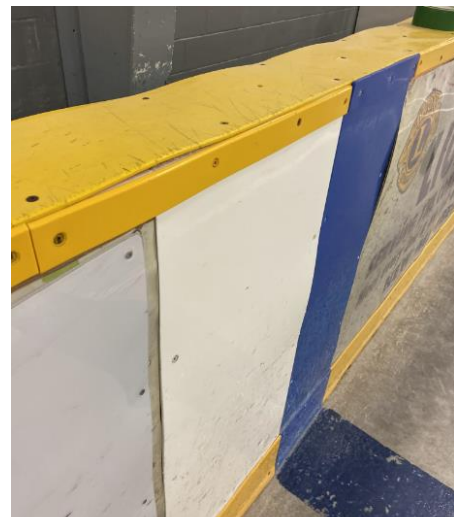
Figure 13: Waviness in board facings

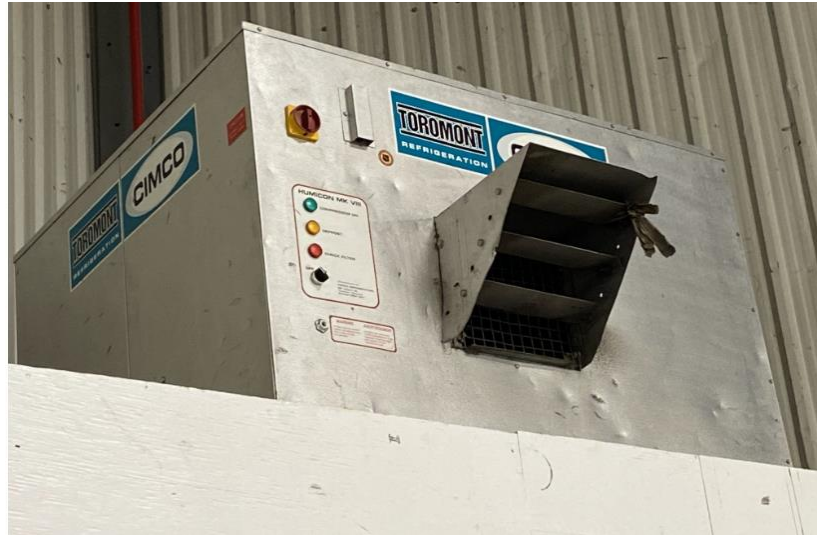
Figure 15: Mechanical dehumidifier in rink zone

- No information on the age of the two dehumidifier units is available and the units were not accessible.
- The units were not in use during the inspection as the rink was out of season, however rusting was observed in the metal structure of the roof showing inadequate dehumidification has been an ongoing issue.

Category	Recommended Action
Immediate Actions	<ul style="list-style-type: none"> <li>• Inspect the dehumidifiers to ensure that both units are working properly.</li> <li>• Continue regular maintenance on the units.</li> </ul>
Short-Term Actions	
Capital Expenditure Planning	<ul style="list-style-type: none"> <li>• Plan to replace the dehumidifiers within 5 years.                             <ul style="list-style-type: none"> <li>○ <b>Consider a central air handling unit with built in dehumidification to provide proper zone conditioning and prevent moisture build ups leading to premature building structural damage and mold growth.</b></li> <li>○ <b>The new dehumidification units should be integrated into a central control system to ensure ongoing monitoring and humidity control in the rink zone.</b></li> </ul> </li> </ul>

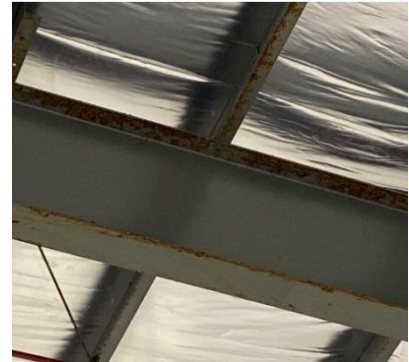
Figure 16: Rusting on ceiling beams

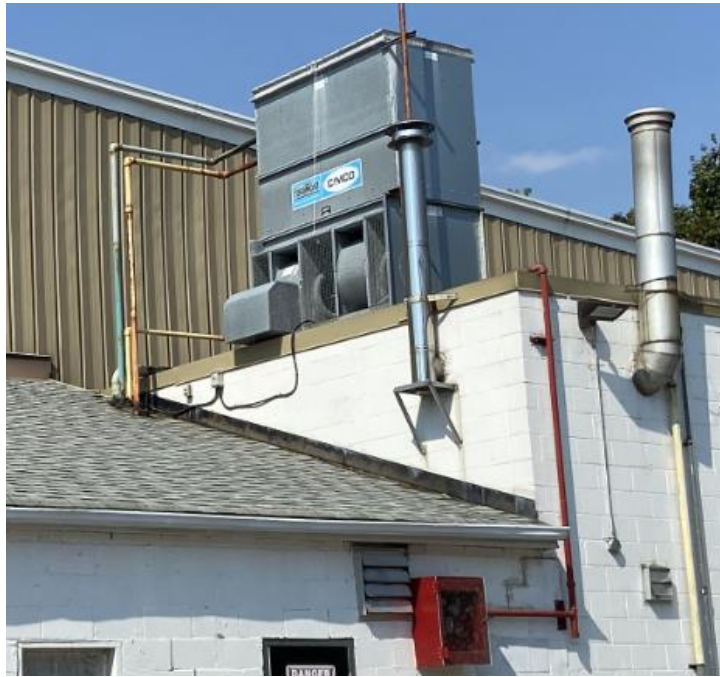
6.1.3 c)	(c) Roof- and mezzanine-mounted equipment shall be set back 3 m (10 ft) from any edge where a fall hazard exists, except under the conditions specified in Item (d). If the workplace safety requirements of the jurisdiction of installation impose a greater setback, those requirements shall apply.	<ul style="list-style-type: none"> <li>Evaporative condenser is installed at the edge of the roof</li> </ul>

6.1.3 Evaporative condenser installed on the roof has no permanently accessible ladder, is on the edge, and has no railing

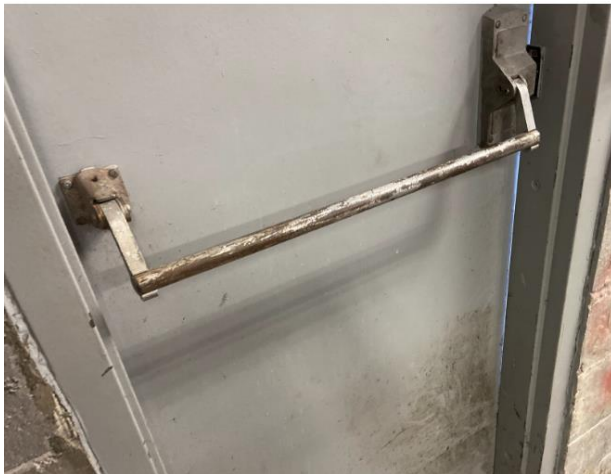
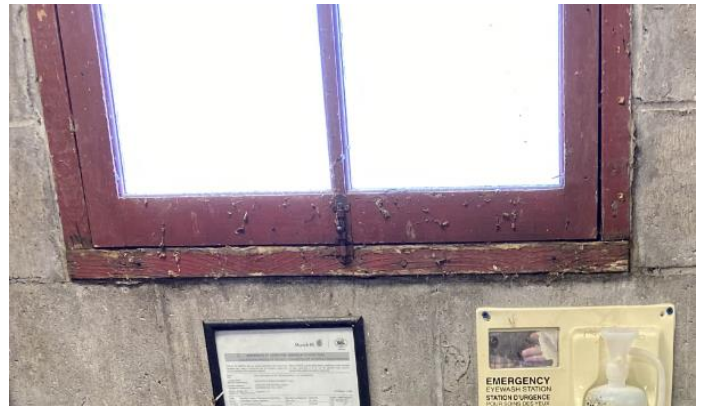
6.3 c)	The machinery room envelope, including any vestibule, shall be of tight construction.	<ul style="list-style-type: none"> <li>Air gaps are visible at the exit door to the room.</li> <li>A wooden window frame with aging wood shows clear signs of leakage.</li> <li>Gaps are visible in the plywood ceiling.</li> </ul>

6.3 c) Room not tightly sealed – daylight clearly visible through door, aging window frame

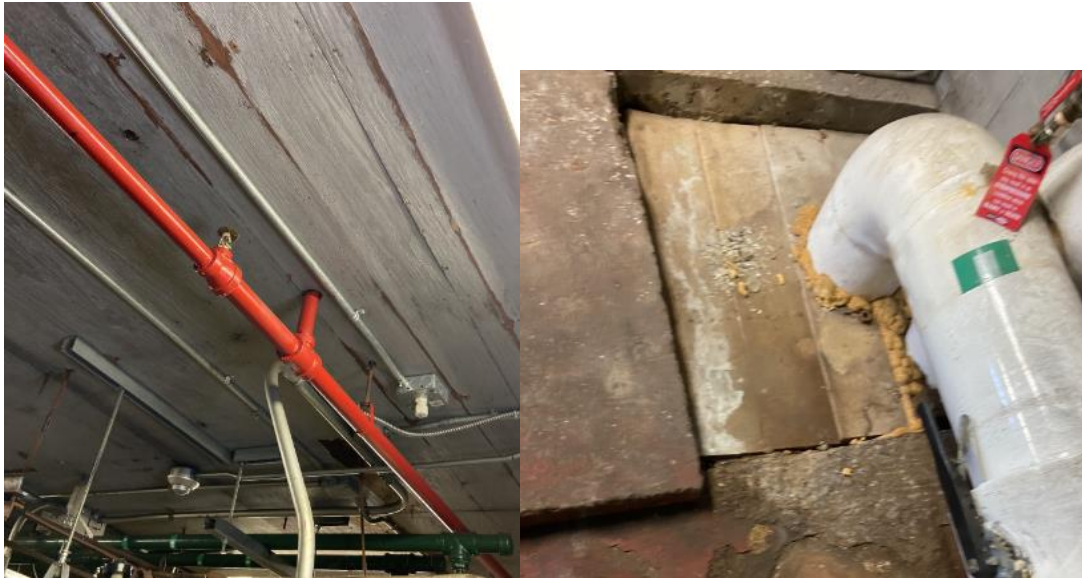
6.3 d) Ceiling and trench cover not made of fire-resistant material

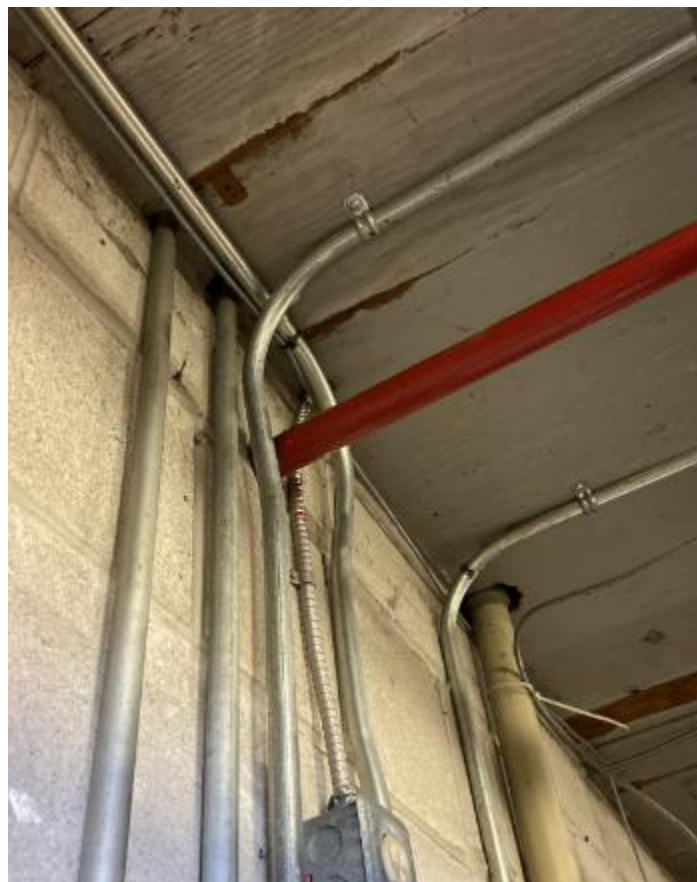
6.3 f) Pipes passing through walls and ceiling not properly sealed

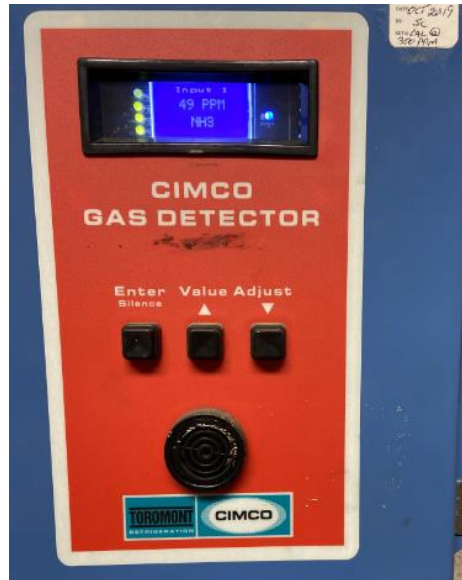
6.3 j)	Detectors working, and in a location where refrigerant would collect. Detector shall start the ventilation fans and actuate alarms.	<ul style="list-style-type: none"> <li>The refrigerant detector was reporting an inaccurate level when observed on site.</li> </ul>

6.3 j) Refrigerant detector reporting inaccurate value

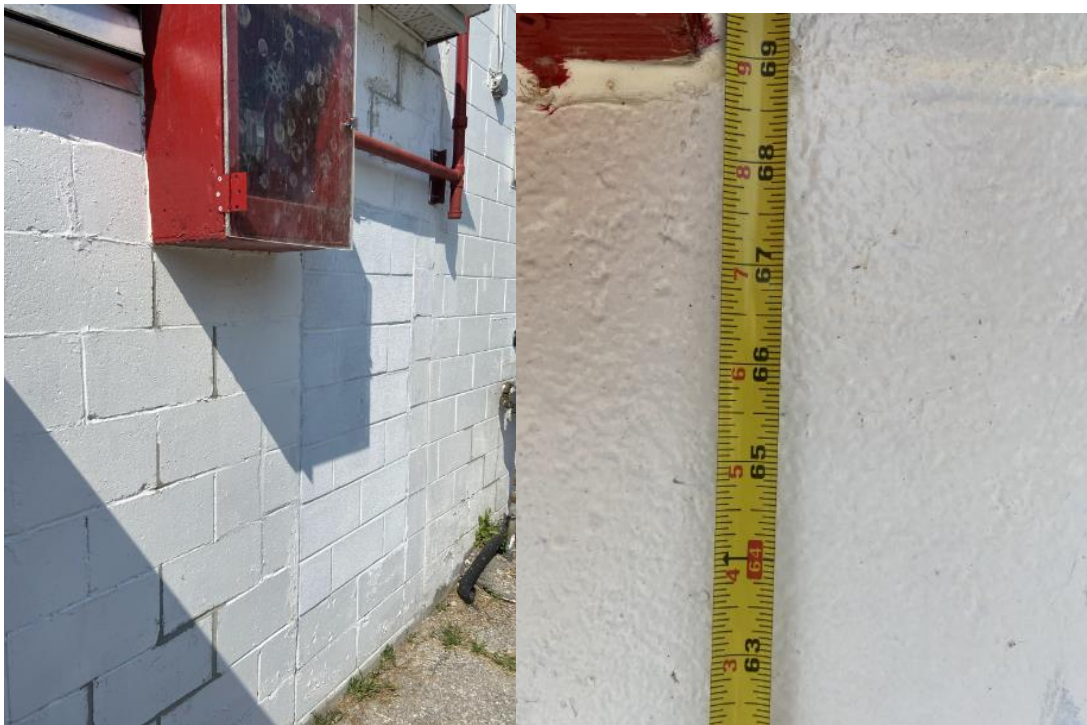
B.2.9 Emergency valve less than 7ft above the ground
