DESIGNATED HAZARDOUS SUBSTANCES INSPECTION

**FORMER WWII POW CAMP 30
CENTRAL CAFETERIA BUILDING
2020 LAMBS ROAD
BOWMANVILLE, ONTARIO**

Report AR107-24

Designated Hazardous Substances Inspection
Former WWII POW Camp 30
Central Cafeteria Building
2020 Lambs Road
Bowmanville, Ontario

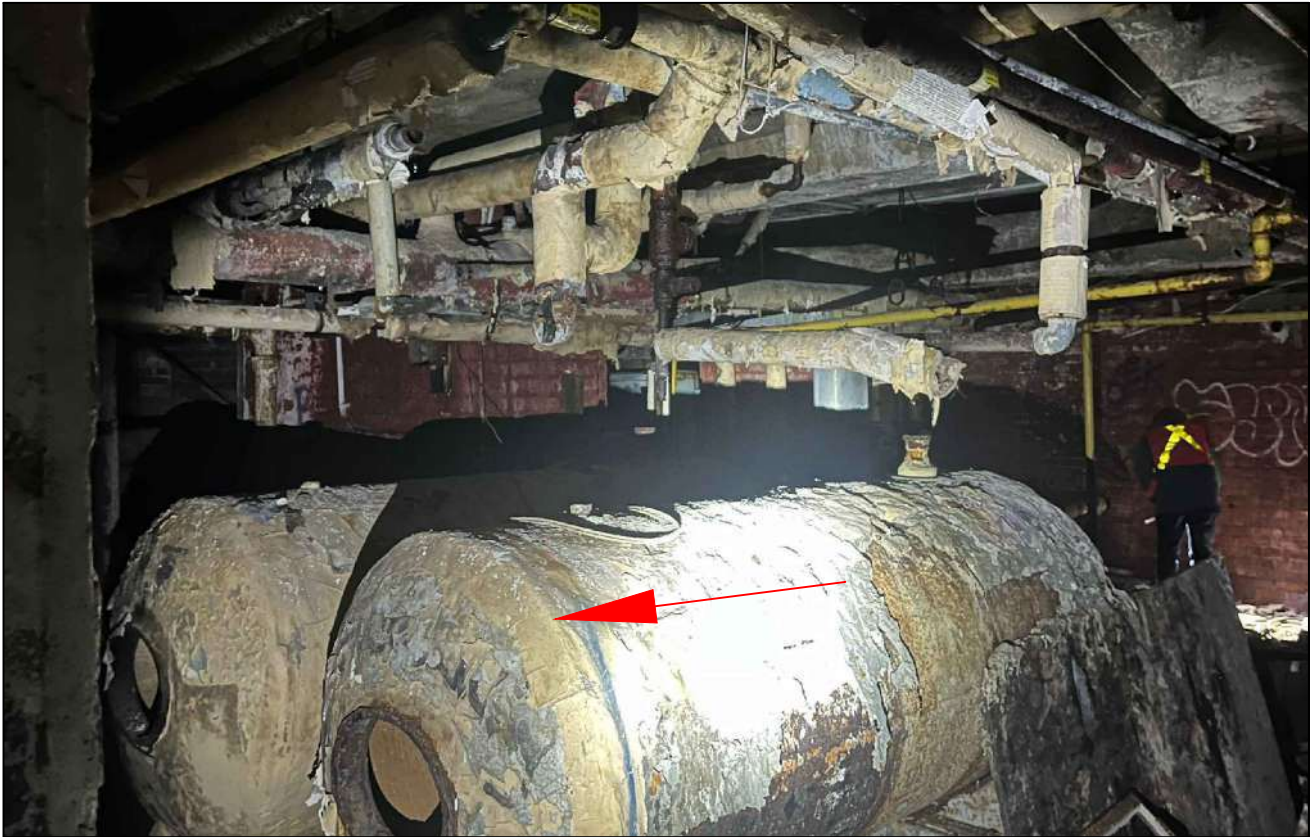
Heating within the building was provided by two hot water boilers located in the central part of the Basement. The boilers are insulated with parging cement material suspected to contain asbestos and sampled. The boiler exhausts are not insulated.

Photograph 1 Asbestos Containing Boiler Insulation

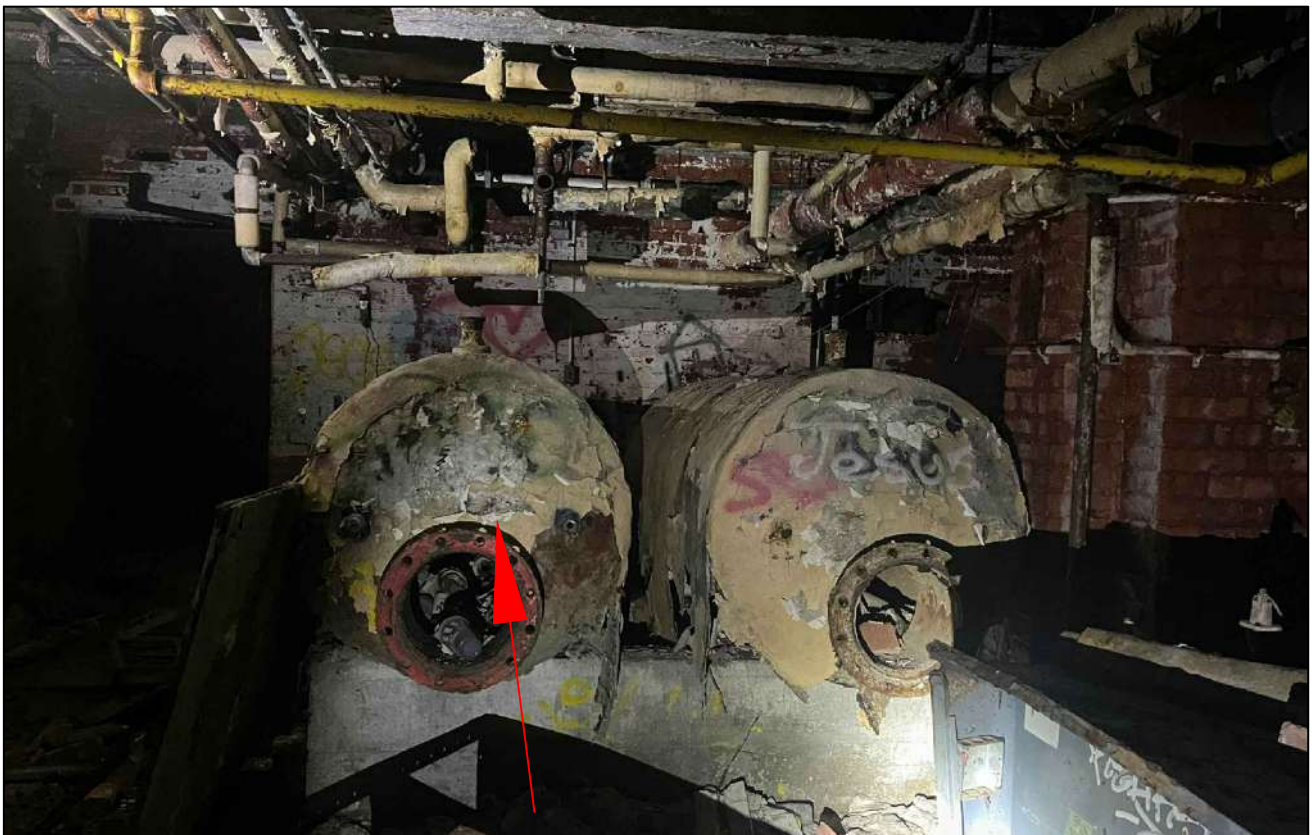
Photograph 2 Asbestos Containing Boiler Insulation

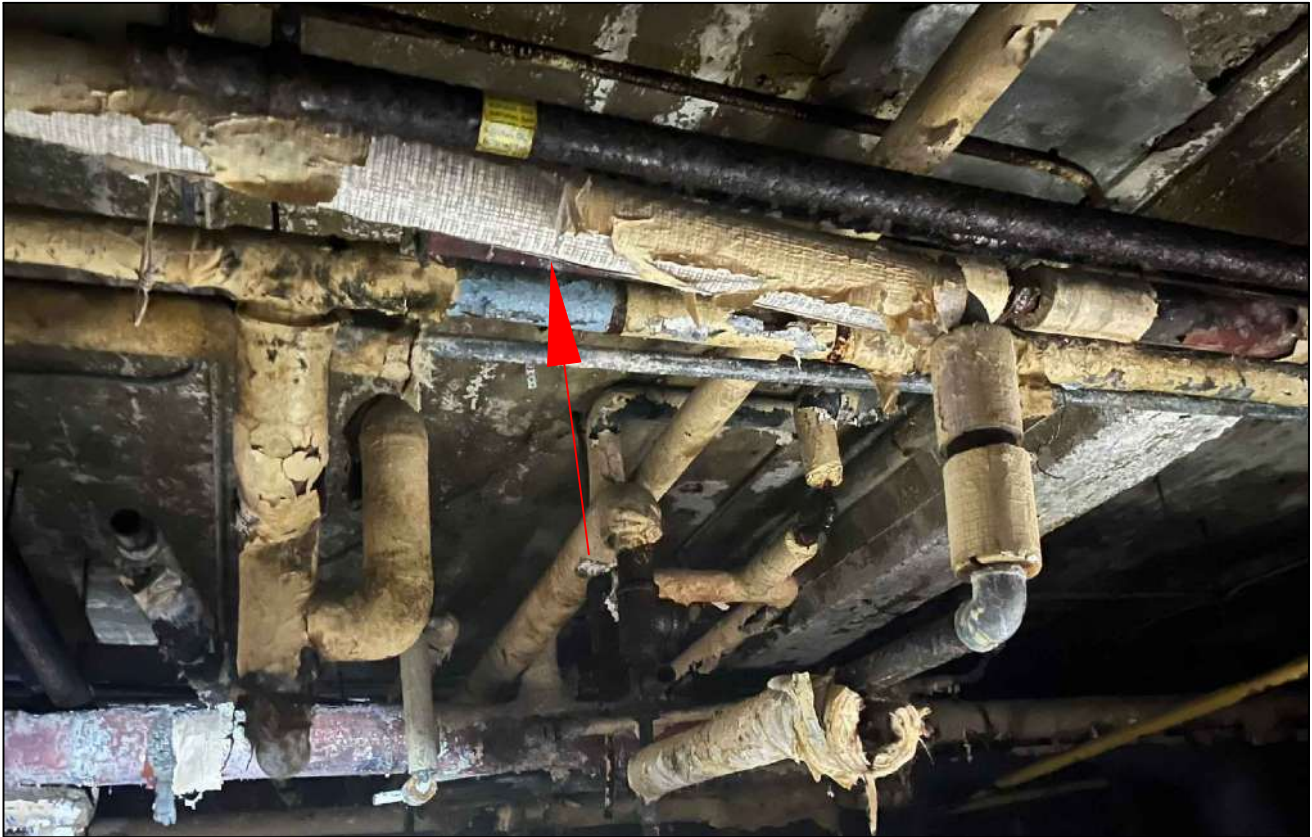
In the Basement area, virtually all of these heating pipelines are wrapped with corrugated cardboard air-cell insulation known to contain asbestos. In addition, the parging cement insulations over the pipe fittings including elbows, valves and tees are suspected to contain asbestos.

Photograph 3 Air-Cell and Parging Cement Insulation in Boiler Room

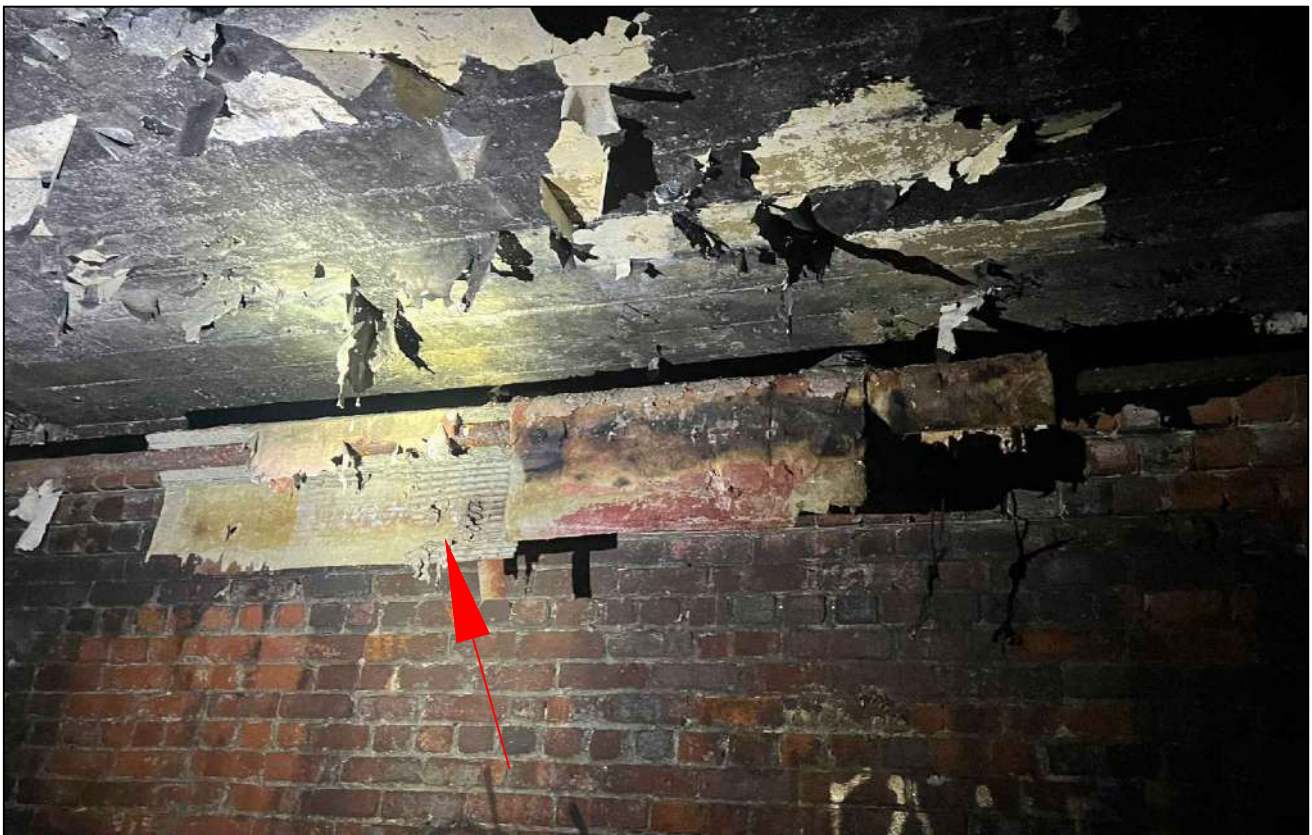
Photograph 4 Air-Cell and Parging Cement Insulation in South East Basement Room

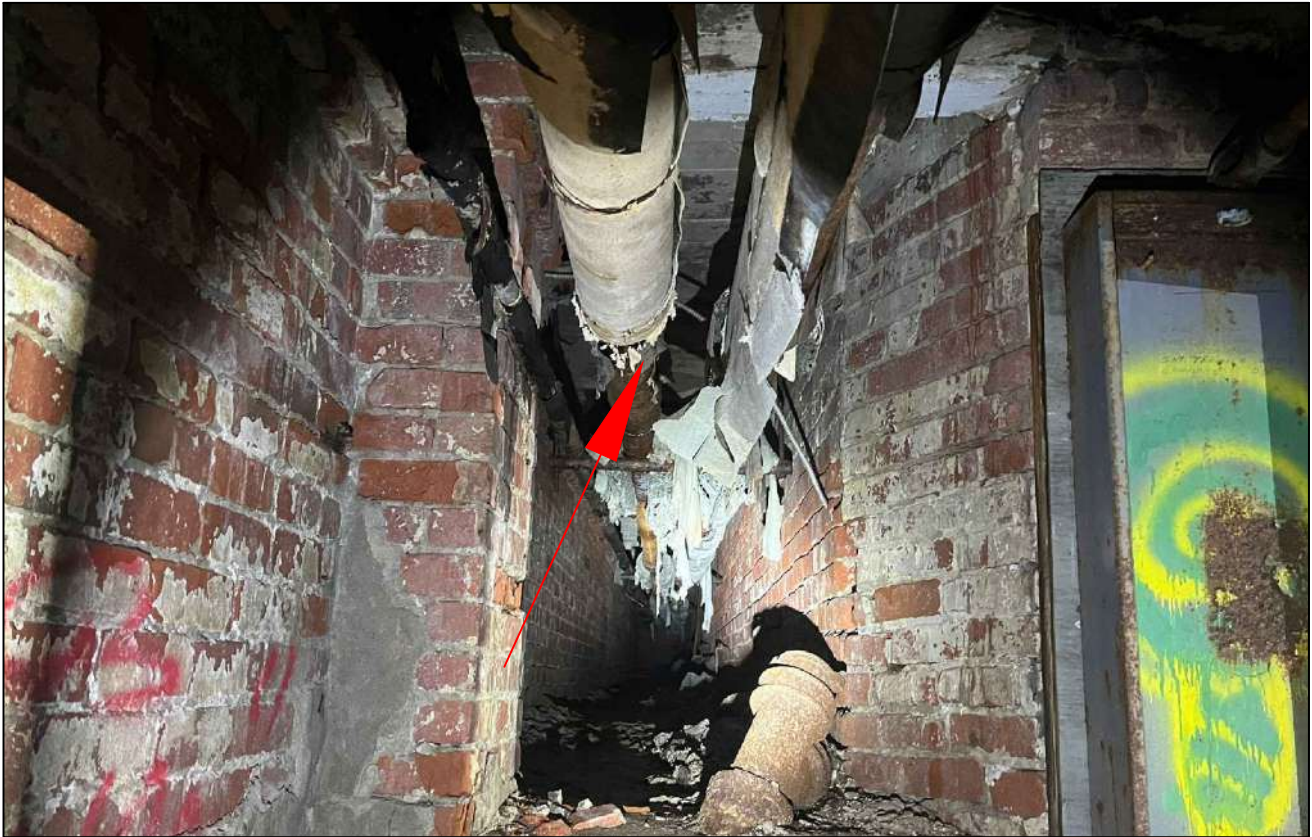
Photograph 5 Air-Cell and Parging Cement on Pipe Insulation leading to Tunnel in South East Basement Room

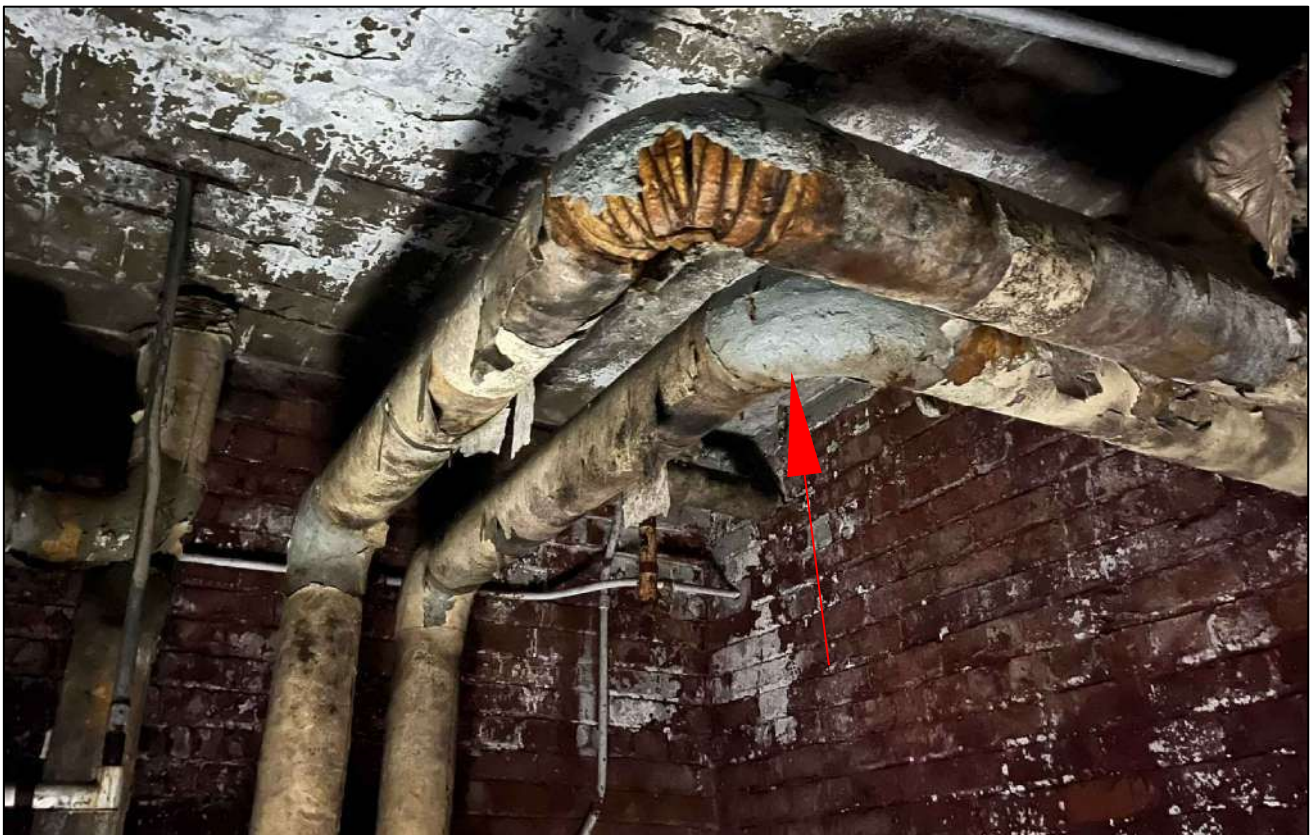
Photograph 6 Parging Cement Insulation on Pipe Elbow in Boiler Room

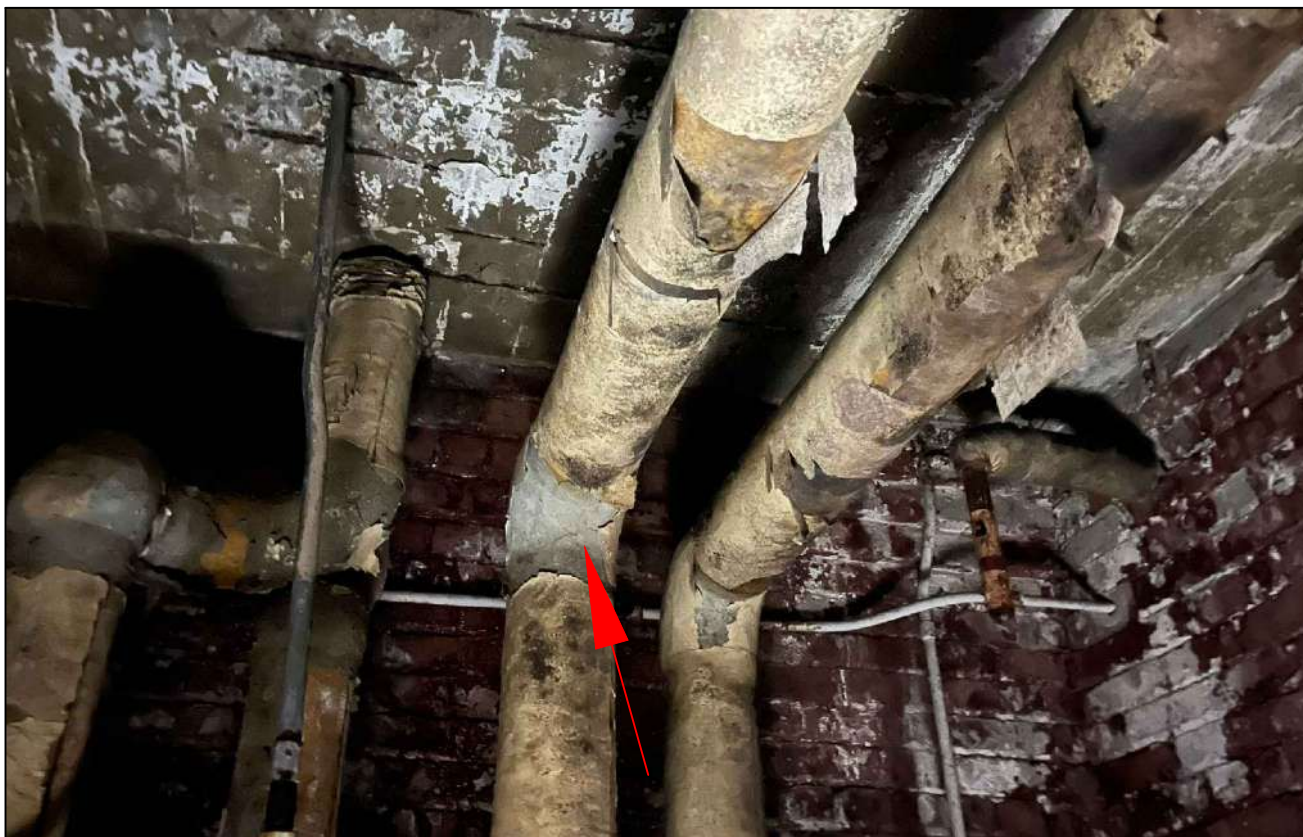
Photograph 7 Parging Cement Insulation on Pipe Elbow in Boiler Room

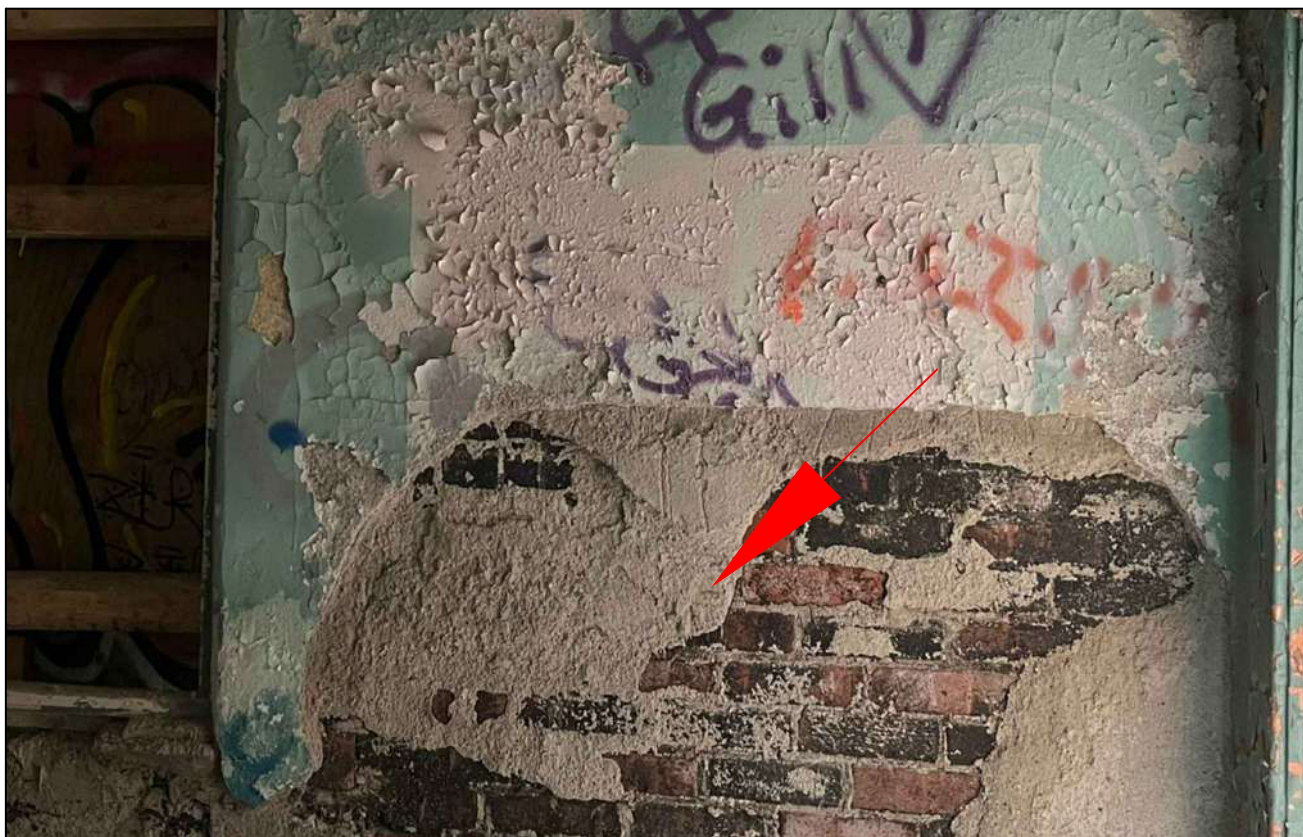
Photograph 8 Asbestos Containing Flat Plaster on Interior North wall at Entrance

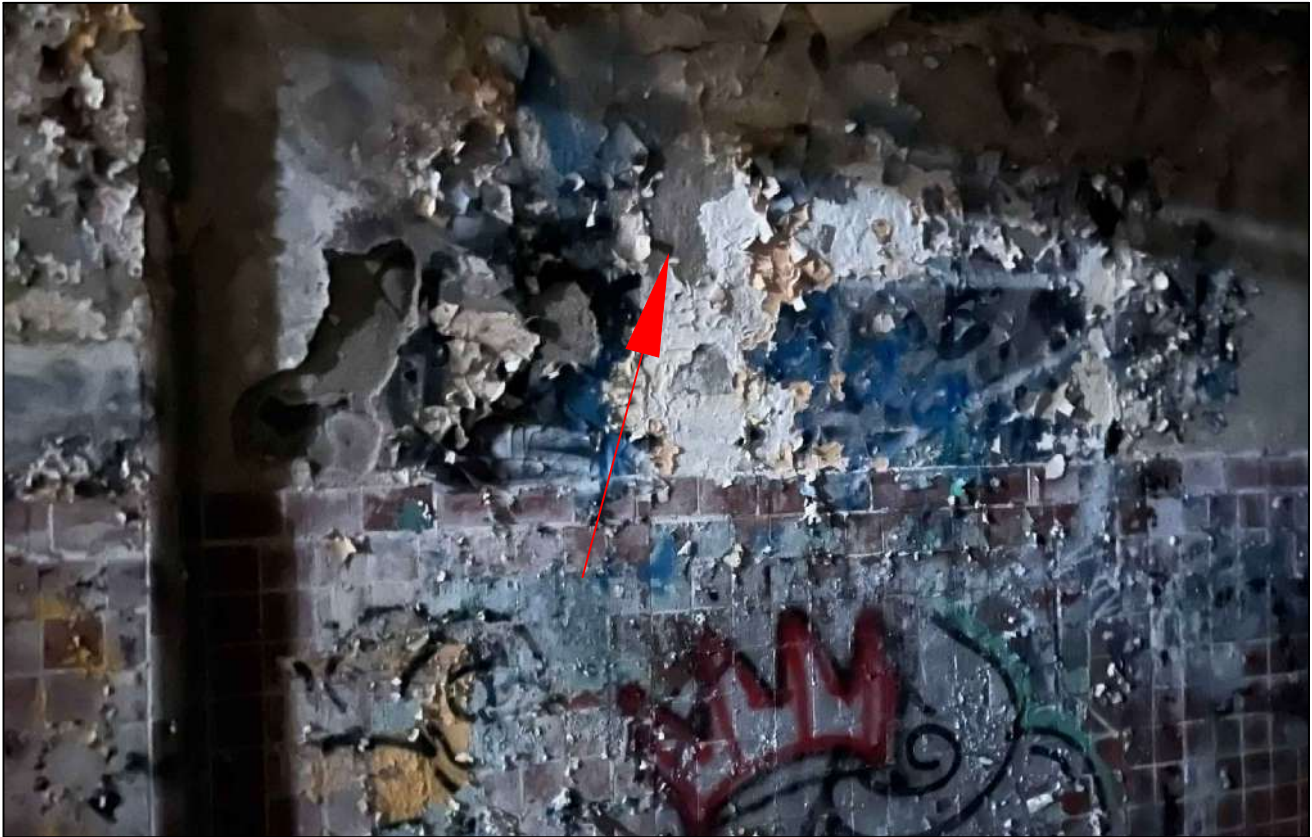
Photograph 9 Asbestos Containing Flat Plaster on Kitchen Wall

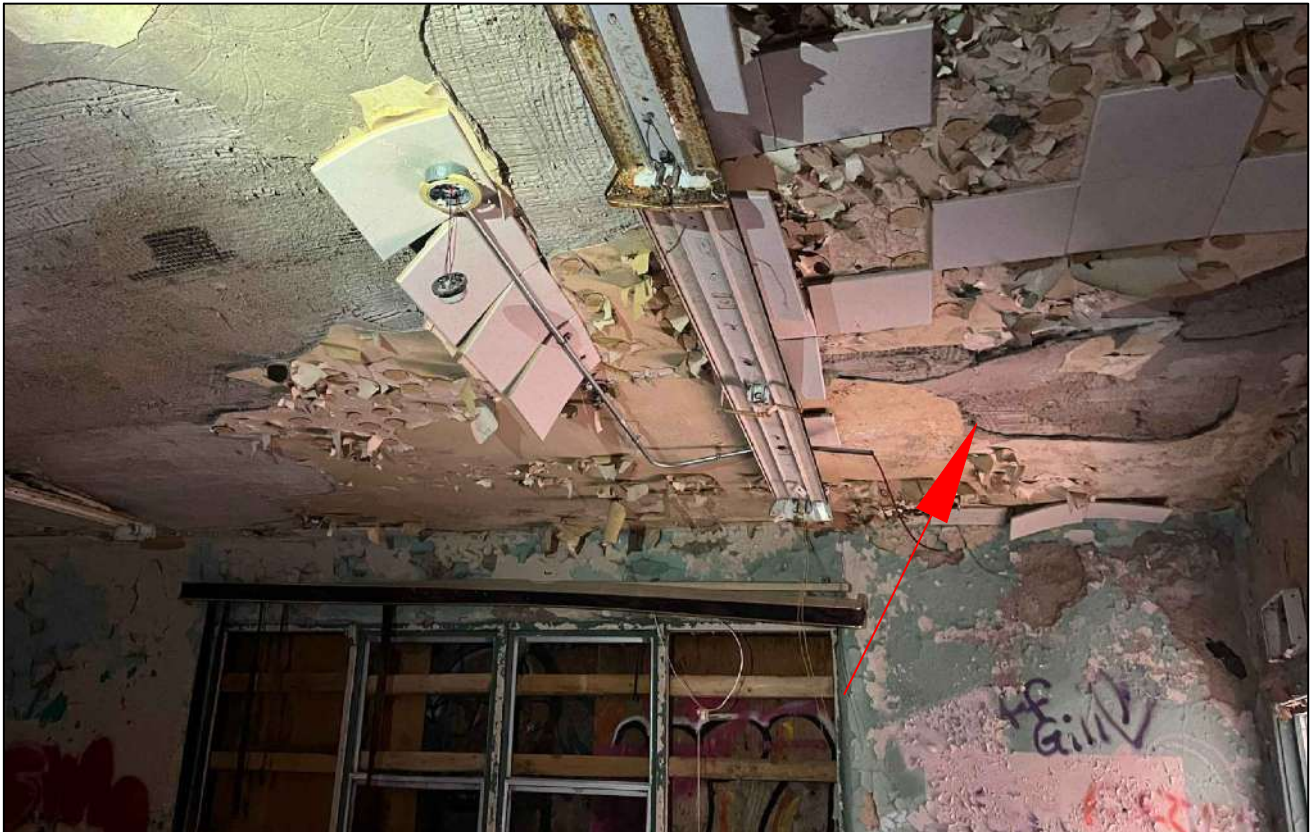
Photograph 10 Asbestos Containing Lower Ceiling Plaster on Interior North West wall

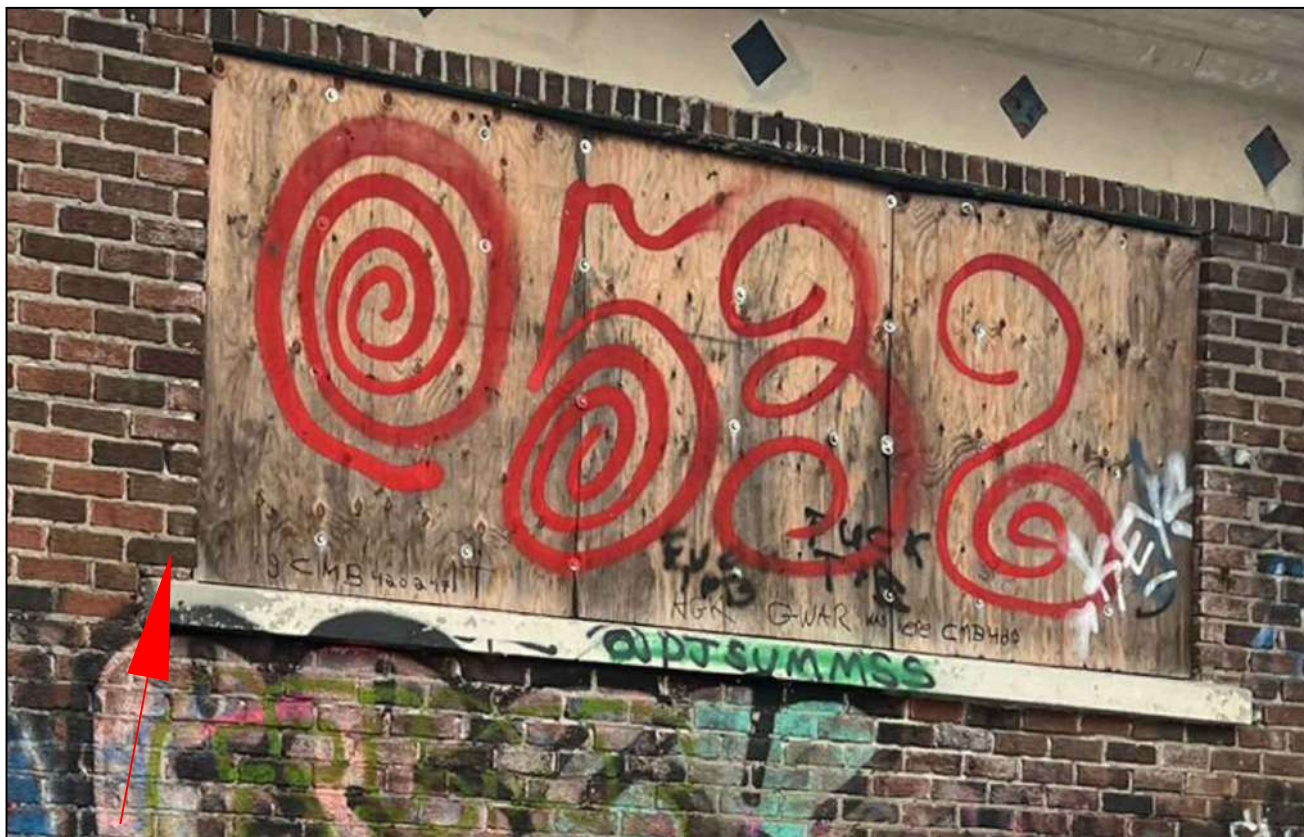
Photograph 11 Asbestos Containing on Window Caulking on Exterior East Wall

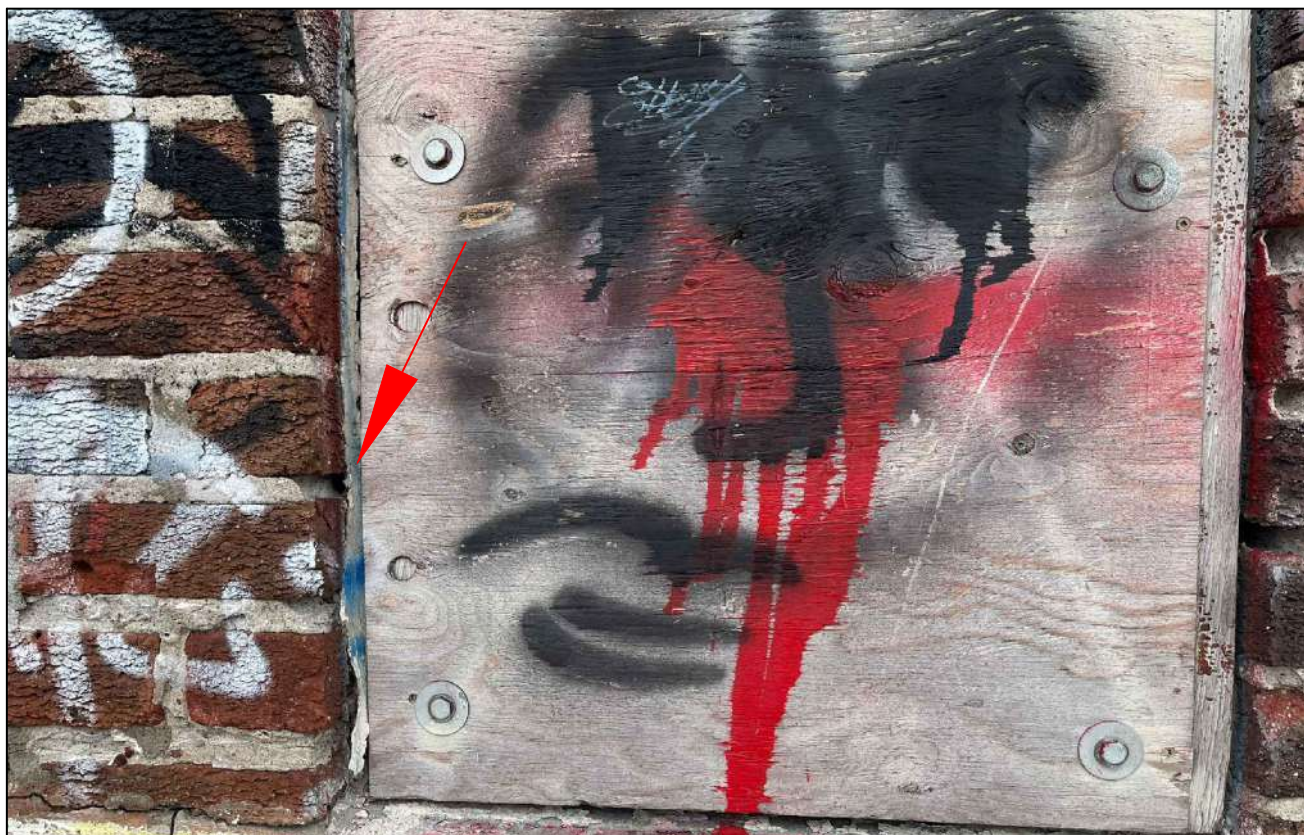
Photograph 12 Asbestos Containing on Window Caulking on Exterior South Wall

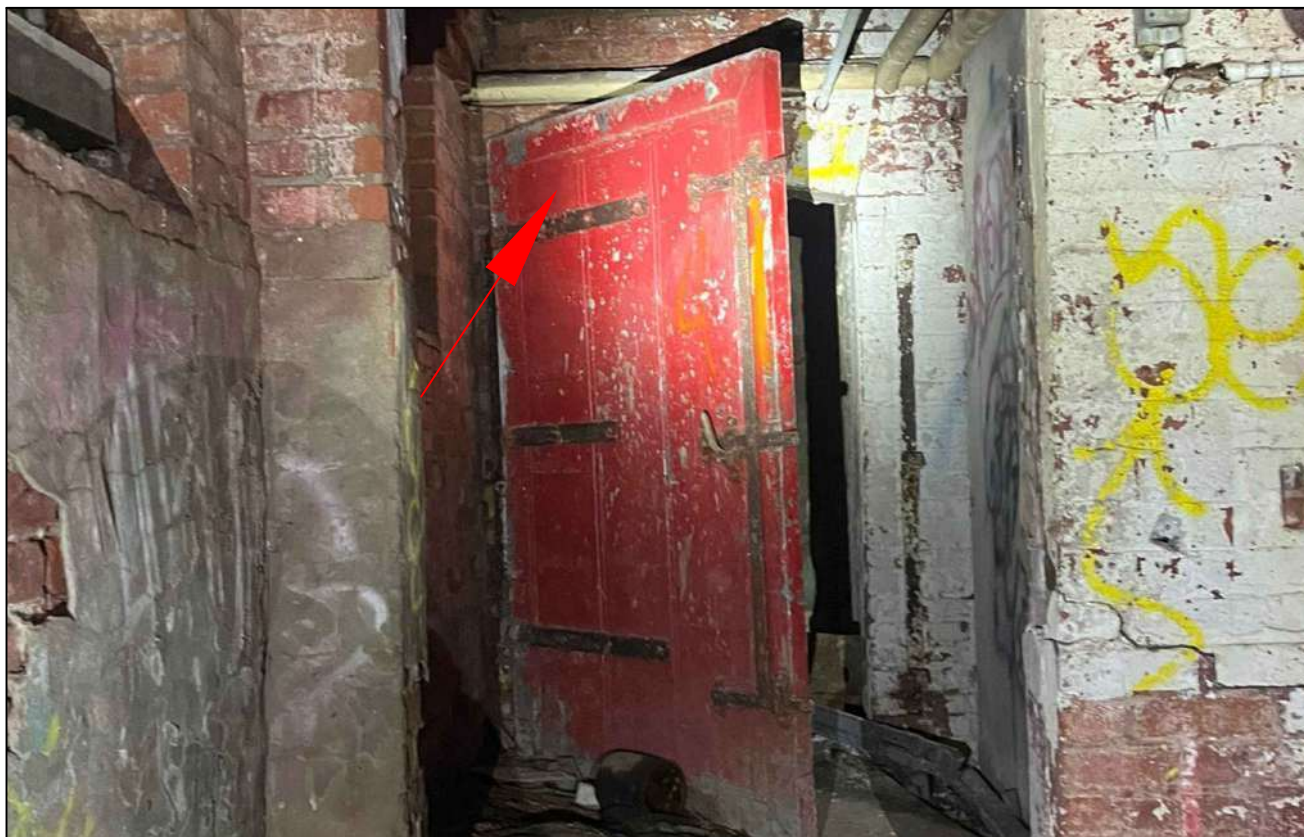
There is a red-painted Fire Door leading to the central area of the Basement where the boilers are located. The core of the Fire Door is assumed to contain asbestos.

In addition to the above, the Fire Door leading from the boilers in the Basement is assumed to have an asbestos-containing core.

Photograph 13 Fire Rated Door with Assumed Asbestos Core in Basement

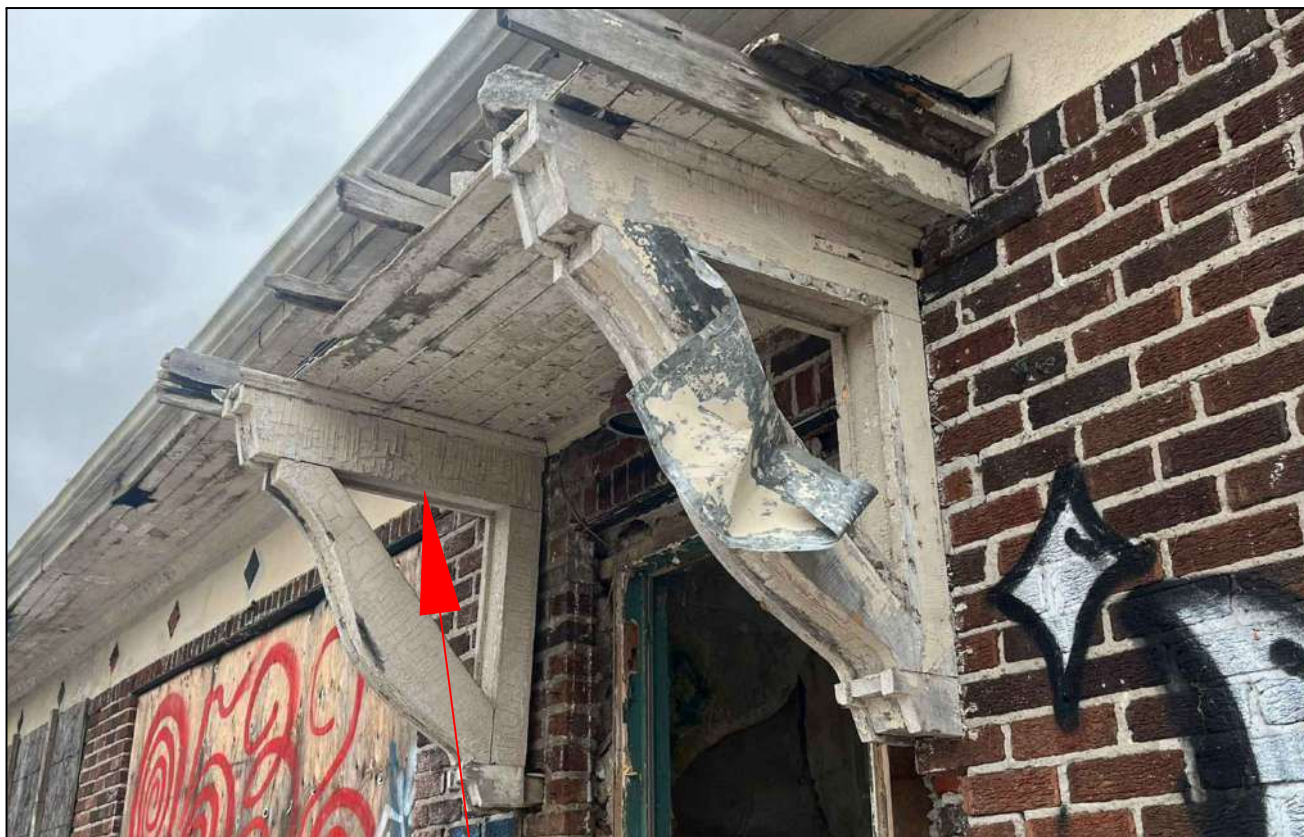
Photograph 14 Lead and Mercury Containing paint on the North Entrance Canopy

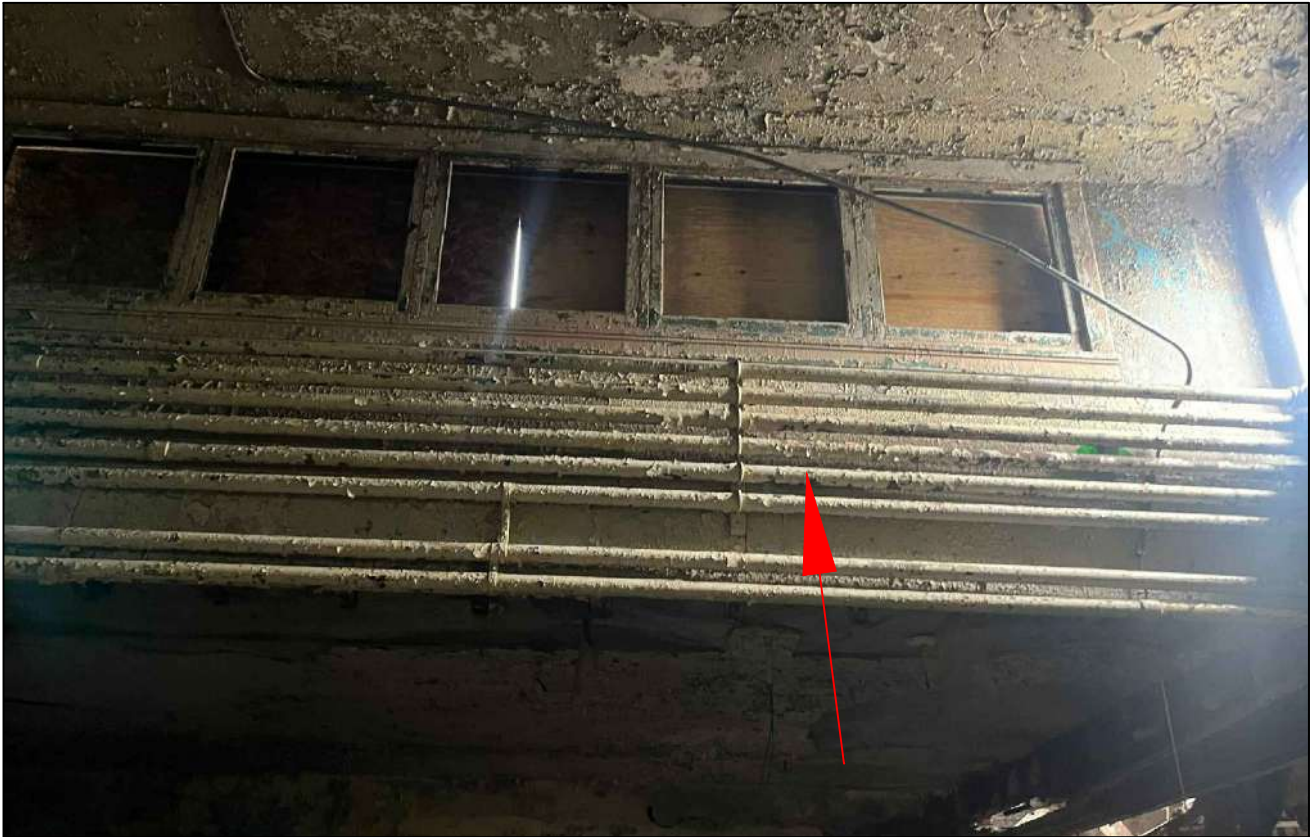
The heating pipelines on the Ground Floor are not insulated. These pipelines are arranged in a raft formation to provide radiant heat. Peeling paintwork exists over these pipelines.

Photograph 15 Peeling Lead Containing paint on Hot Water Lines

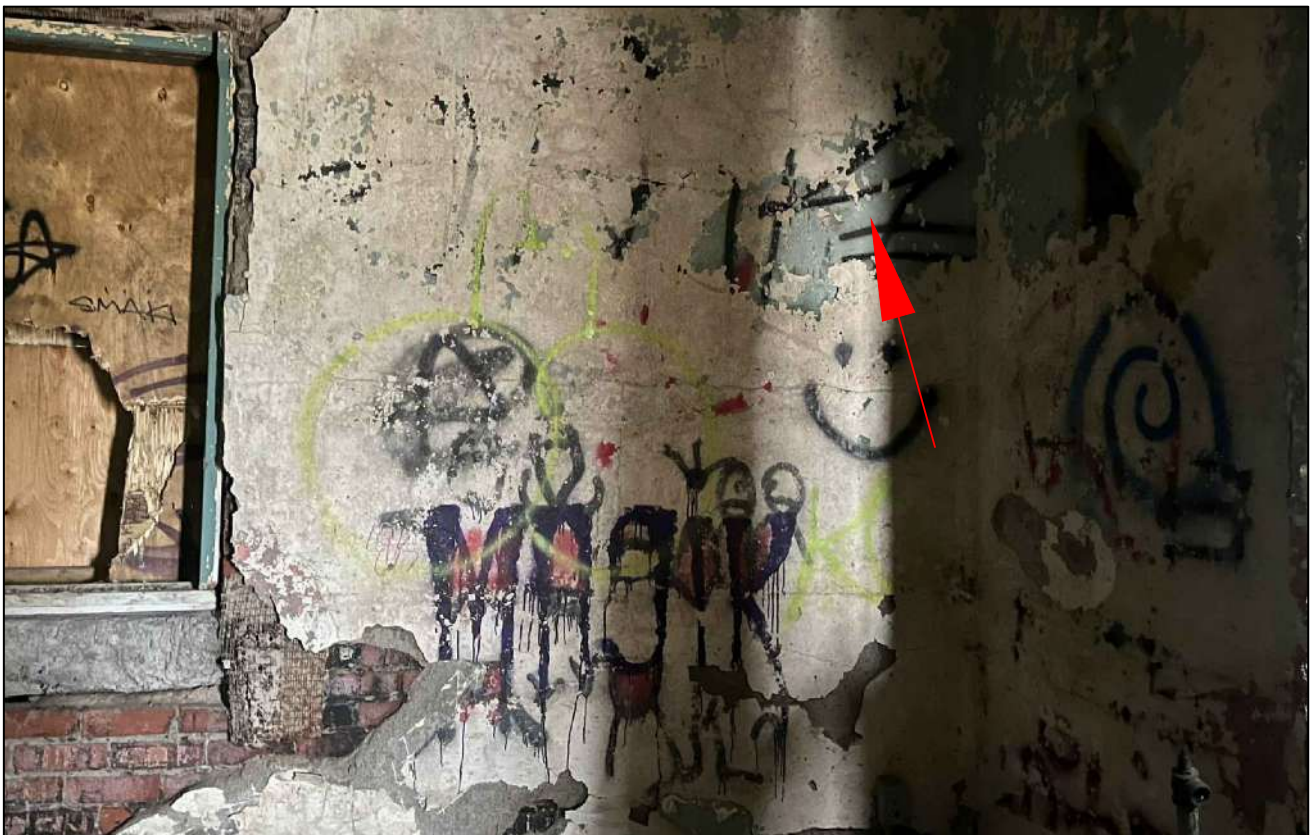
Photograph 16 Lead Containing paint on South East Interior Wall

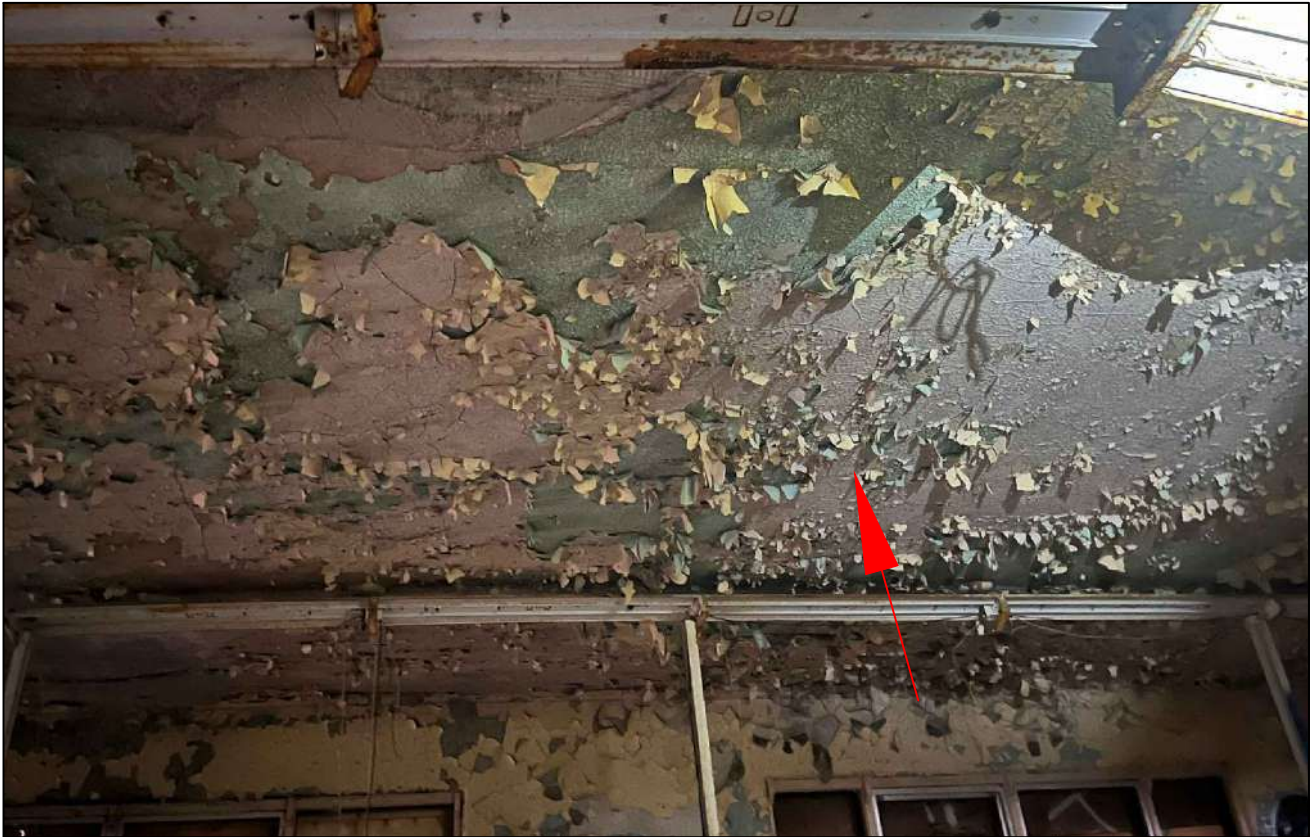
Photograph 17 Lead Containing paint on Interior South Lower Ceiling

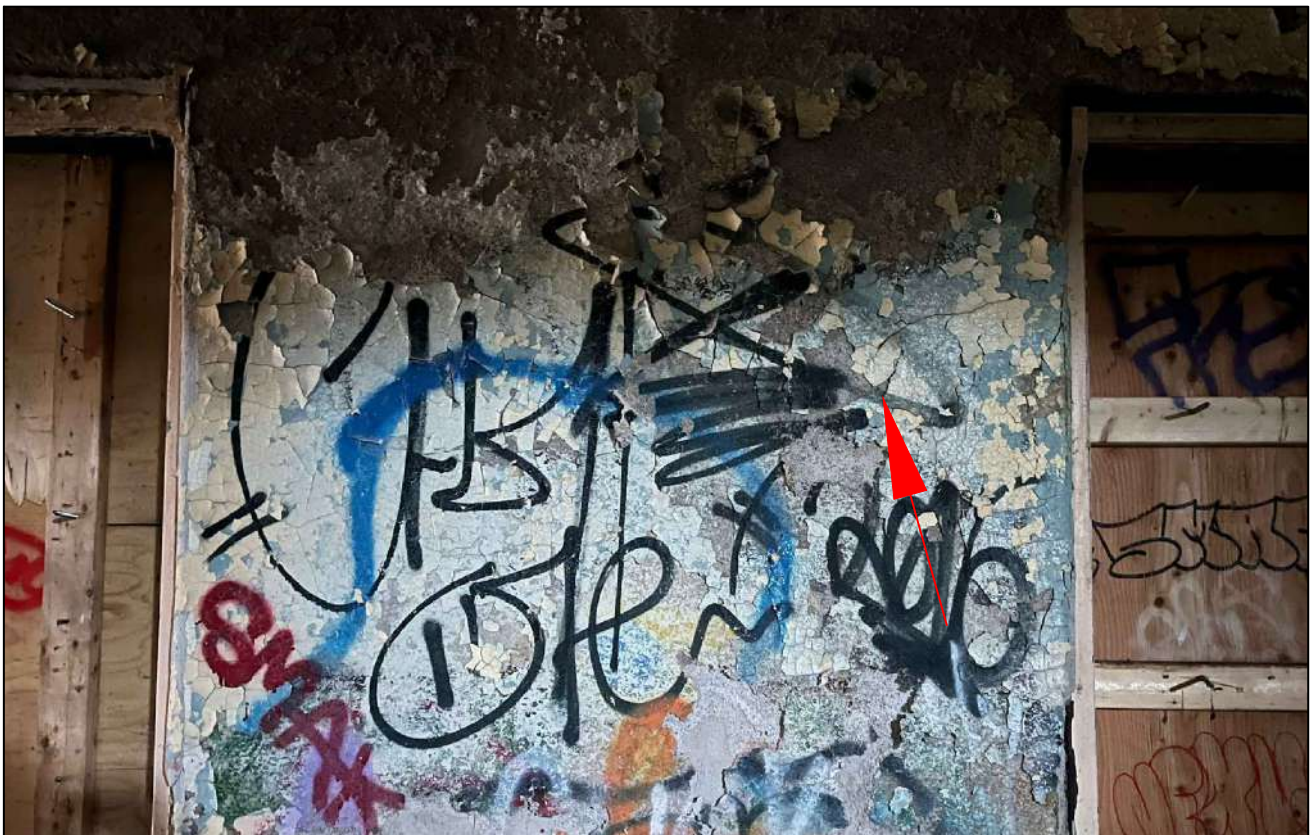
Photograph 18 Lead Containing paint on Interior South Wall

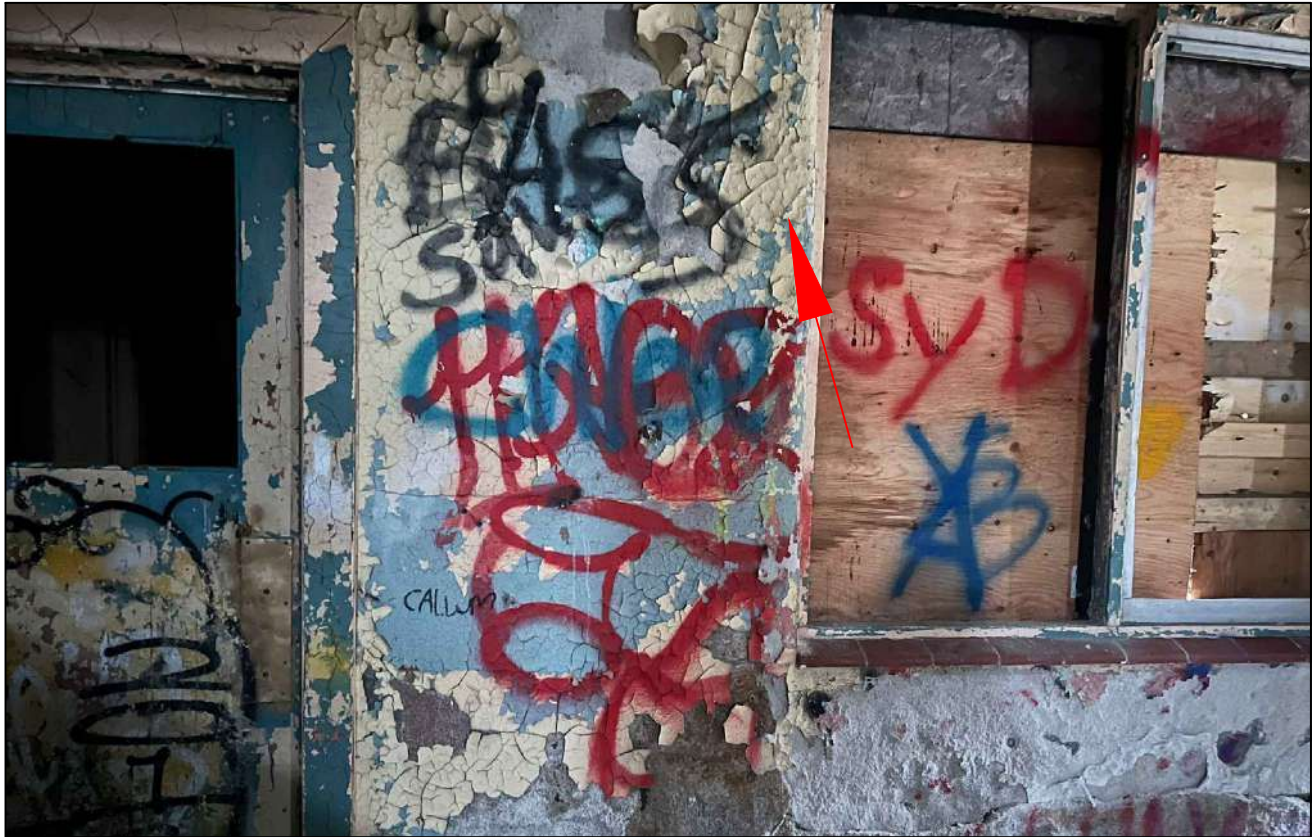
Photograph 19 Lead Containing paint on Interior West Wall

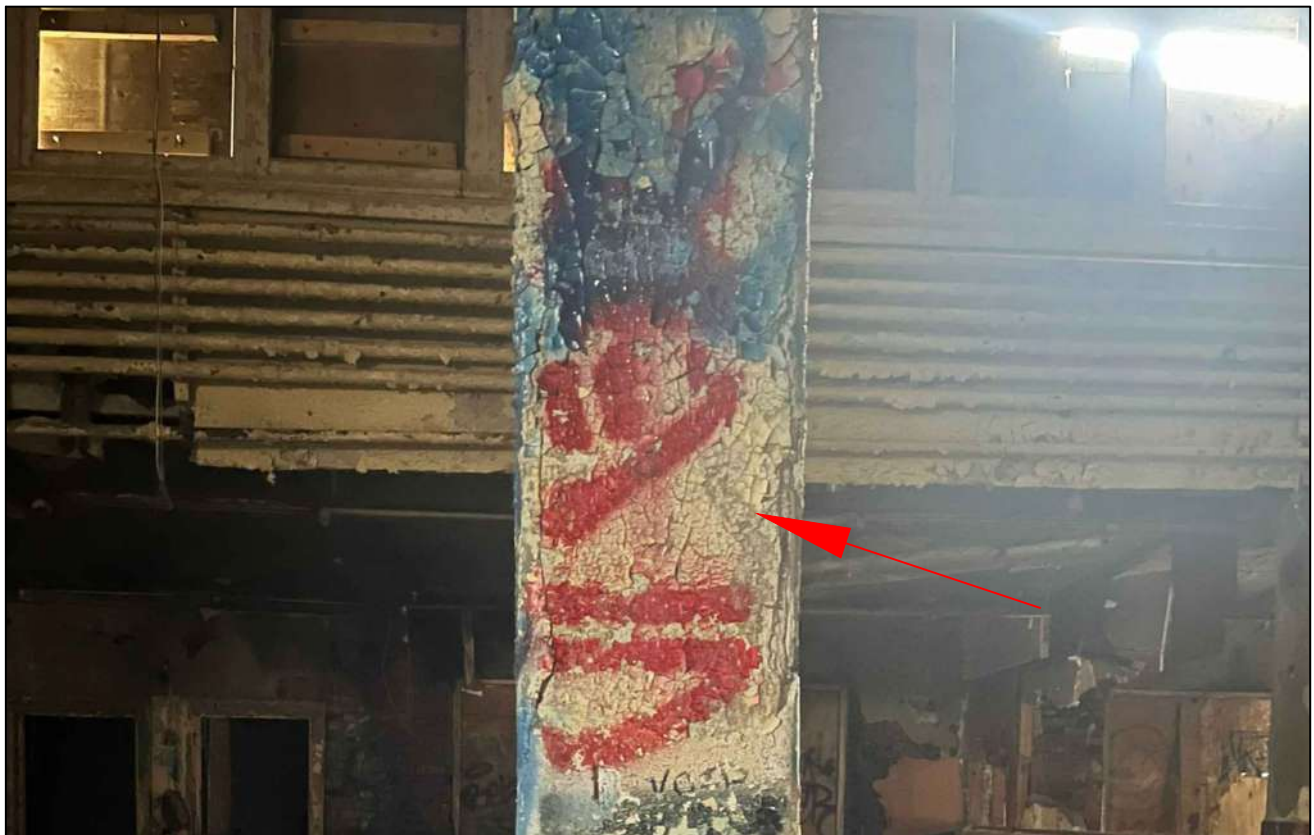
Photograph 20 Lead Containing paint on South East Column
