## Structural Condition Review

### Camp 30 Cafeteria Building

*2020 Lambs Road, Municipality of Clarington*

**BBA PROJECT NO. 22092**

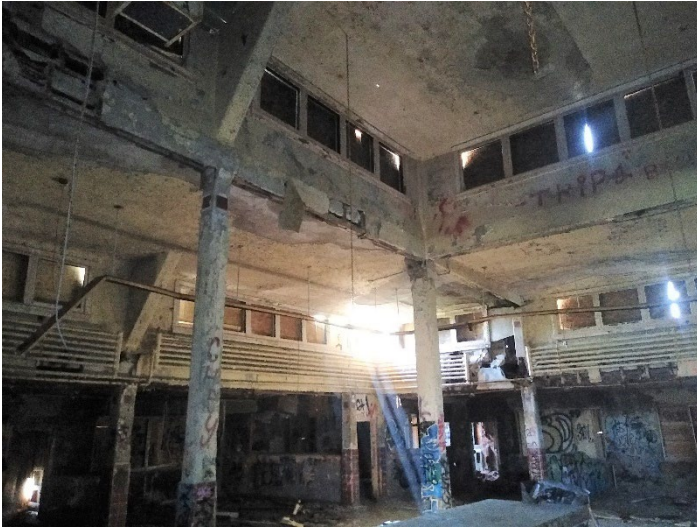
- The roofing appears from drone footage to be fully comprised in most locations. There was excess water staining observed throughout the building. (Photo 001)

Photo 001 – Visible Water Staining Throughout Structure

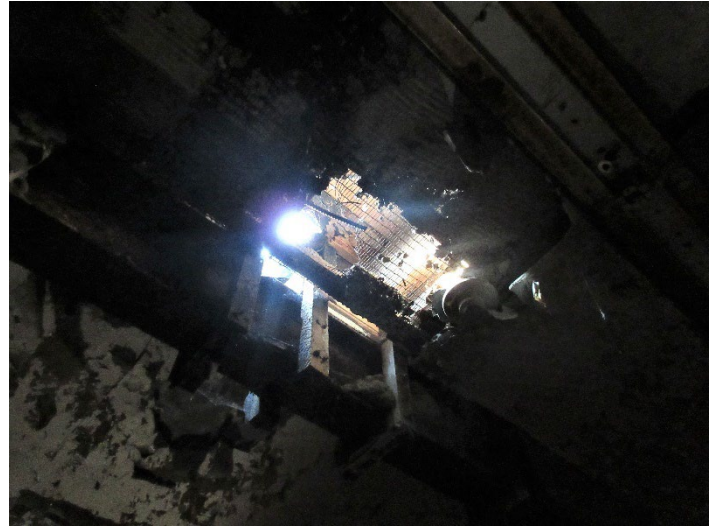
- The wood decking was completely rotted in many locations as a result of prolonged exposure to the exterior elements. (Photo 002)
- The wood roof decking and rafters showed excessive deterioration and/or deflected (sagging) showing evidence of localized failures likely resulting from prolonged exposure to moisture. (Photos 003 & 004)

Photo 002 – Rotted Decking Viewed from below

- Replacement of the deteriorated wood plank decking. Salvage decking in good condition where possible.
- Replacement of the deteriorated wood rafters. Salvage wood rafters where possible.
- Conduct a closeup visual review of the interior structural steel transfer beams. Complete reinforcing as necessary. It is believed that reinforcing will be required on at least 50% of the structural components.
- Installation of a new roof with historic flashings, fascia, and soffits to match the original building condition.

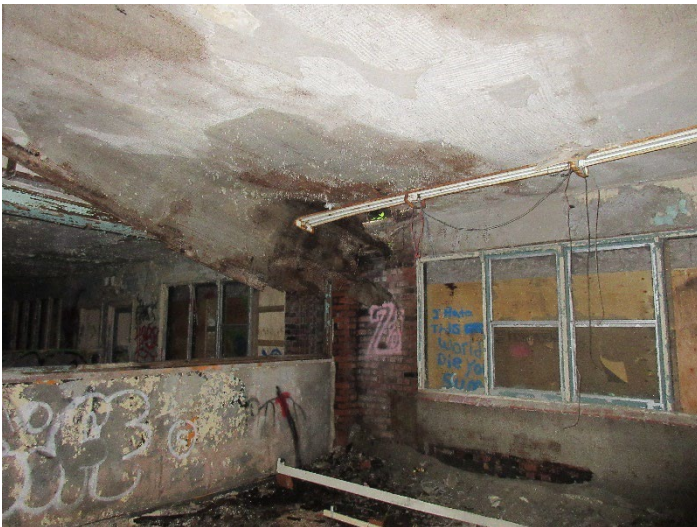
Photo 003 – Excessive Deterioration and Local Failure of Rafters (1/2)

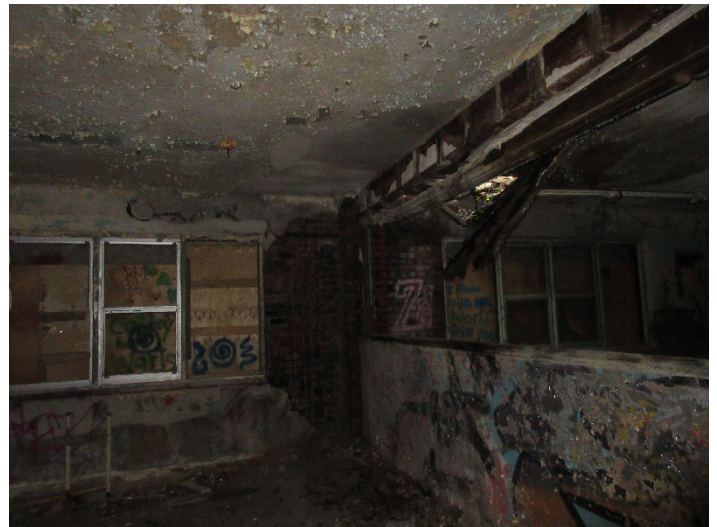
Photo 004 – Excessive Deterioration and Local Failure of Rafters (2/2)

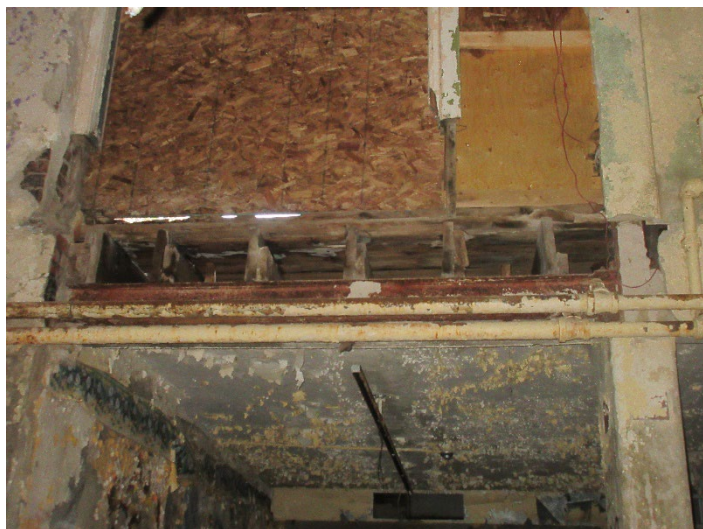
- The structural steel transfer beams, where exposed, were in poor condition and had evidence of severe surface corrosion resulting from exposure to the exterior elements. (Photos 005 & 006)

Photo 005 – Exposed Transfer Beam with Water Damage Visible

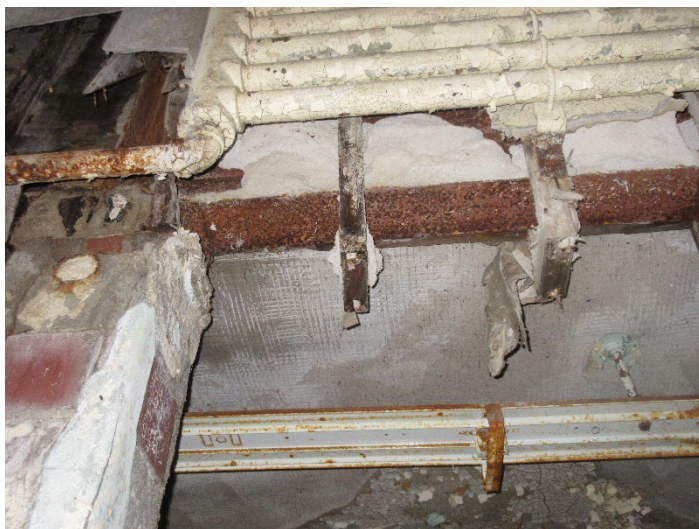
Photo 006 – Corrosion of Exposed Transfer Beam

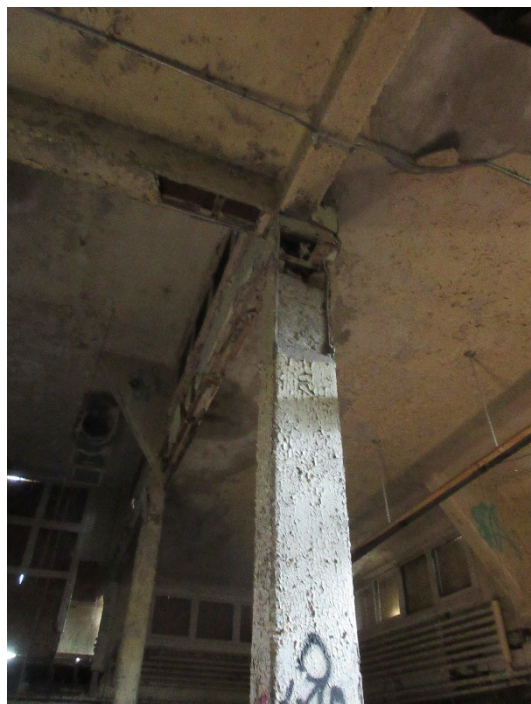
- The roof beams were supported by concrete encased structural steel columns. The concrete encasing had locally been removed, however, in general the structural steel columns appeared in fair to good condition. We did not observe any excessive deterioration or evidence of structural distress at the time of the site visit. (Photos 007 & 008)

Photo 007 – Ground Floor Concrete Encased Beams and Columns

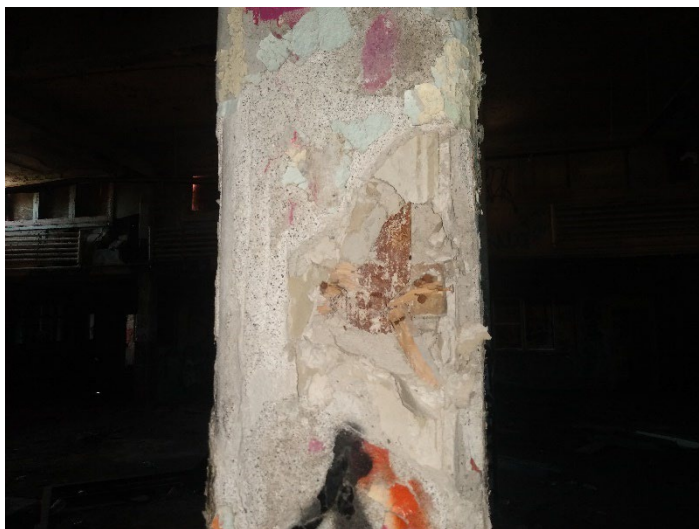
Photo 008 – Damage to Concrete Encasement

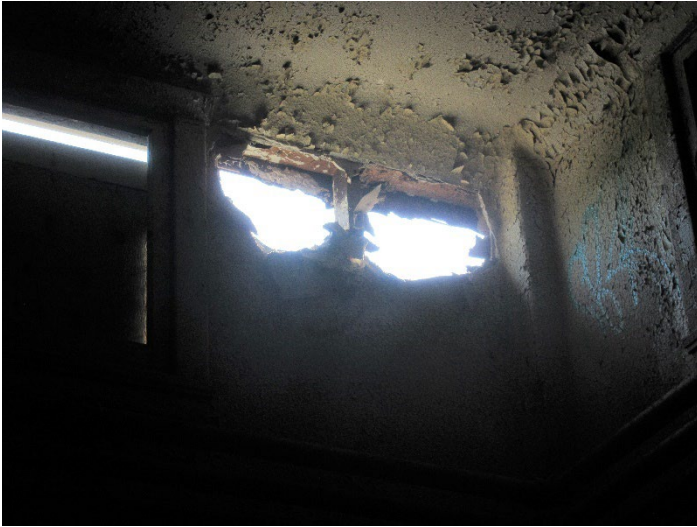
- The exterior cladding had fully failed in many locations leaving the interior of the building exposed to the exterior elements. (Photo 009)
- Excessive moisture exposure was observed from the interior of the clerestory walls. Likely a result of water penetration through the open windows, exterior wall cladding, and deteriorated roof. (Photos 001-009)
- The transfer beams supporting the clerestory walls were corroded (rusted) as a result of prolonged exposure to moisture. (Photos 005, 006 & 010)
- The wood window framing and glazing in the clerestory walls appeared deteriorated and had been boarded with plywood. (Photo 011)
- We could not confirm the connection of the top and bottom of the wall, however, it is likely made with nail fasteners which have deteriorated with the exposure to prolonged moisture.

Photo 009 – Failure of Exterior Cladding

- Replacement of the deteriorated wood panelling. Salvage panels where possible. Re-introduction of moisture resisting membrane is recommended.
- Replacement of the deteriorated wood studs. Salvage studs where possible.
- Replacement of the deteriorated window frames and installation of new glazing.
- Re-finish internal walls with lath and plaster, or similar, to match original building finish.

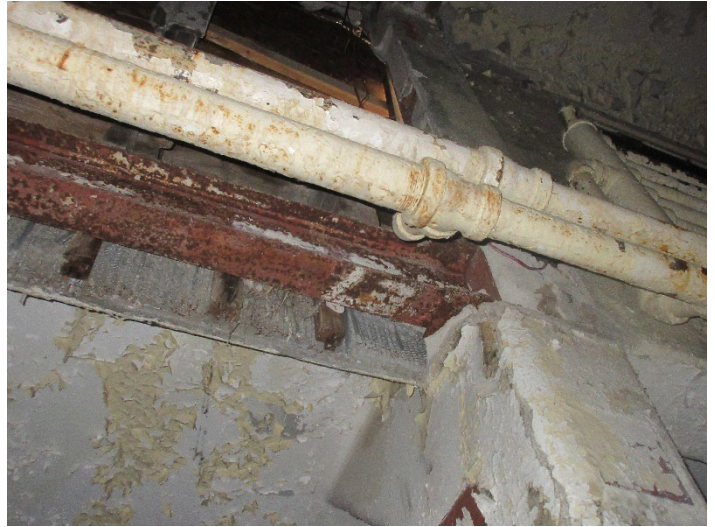
Photo 010 – Corrosion of Exposed Transfer Beam  
Supporting Clerestory

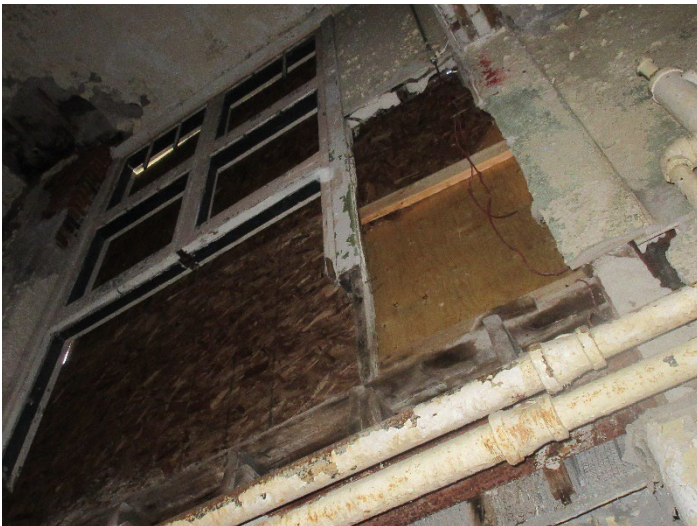
Photo 011 – Boarded Windows of Clerestory

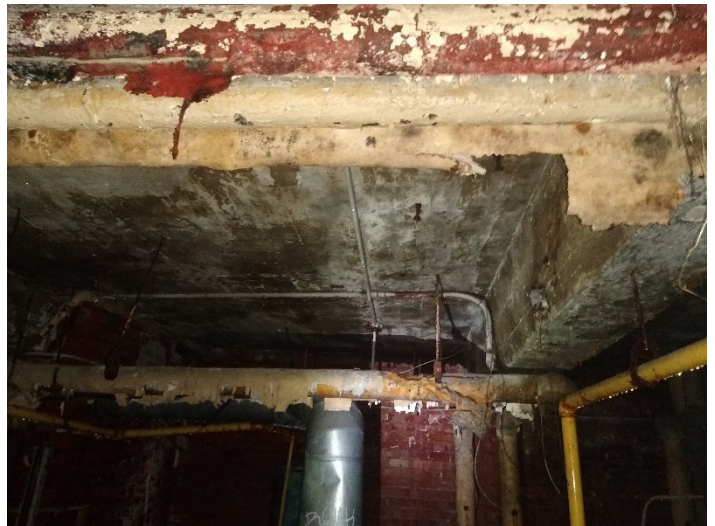
- We observed some areas where notable moisture infiltration on and/or through the slab had occurred where efflorescence accumulation and isolated spalls were located on the underside of the slab. (Photo 012)

Photo 012 – Moisture Infiltration of Suspended Slab

- Conduct a closeup visual review of the suspended slab once exposed. It is believed that the presence of moisture may have had an effect on the top of slab, however, the structural integrity of the slab appears intact. Repair any surface damage present.
- Conduct additional review of concrete encased beams once accessible. Replace and/or repair damaged and deteriorated sections concrete. Reinforce where required. Should more concerns be found upon review, provide shoring and reinforcement where required.
- Conduct additional review of concrete stairs once accessible. Replace and/or repair damaged and deteriorated sections concrete.
- Repair and refinish underside of slab where necessary.

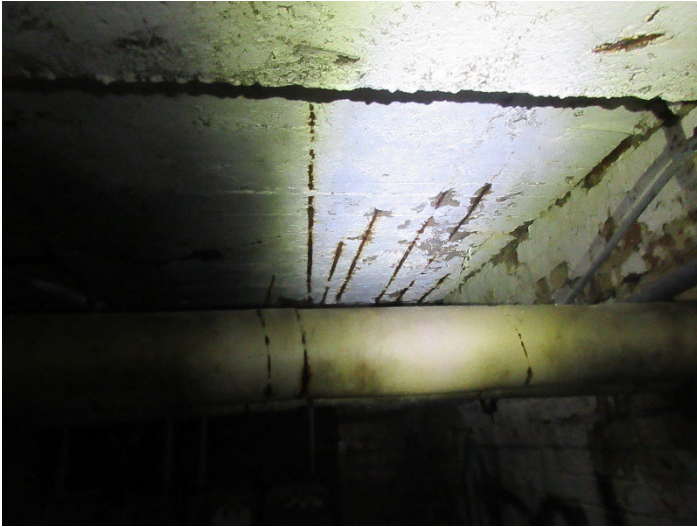
- We observed corroded reinforcing steel at several locations on the underside of the slab. The reinforcing steel did not appear to have sufficient clear cover on the concrete and with the exposure to moisture has corroded and cause the slab to spall. (Photo 013)

Photo 013 – Exposed Rebar on Underside of Suspended Slab

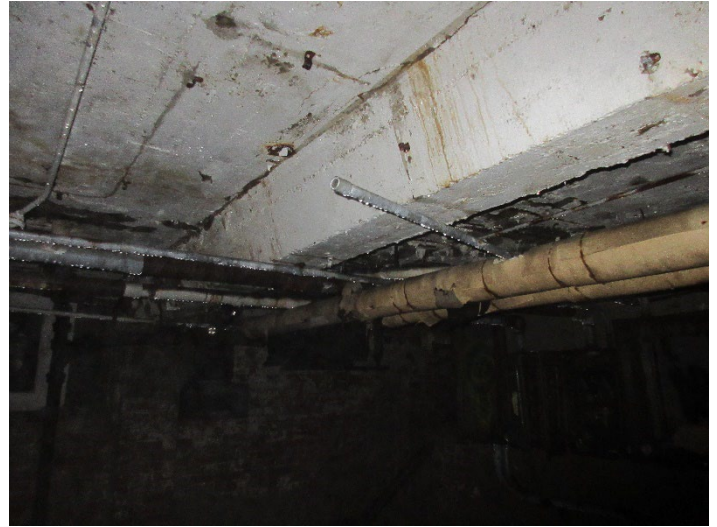
- The concrete beam and steel encased concrete beams generally appeared in fair to good condition at the time of the visit. However, verification of the structural adequacy (i.e. chloride ion content and compressive resistance) after exposure to the exterior elements will need to be confirmed. Additionally, there are localized repairs that will be required to restore isolated spalling and deterioration observed at areas where prolonged exposure to the exterior elements occurred. (Photo 014)

Photo 014 – Concrete Encased Beam

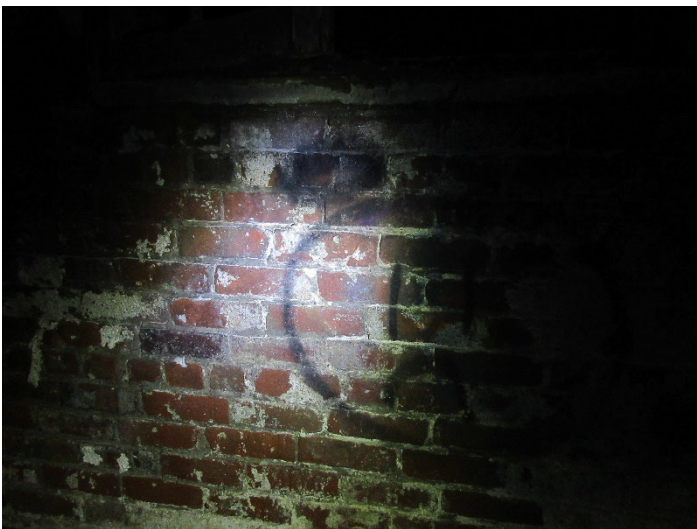
- The foundation walls, as observed from the interior, appeared in moderate condition with varying levels surface wear, likely due to moisture exposure. We observed peeling paint and isolated surface corrosion/dusting on the brick units in many locations. (Photo 015)
- The masonry brick mortar joints in many areas on the exterior wall were dusting and had deteriorated. We observed localized step cracking at some locations likely resulting from differential movement due to frost action during winter months since the basement is no longer conditioned.
- Not all foundation walls were observable due to access at the time of the site visit, after areas of the basement are cleaned further review may be required.

Photo 015 – Clay Brick Masonry Foundation Wall

- Complete further review work of the basement to confirm conditions in areas that could not be safely reviewed.
- Consider temporary heat to assist with preventing frost action in the basement which will cause differential movement.
- Consider moisture mitigation (i.e. sump) pit to ensure that any standing water is removed from the basement prior to cold weather that could cause ice building up in the building and apply stress to the load bearing walls.
- Restore the brick masonry foundation walls on the interior which will include repointing using historic mortar application, localized brick replacements, and possible localized wall re-construction where cracking has occurred.
- Consider an exterior waterproofing membrane and weeping tile along the perimeter of the basement.

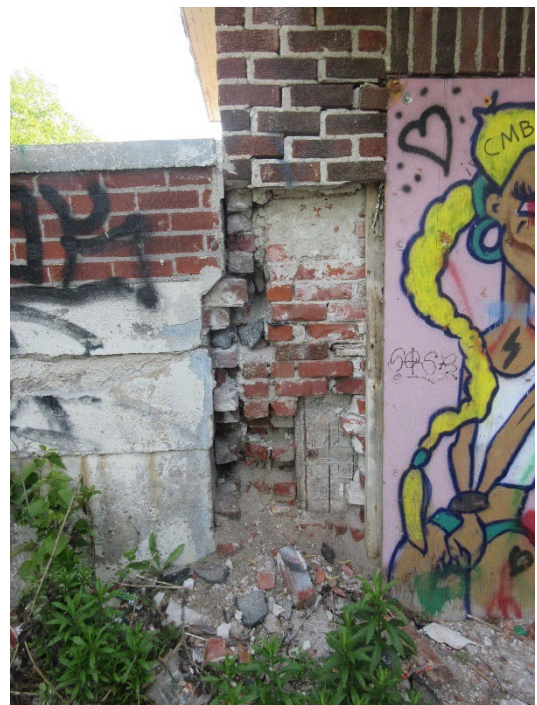
- Localized areas of extensive damage were observed where façade is no longer present. (Photos 016 – 018)
- The interior lath and plaster finished was mostly in a failed condition along the interior of the building. There was evidence of severe deterioration, likely due to the moisture exposure through the open windows, exterior wall cladding, and deteriorated roof. The interior space had been vandalised throughout most of the space. (Photos 003 & 004)
- The wood window framing and glazing at the ground level appeared deteriorated and had been boarded with plywood. (Photos 003 & 004)
- Cracking, mortar delamination, and lost mortar observed throughout.

Photo 016 – External Brick Masonry Wall Damage (1/3)

- Replacement of damaged and deteriorated sections of wall. Salvage clay bricks where possible for re-use in the new construction
- Salvage existing window frames where possible for re-use or to assist with creating replica frames for a rebuild.
- Re-construct new load bearing masonry walls to match the existing architectural façade, consider a new structural back up such as metal studs to eliminate one (1) wythe of brick which should allow for the reclaimed bricks to be fully utilized in a re-construction.
- Repoint rebuild with historic mortar procedures.

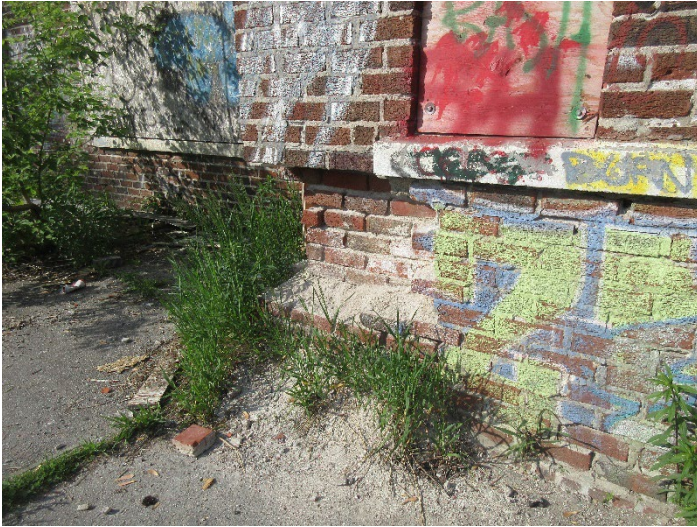
Photo 017 – External Brick Masonry Wall Damage (2/3)

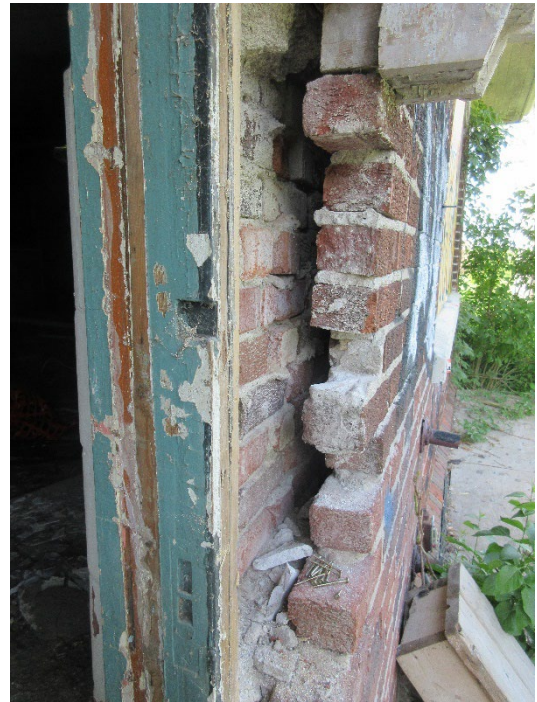
Photo 018 – External Brick Masonry Wall Damage (3/3)
