# Camp 30/Bowmanville Boys School Bowmanville

## Stabilization & Security Measures Report for Building 5 - Cafeteria Hall

October 2024

Prepared by GBCA

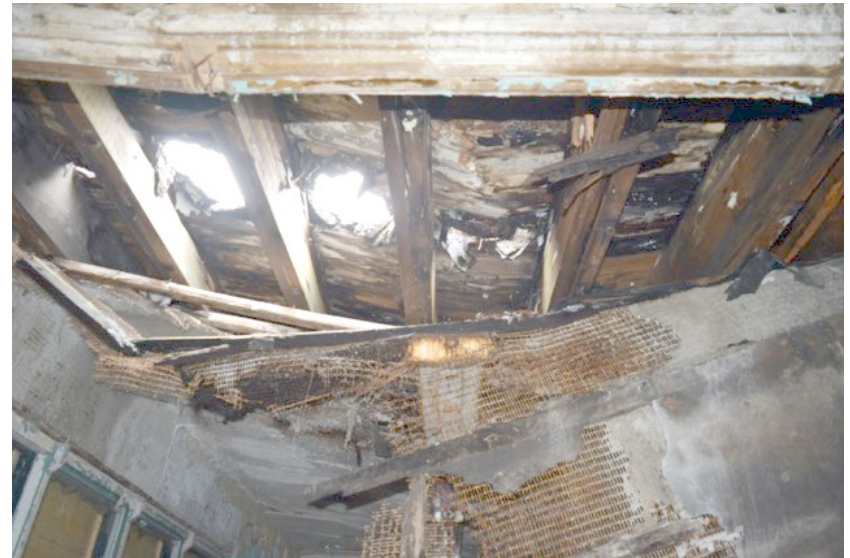
Collapsed lath and plaster ceiling including wood decking and joists.

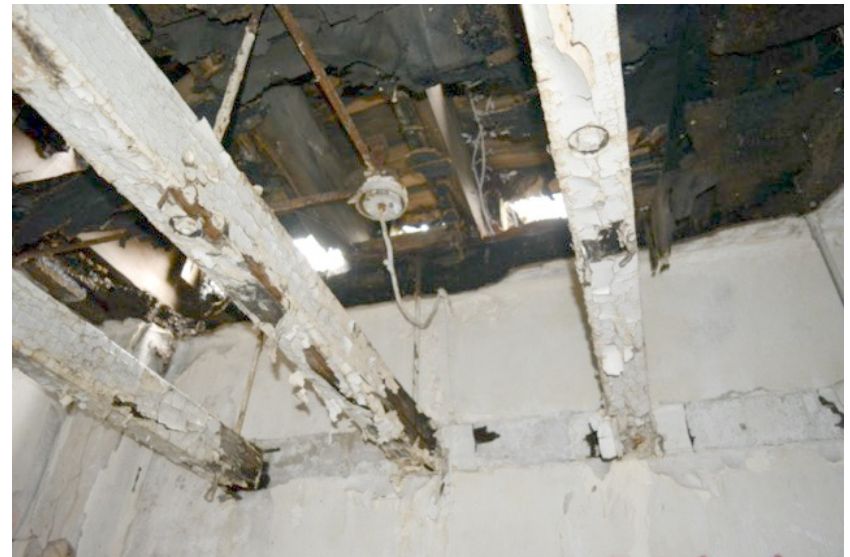
Wood ceiling joists in very poor condition where ceiling has caved in.

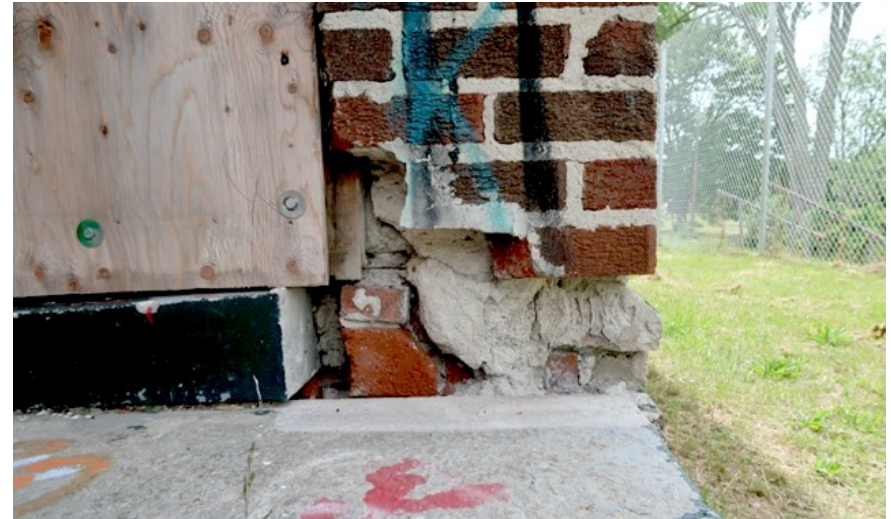
Broken bricks around doorway sills in a few locations requiring reconstruction.

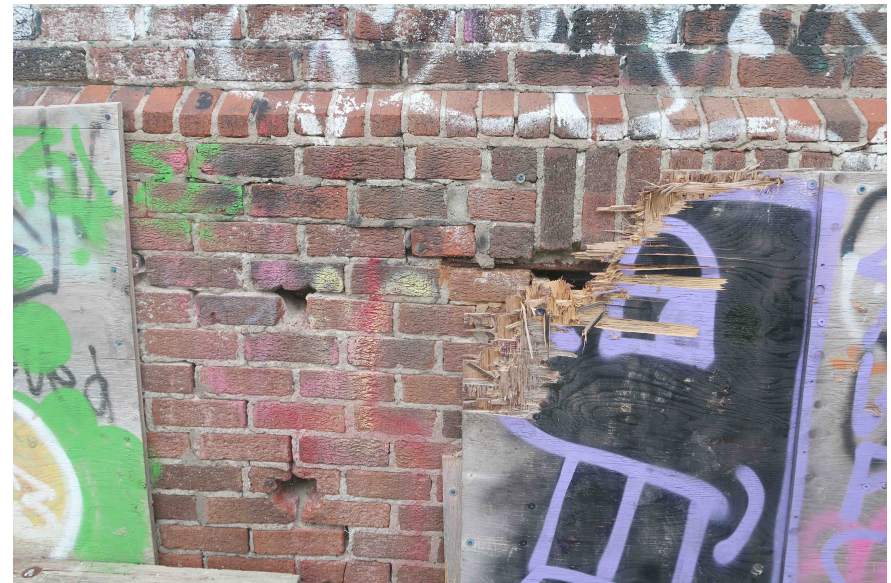
Holes in brick. This surface hoarding is damaging to the brick.

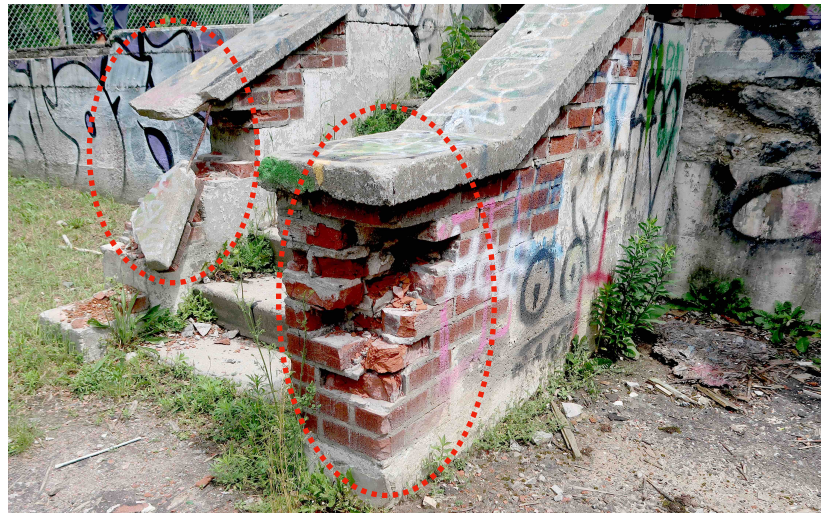
Steps on north side extensively deteriorated and may have been subjected to vandalism

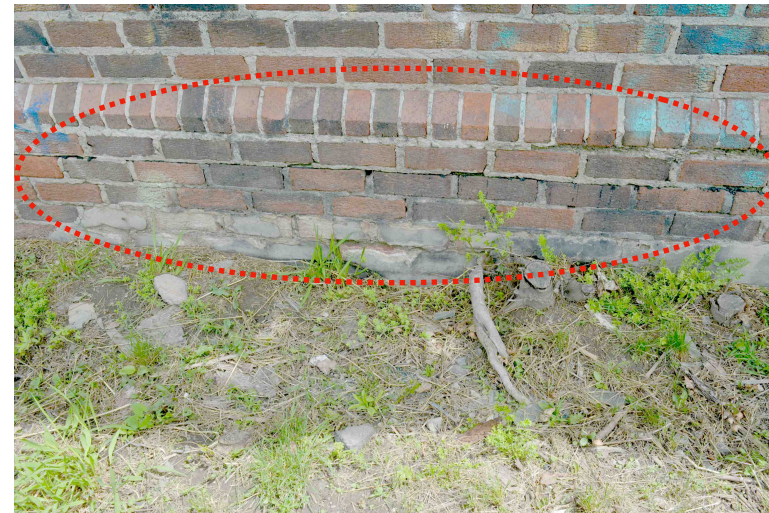
Old repairs to damaged foundation on west side .

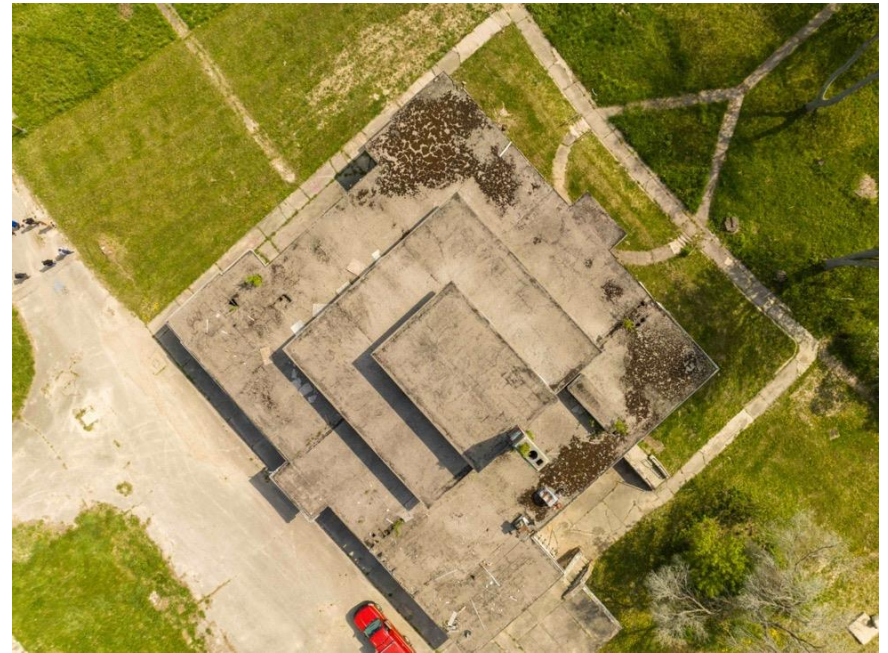
Roof Plan showing soiling at west side

- Remove vegetation from the roof of the building.
- The roofing must be replaced as it has reached the end of its life. Remove existing roof membrane, all legacy mechanical and plumbing penetration through roof.

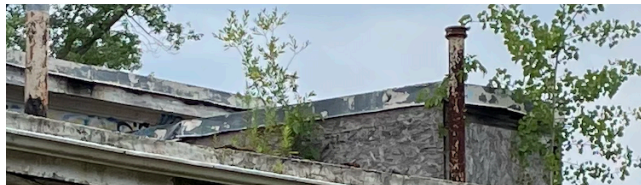
Small cupola in boarded up condition in 2024

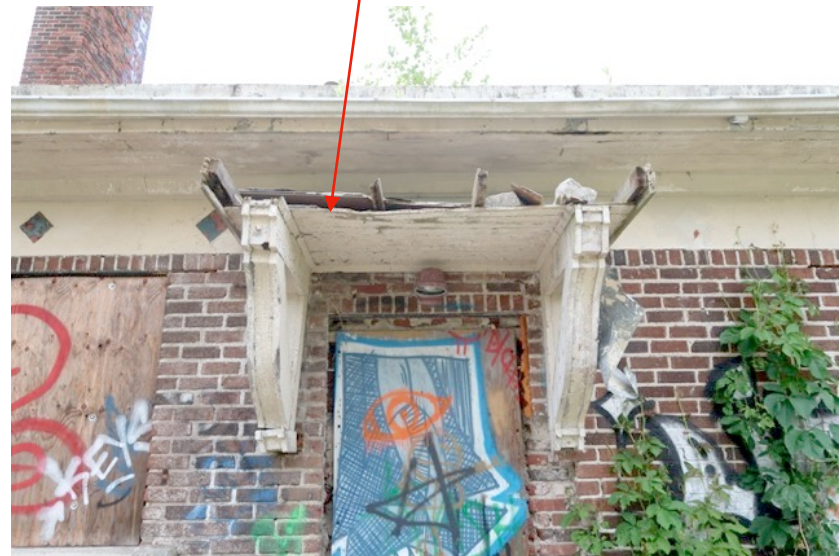
Remains of Canopy roof facing north.

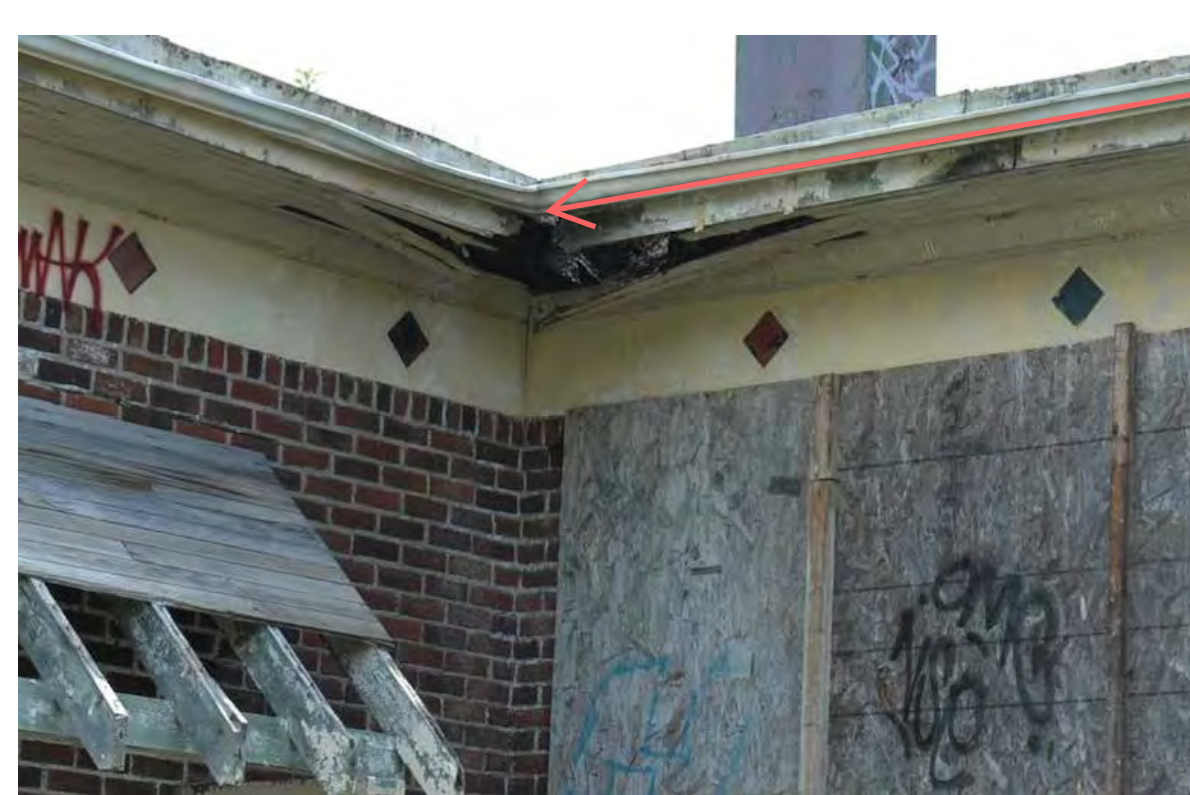
DETERIORATED FLASHING, FACSIA AND SOFFIT

FASCIA AND SOFFIT TO BE PATCHED

UPPER PLYWOOD WINDOW/DOORS PLUGS TO INCORPORATE VENTILATION GRILLE

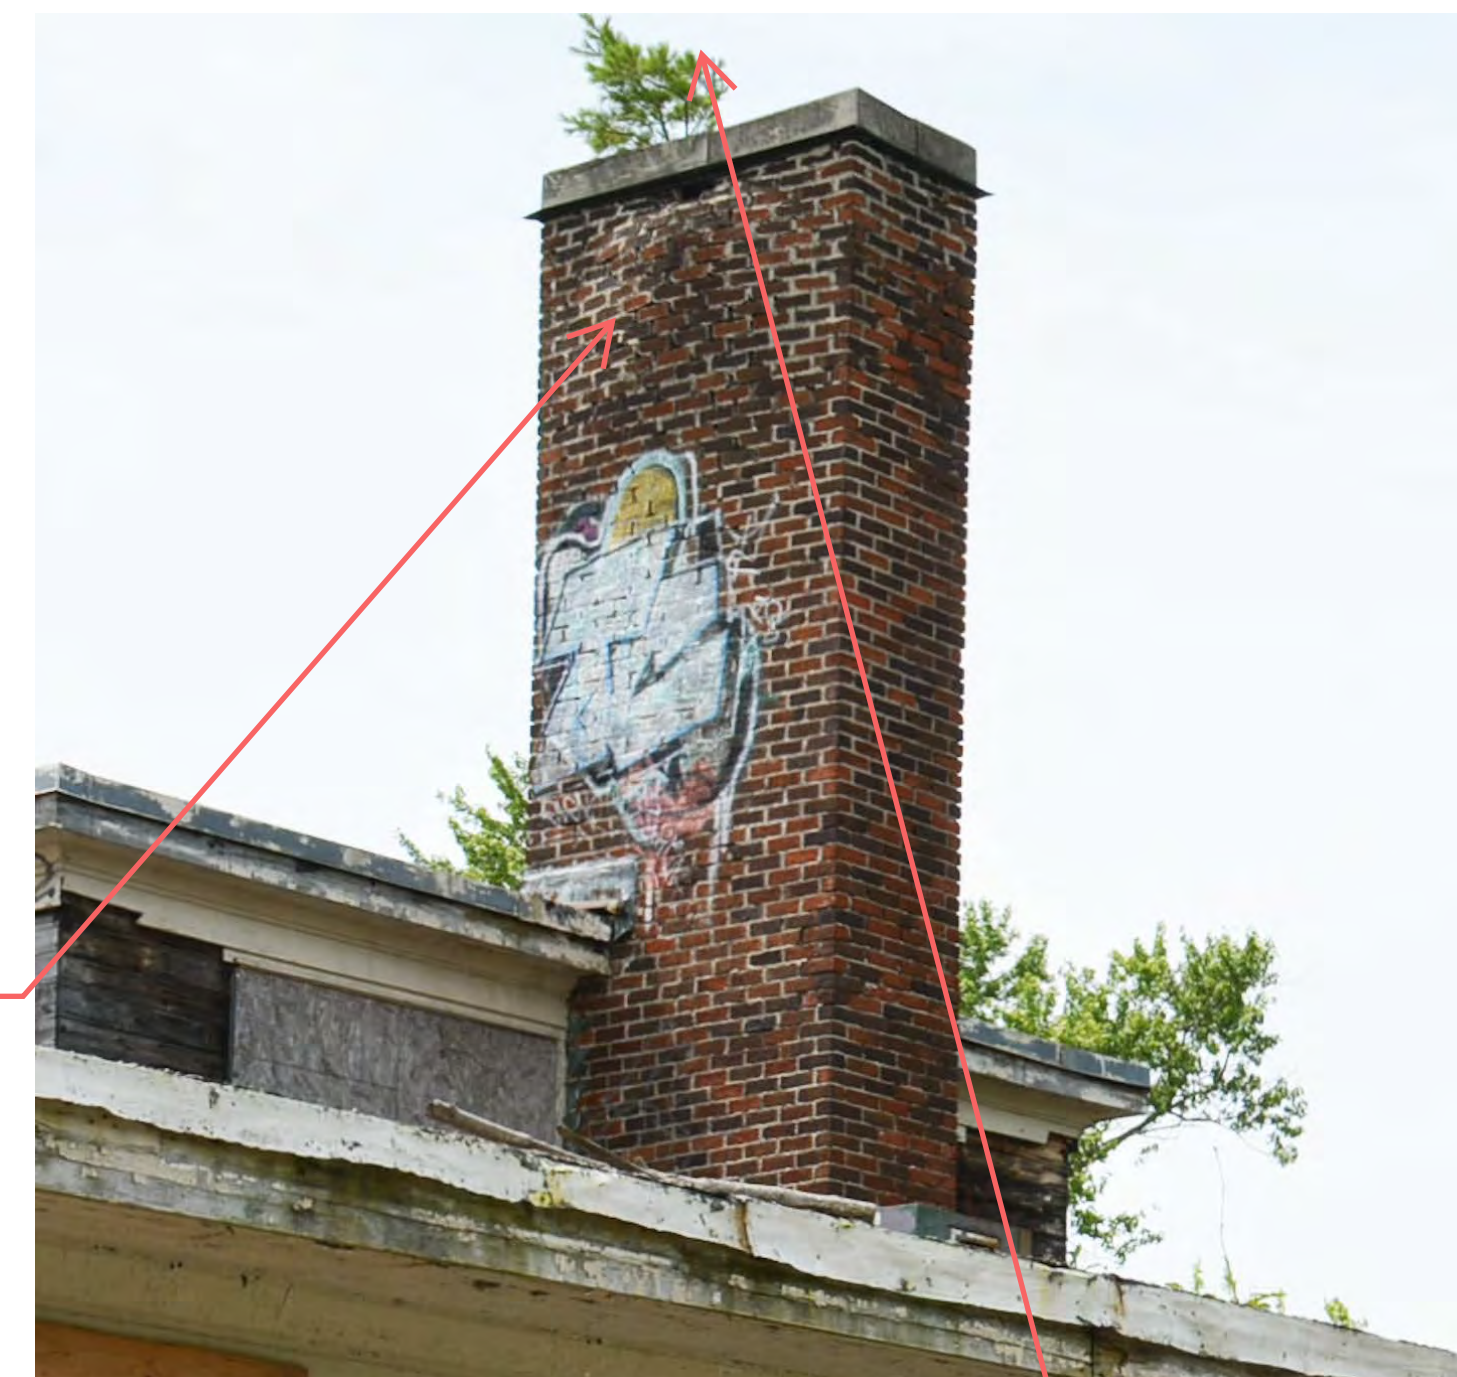
BULGING CHIMNEY AND VEGETATION GROWTH

BULGING CHIMNEY TO BE DISMANTLED AND REBUILT. STABILIZATION BY TO BE SPECIFIED BY STRUCTURAL ENGINEER

REMOVE ROOTS, TREES AND OTHER VEGETATION. BY ARBORIST CONSULTANT AND AUTHORITIES HAVING JURISDICTION

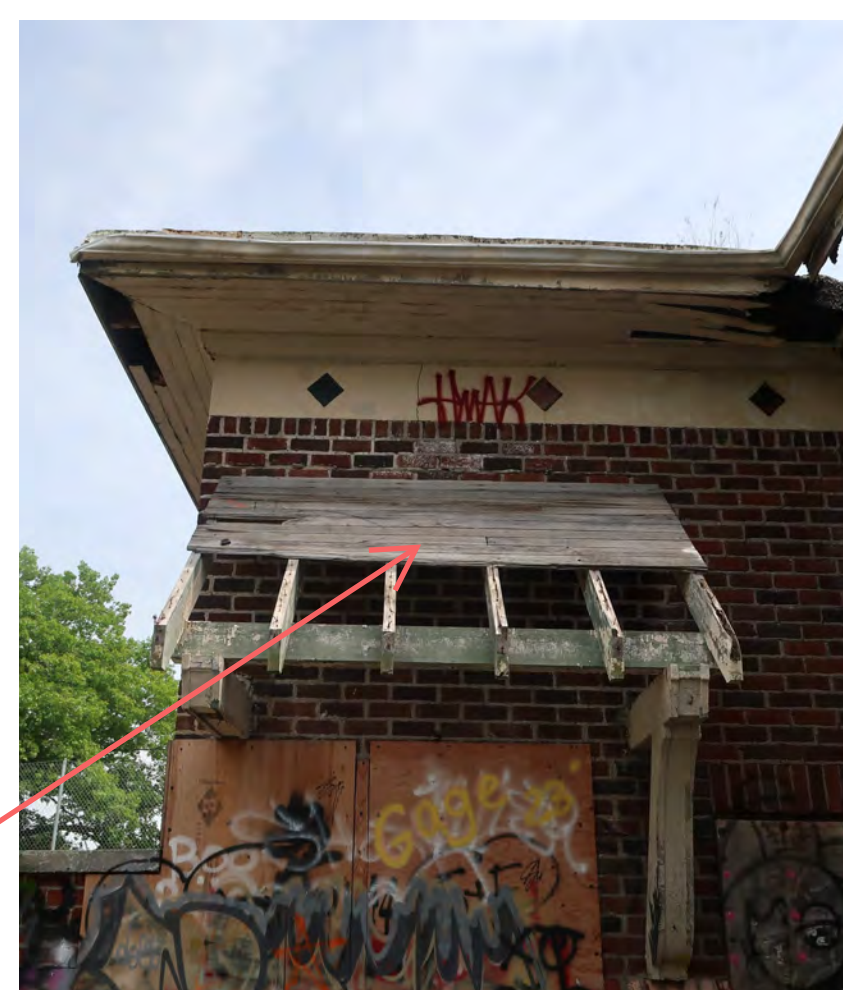
DETERIORATED CANOPY AND BRACKET

DETERIORATED CANOPY AND BRACKETS TO BE REMOVED AND STORED

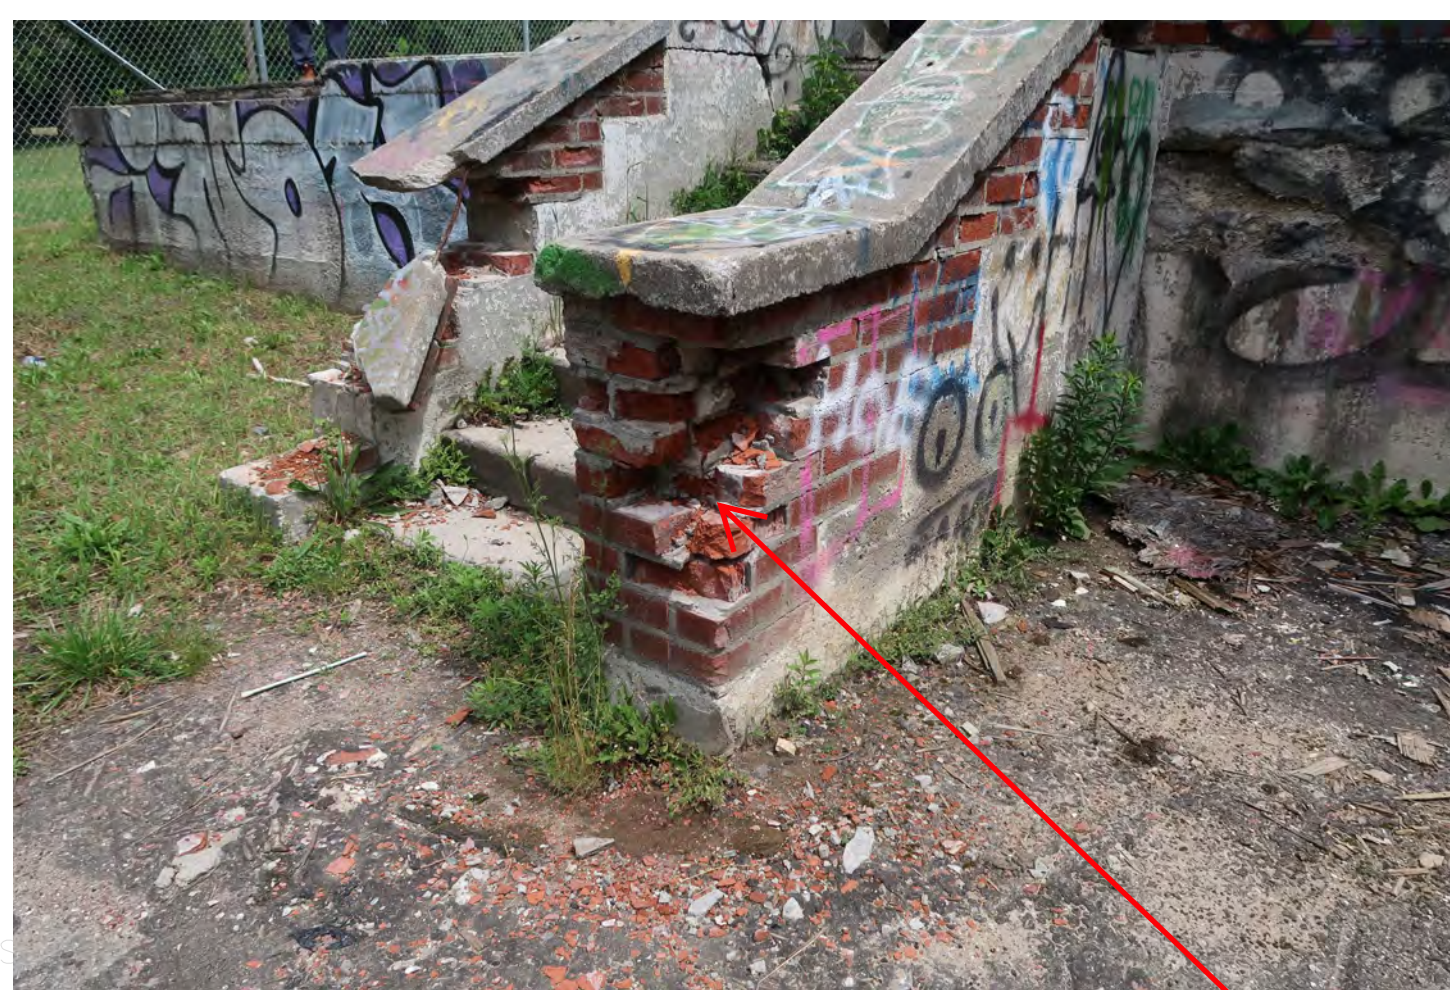
DETERIORATED EXTERIOR STAIRS

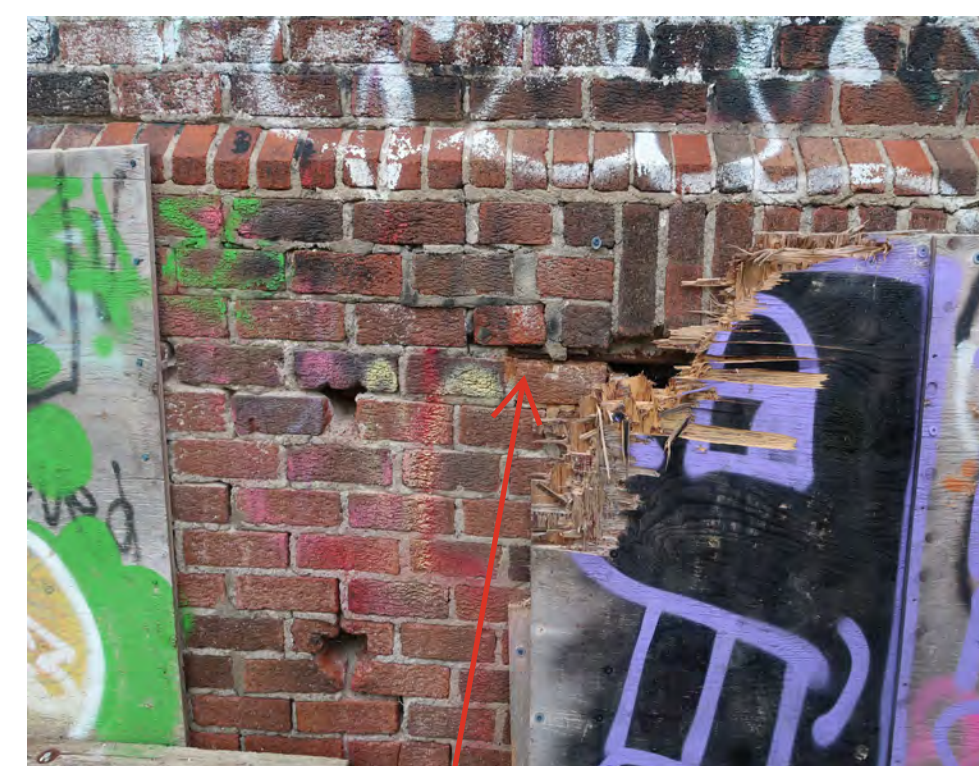
HOLES IN BRICKS

MASONRY REPAIRS

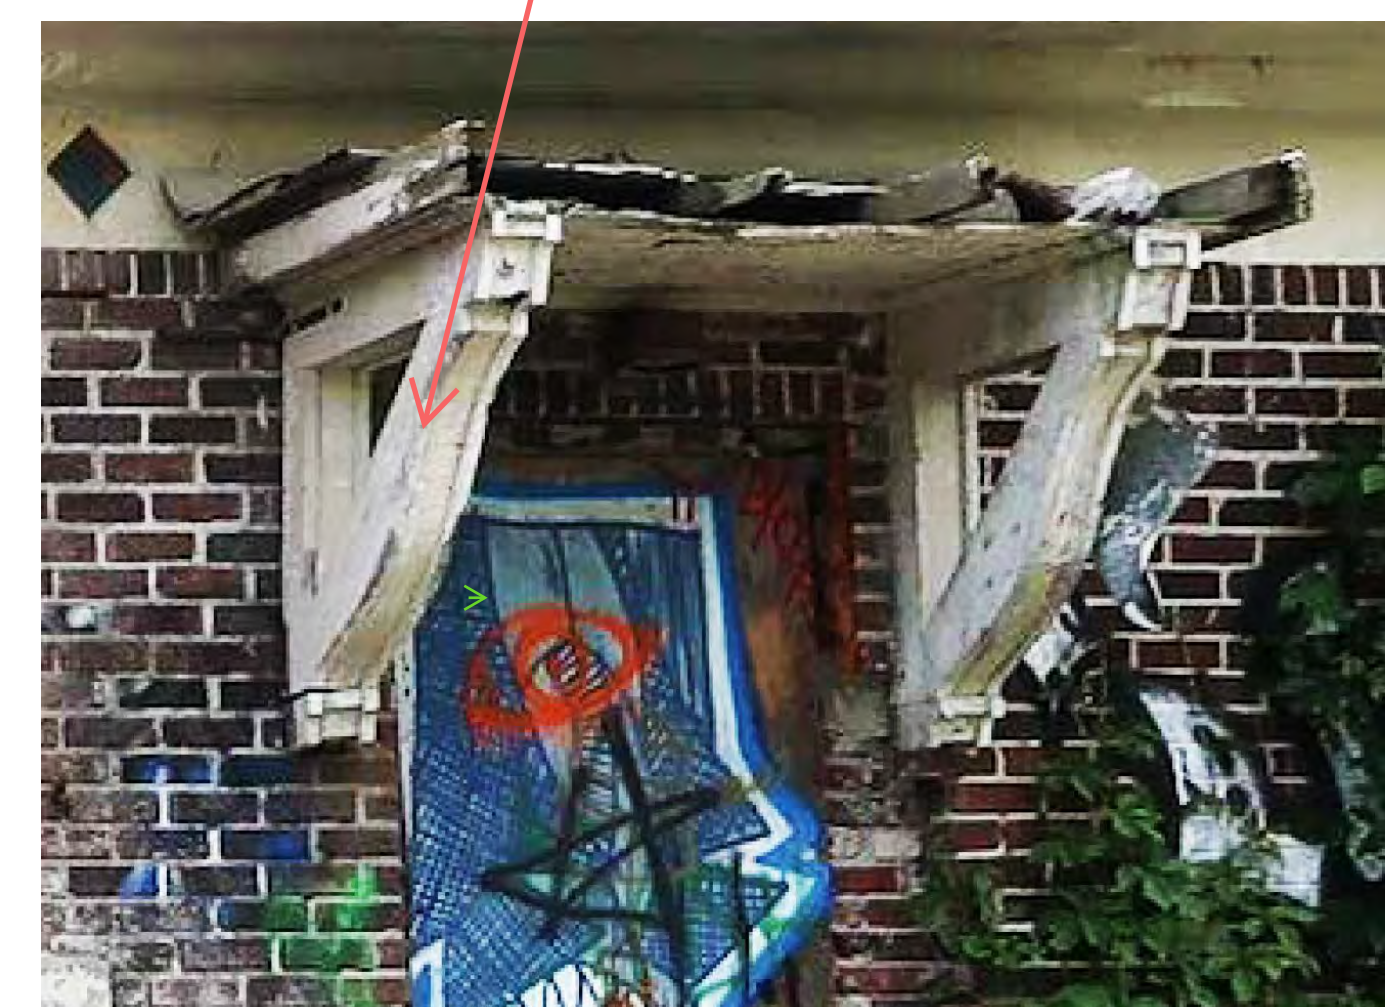
DETERIORATED CANOPY

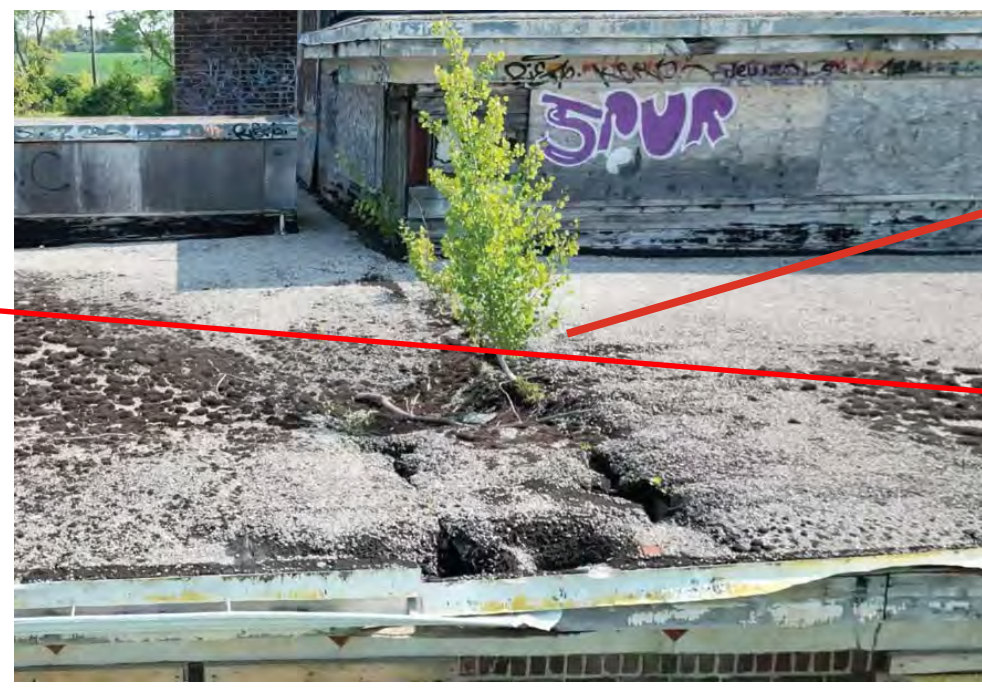
DETERIORATED ROOF CAVING IN AND BIOLOGICAL GROWTH

DO LOCALIZED REPAIRS TO ALL THREE LEVELS OF EXISTING ROOF WOOD PLANKS WITH 3/4" PLYWOOD SHEATHING. ESTIMATED 40% OF ROOF. REMOVE EXISTING ROOF MEMBRANE AND ANY VEGETATION, ALL LEGACY MECH & PLUMBING PENETRATION THROUGH ROOF. PATCH FASCIA BOARD, REMOVE DETERIORATED FLASHING AND GUTTERS THROUGHOUT AND INSTALL NEW FLASHING, GUTTERS, AND RWL'S. INSTALL 5 YEAR TEMPORARY ROOF MEMBRANE ON ENTIRE ROOF

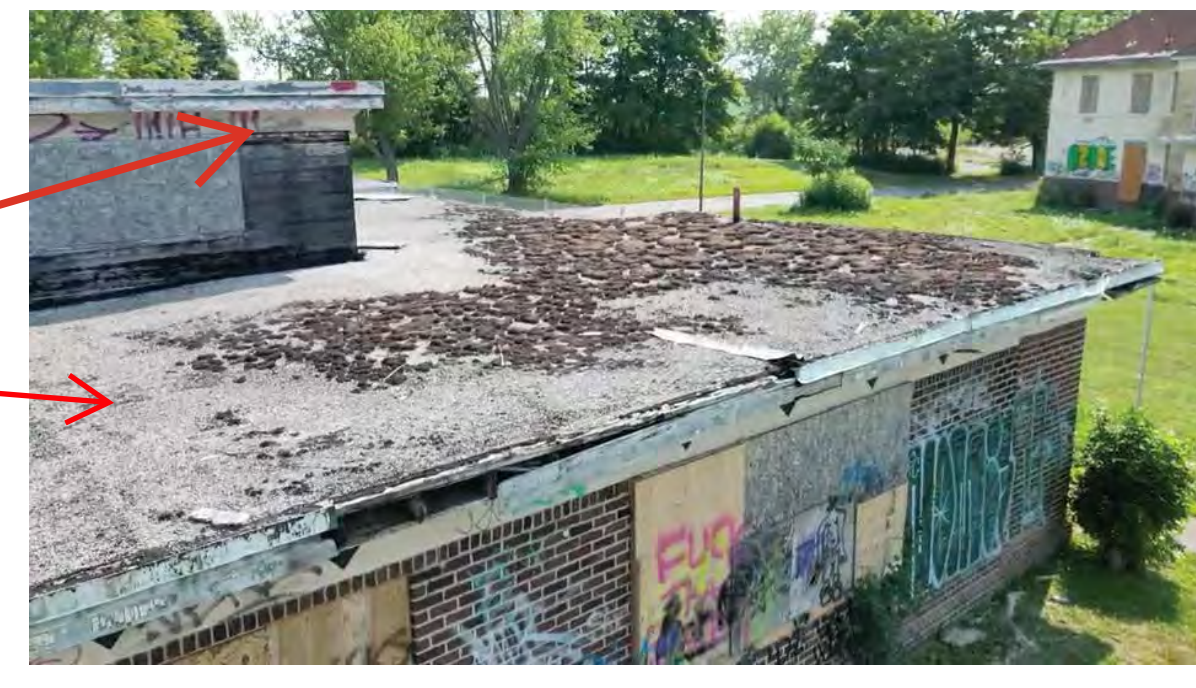
DETERIORATED ROOF SHOWING SOIL AND BIOLOGICAL GROWTH

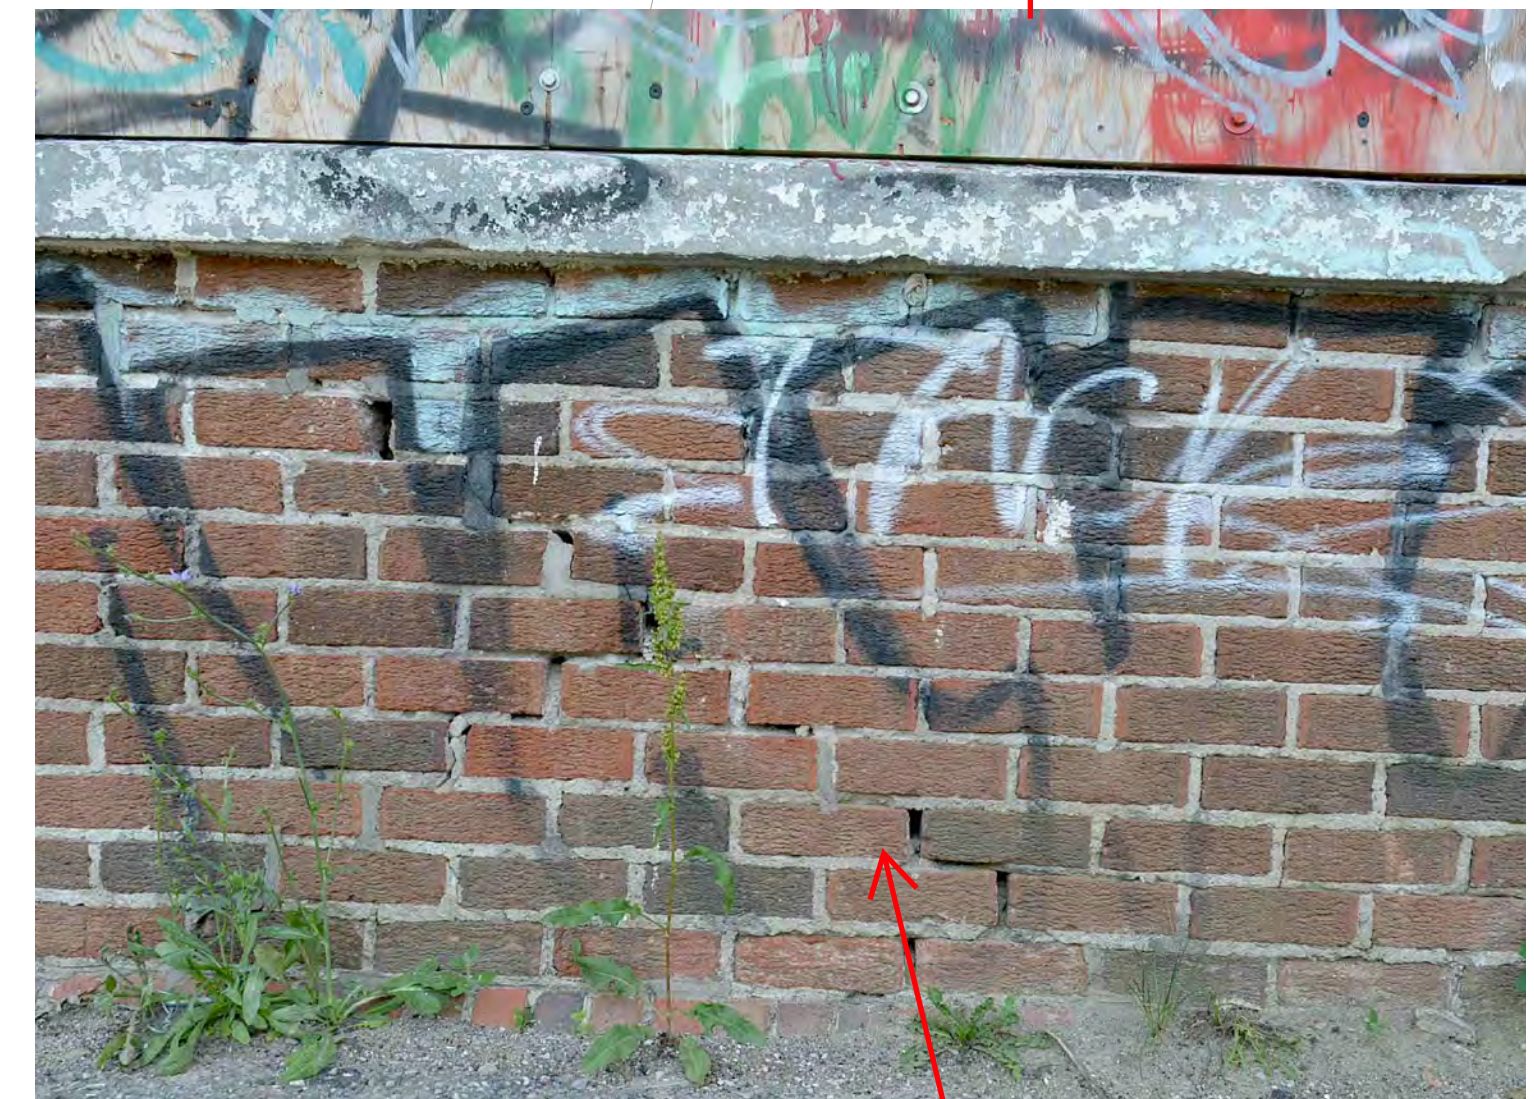
DETERIORATED MORTAR JOINTS

MASONRY REPAIRS. ESTIMATED 35%

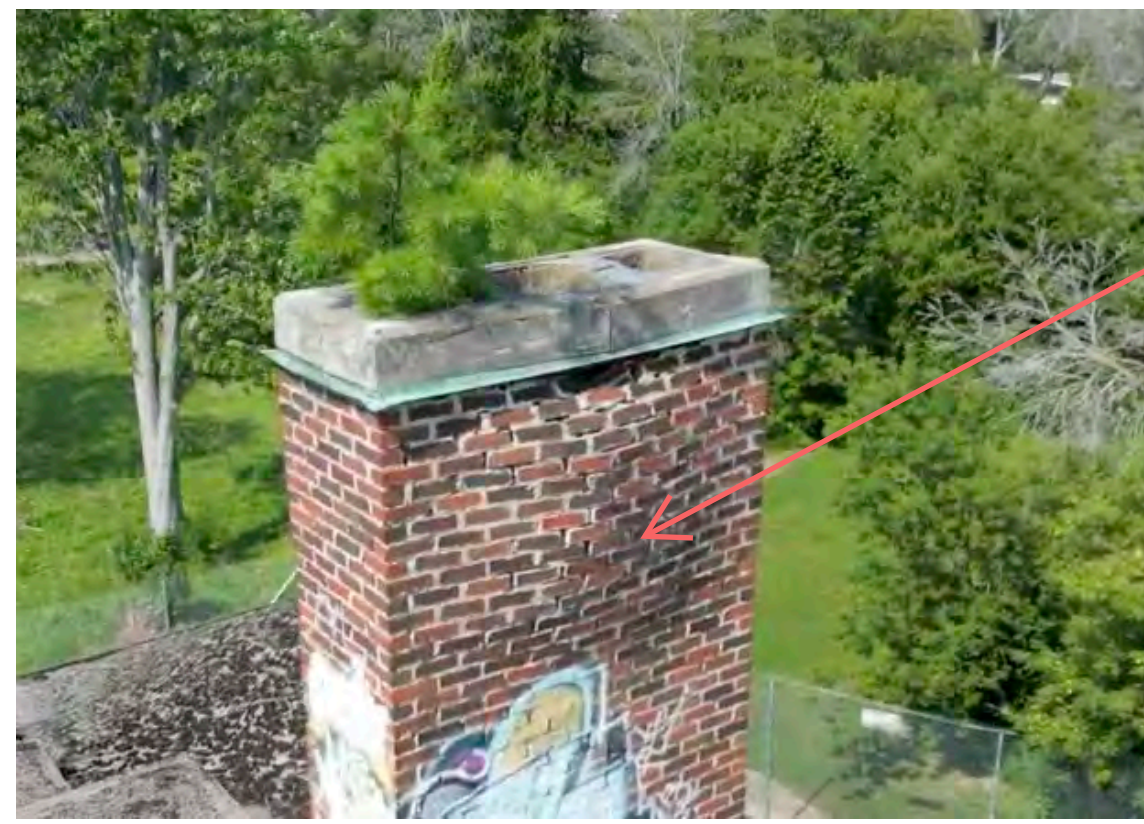
DETERIORATED CHIMNE SHOWN SIGNS BULGING AND VEGETATION GROWTH FROM THE FLUE

BULGING CHIMNEY TO BE DISMANTLED AND REBUILT PER STRUCTURAL ENGINEER

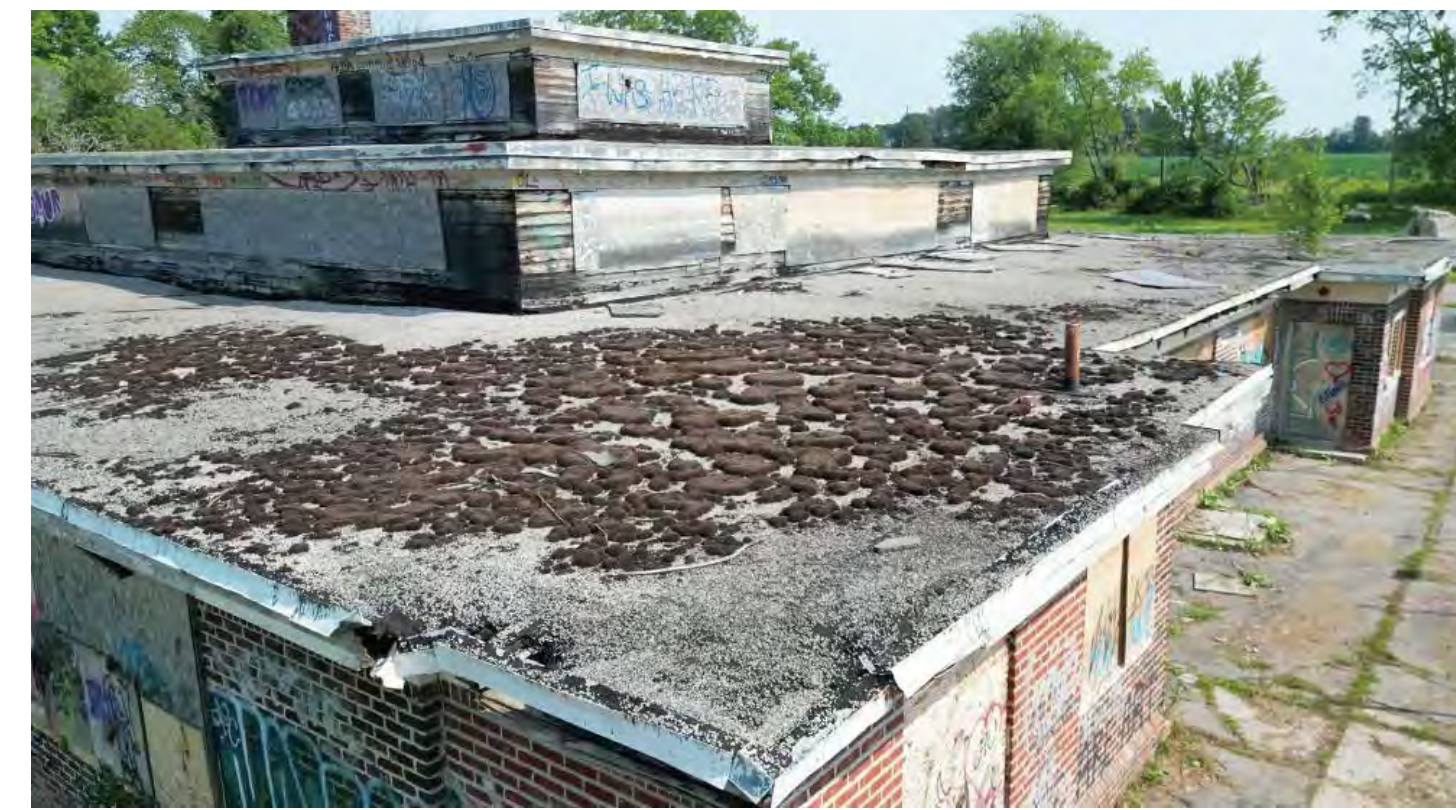
TRIPPLE HEIGHT ROOF FORM SHOWING ABSENCE OF GUTTERS DETERIORATED FLASHING AND ROOF

UPPER PLYWOOD WINDOW/DOOR PLUGS TO INCORPORATE VENTILATION GRILLES

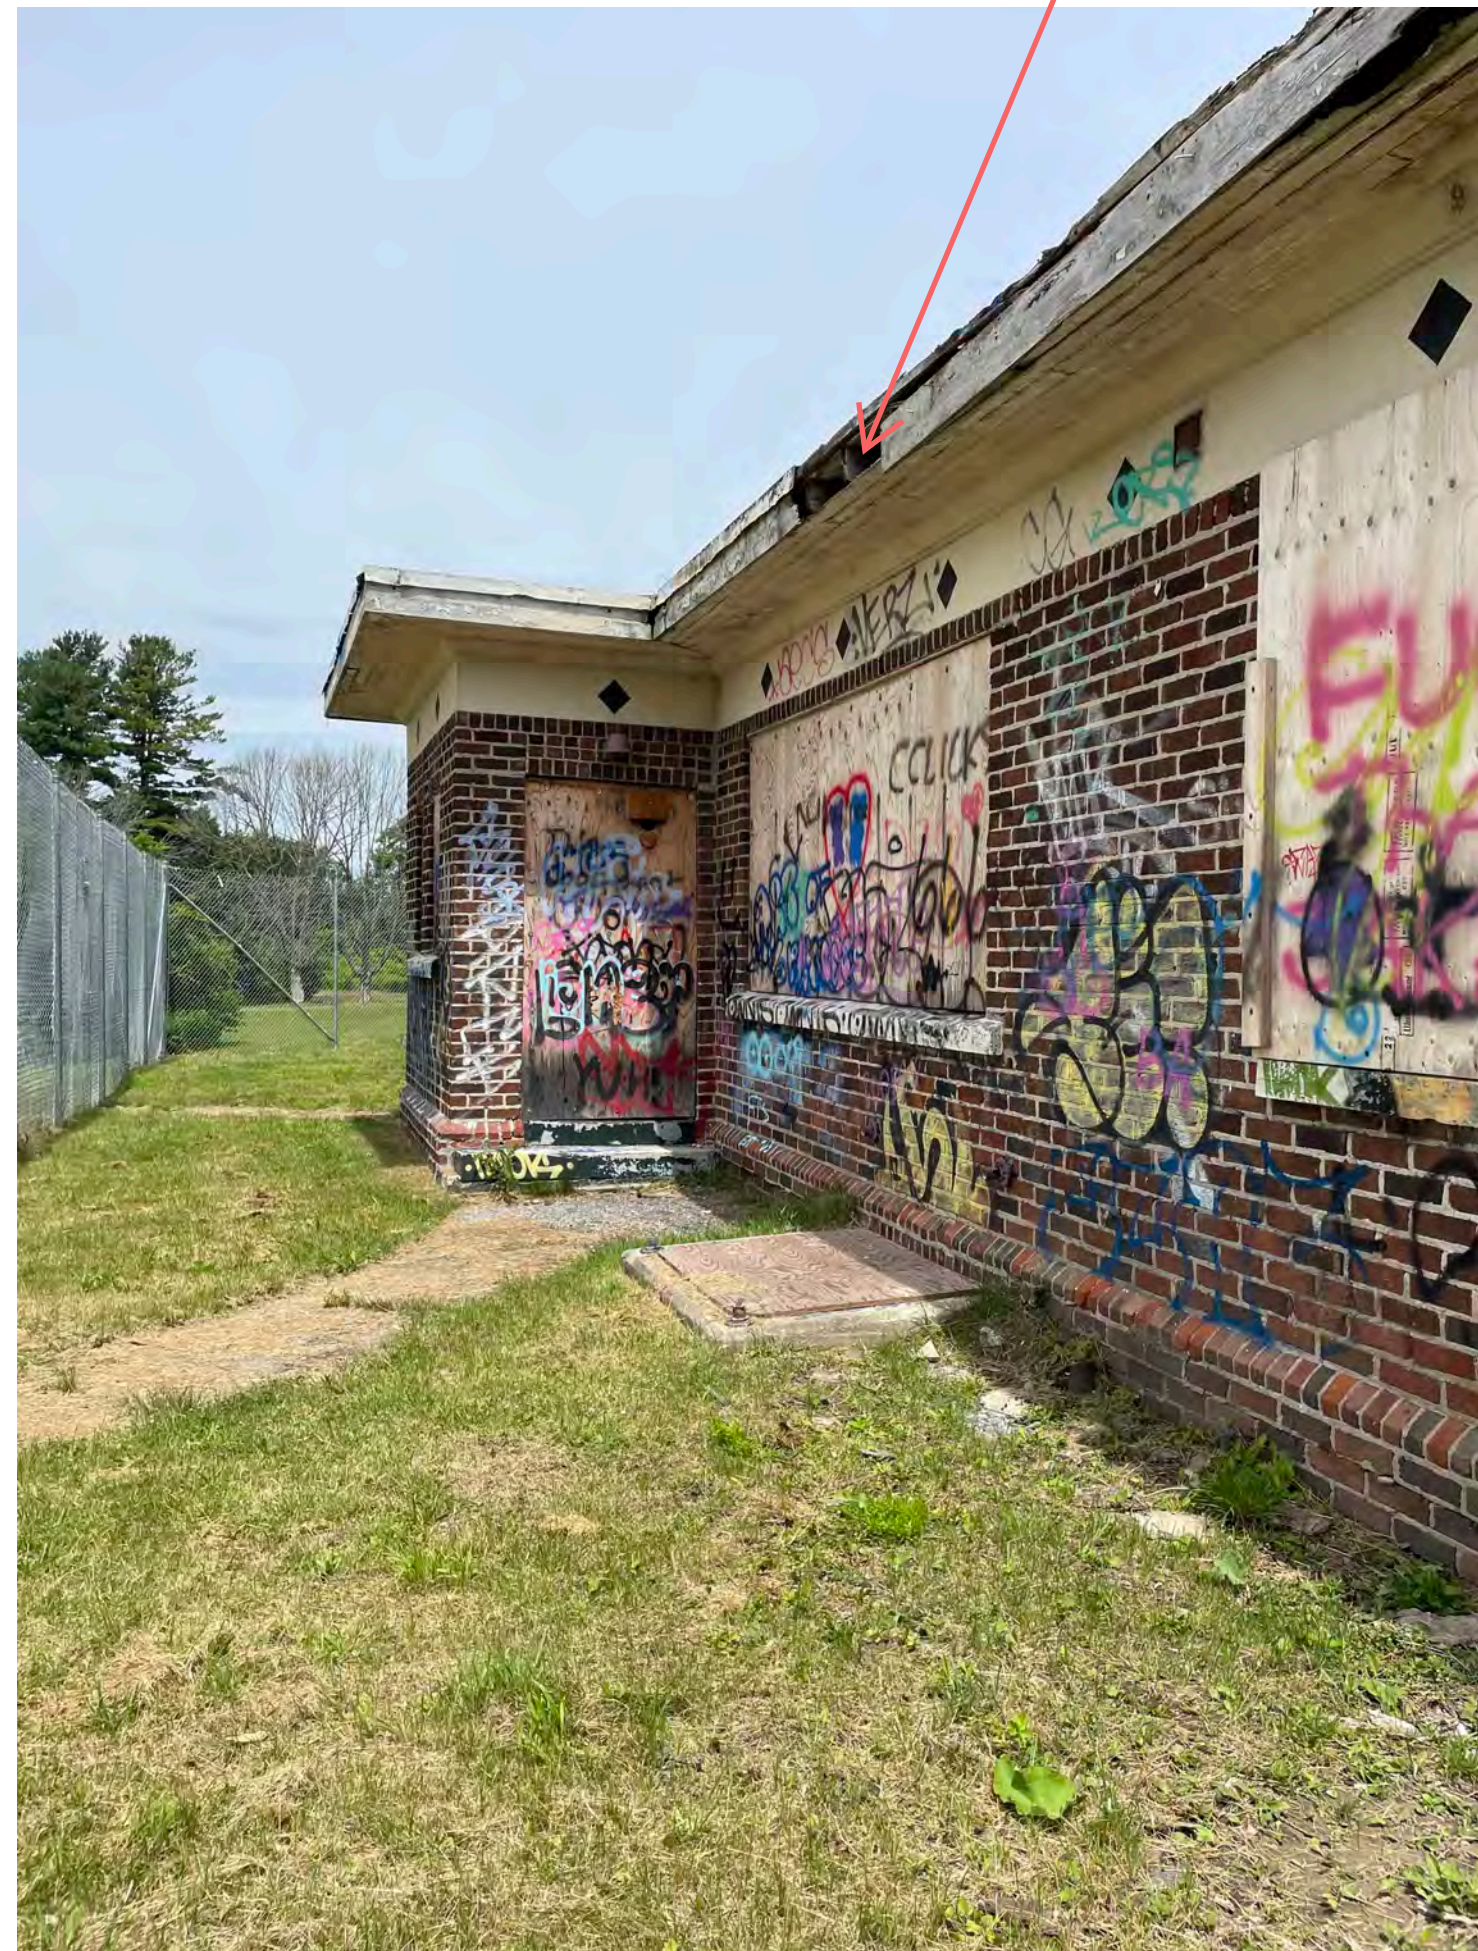
ELEVATION SHOWING VANDALISM

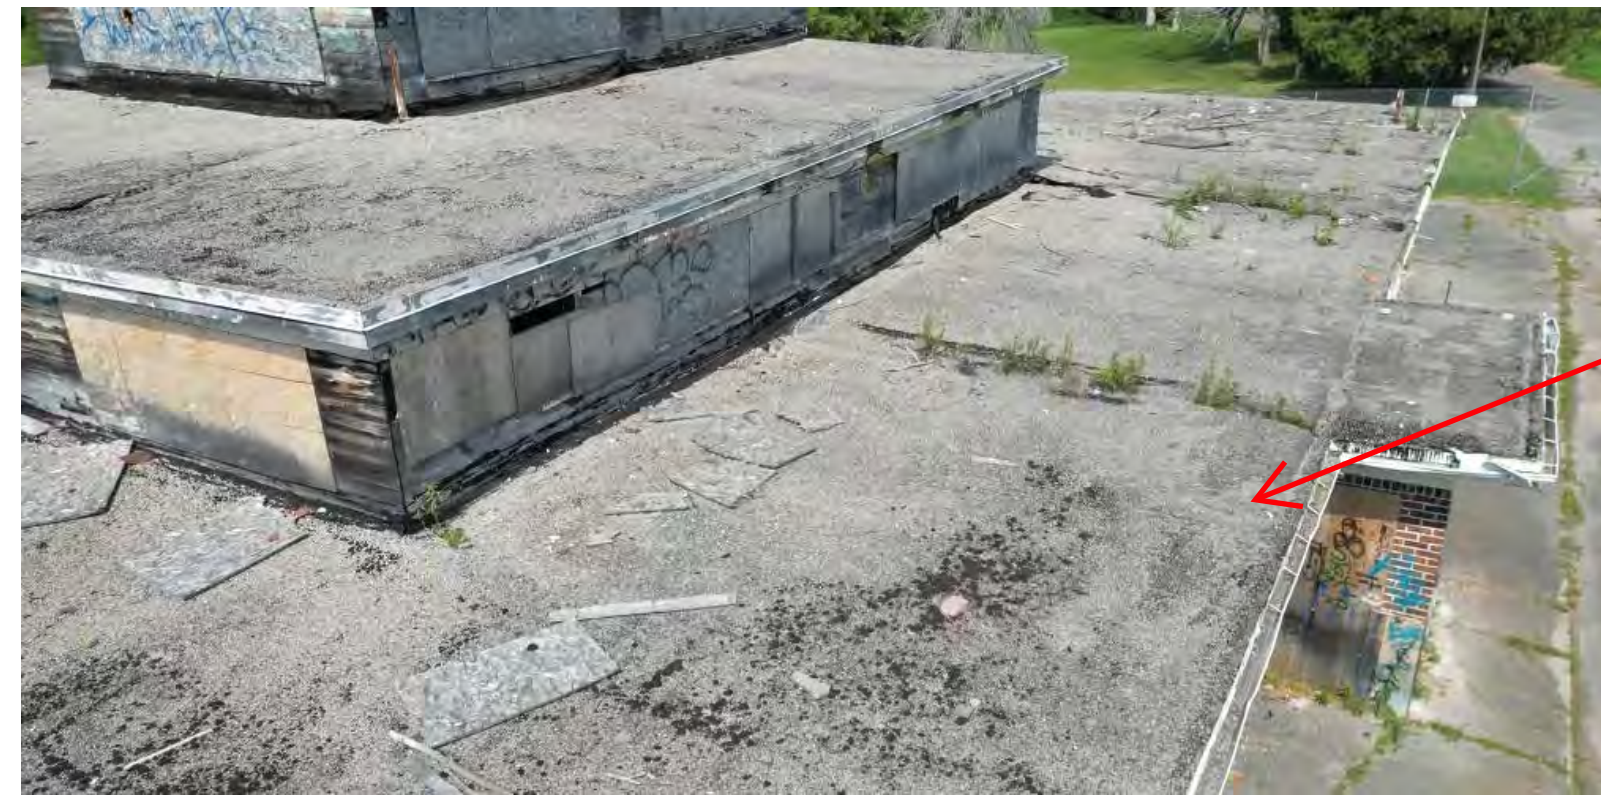
DETERIORATED ROOF AND BIOLOGICAL GROWTH

DO LOCALIZED REPAIRS TO ALL THREE LEVELS OF EXISTING ROOF WOOD PLANKS WITH 3/4" PLYWOOD SHEATHING. ESTIMATED 40% OF ROOF. REMOVE EXISTING ROOF MEMBRANE AND ANY VEGETATION, ALL LEGACY MECH & PLUMBING PENETRATION THROUGH ROOF. PATCH FASCIA BOARD, REMOVE DETERIORATED FLASHING AND GUTTERS THROUGHOUT AND INSTALL NEW FLASHING, GUTTERS, AND RWL'S. INSTALL 5 YEAR TEMPORARY ROOF MEMBRANE ON ENTIRE ROOF

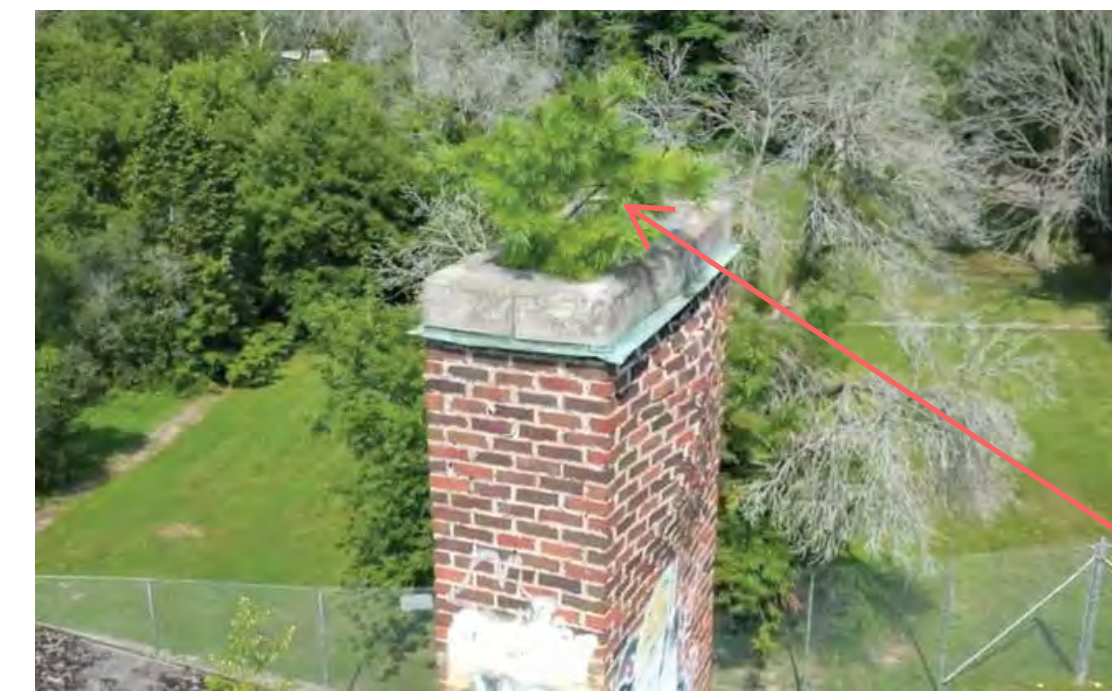
DETERIORATED CHIMNEY SHOWN SIGNS BULGING AND VEGETATION GROWTH FROM THE FLUE

REMOVE ROOTS, TREE AND OTHER VEGETATION

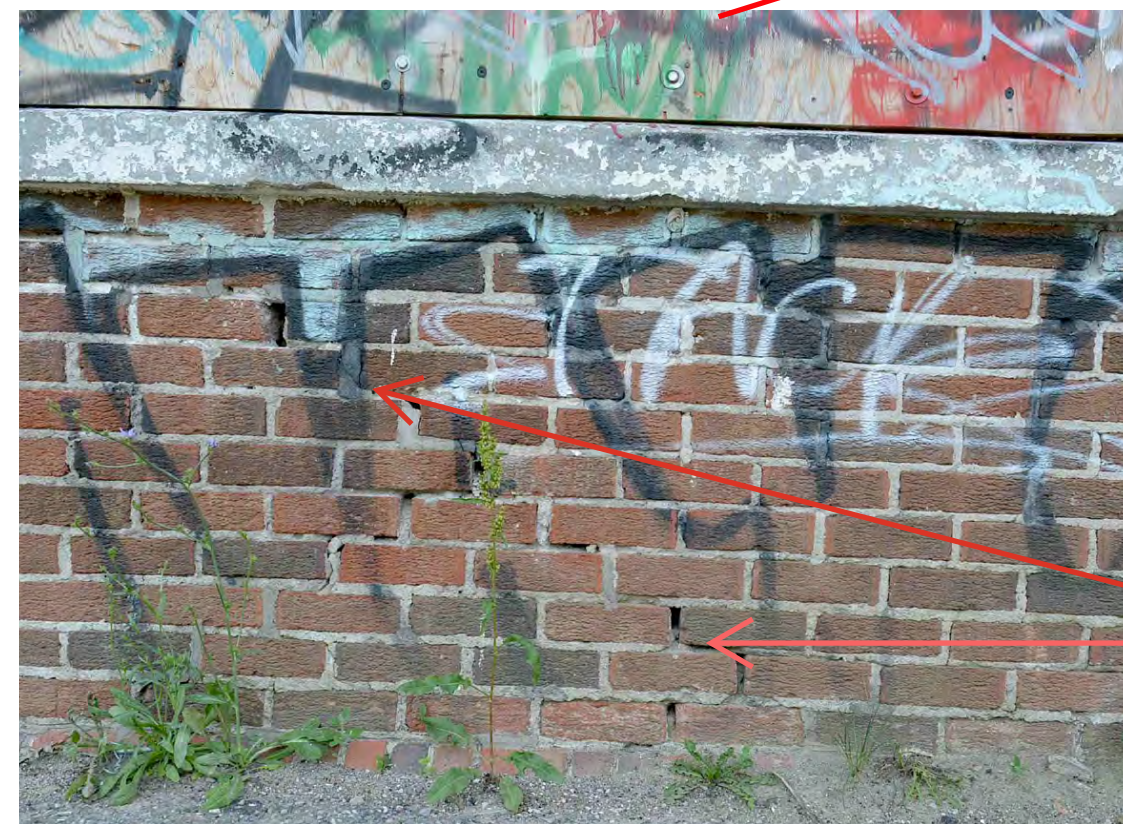
DETERIORATED MORTAR JOINTS

MASONRY REPOINTING REPAIRS. ESTIMATED 35%
