Structural Condition Review
Camp 30 Cafeteria Building
2020 Lambs Road, Municipality of Clarington
The Corporation of the Municipality of Clarington

BBA PROJECT NO. 25120

August 25, 2025

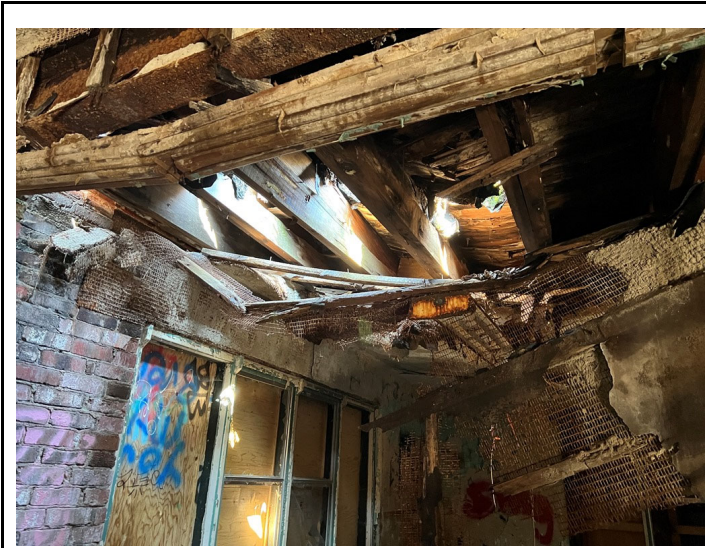
Photo 1

- At the North-West corner of the structure, where excessive deterioration and localized failure of the roof deck was previously observed, a larger portion of the roof deck and ceiling has collapsed (Photo 001).
- Along the South side of the structure, the ceiling along the low roof was actively failing (Photo 002).
- At the South-East corner of the structure, complete collapse of the roof system was observed (Photo 003, 004).
- At the North-East and South-West corners, deterioration and localized failure of the roof deck was observed, as well as active collapse of the ceiling below (Photo 005).

- A collapse perimeter should be set up around all areas of heavy deterioration. No persons should enter these areas other than those permitted for remedial works. Should use of the building continue, complete engineered shoring for the roof structure and support structure should be installed.
 - Replacement of the deteriorated wood plank decking. Salvage decking in good condition where possible.
 - Replacement of the deteriorated wood rafters. Salvage wood rafters where possible.
- Conduct a closeup visual review of the interior structural steel transfer beams. Complete reinforcing as necessary. It is believed that reinforcing will be required on at least 75% of the structural components.
- Installation of a new roof with historic flashings, fascia, and soffits to match the original building condition.

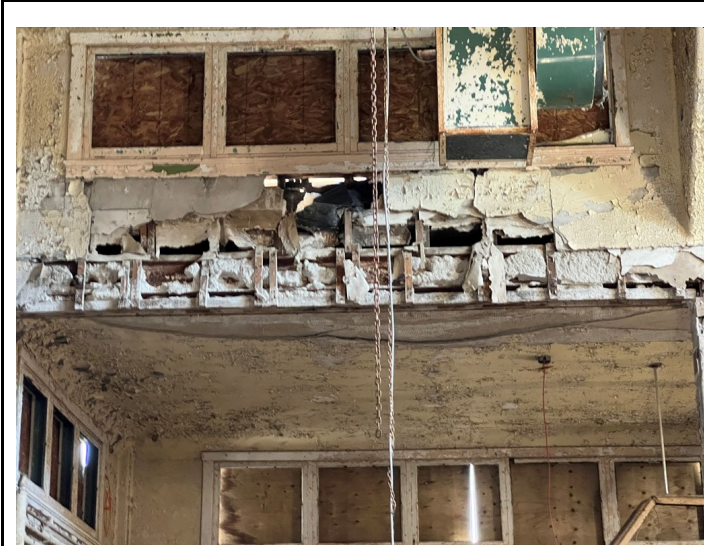
Photo 7

- Continued deterioration of the clerestory walls was observed throughout (Photo 007).
- Additional damage and deterioration were observed around areas of vandalism and break-in (Photos 008 and 009).

The elevated clerestory walls were in poor condition at the time of the site visit. We believe that partial collapse of the wall system is possible with further exposure to the exterior elements and severe weather conditions. Full reinforcing and/or replacement of the clerestory wall system is required to structurally stabilize the building structure and continue operation.

- All load-bearing walls shall be included in the roof structure collapse zone.
- A complete engineered shoring plan for the load-bearing walls shall be installed if access to the structure remains, or if remedial works are to commence.
 - Replacement of the deteriorated wood panelling. Salvage panels where possible. Re-introduction of moisture resisting membrane is recommended.
 - Replacement of the deteriorated wood studs. Salvage studs where possible.
 - Replacement of the deteriorated window frames and installation of new glazing.
 - Re-pointing and replacement of damaged and deteriorated masonry and masonry joints.
 - Re-finish internal walls with lath and plaster, or similar, to match the original building finish.

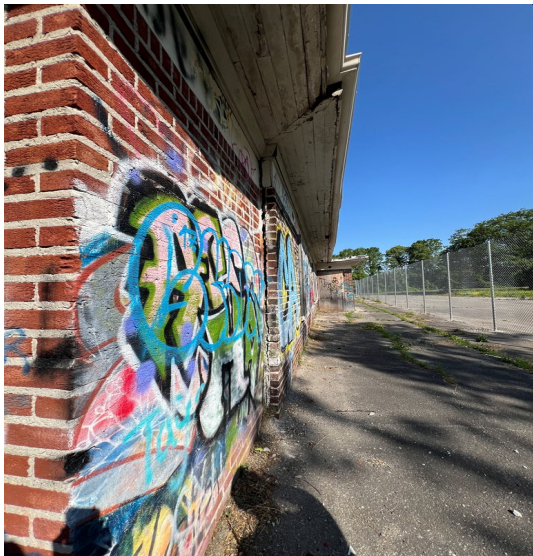
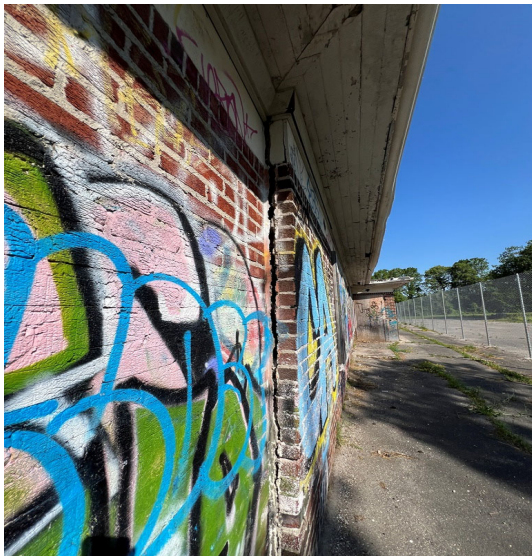
- At the South-East corner where the roof collapse had occurred, the load-bearing exterior wall has cracked and deflected (Photos 010 and 011).
- From ground level, the chimney structure appeared to be heavily deteriorated and bulging at its upper-most section (Photo 012).

The exterior walls were in very poor condition at the time of review. We believe that partial collapse of the South-East corner and chimney structure is possible with further exposure to the exterior elements and severe weather conditions. Full reinforcing and/or replacement of these areas is required to structurally stabilize the building structure and continue operation.

The double wythe exterior brick masonry was severely damaged and deteriorated, with localized failure and collapse observed. Generally, we observed significant cracking, separation of the wall wythes, and displacement of the mortar. It is the opinion of BBA that the exterior clay brick masonry walls and chimney are at the end of life in the current condition; it is recommended that due to the extensive amount of failures and unstable conditions of the existing brick masonry walls and chimney, a collapse perimeter should be set up around all areas of heavy deterioration. No persons should enter these areas other than those permitted for remedial works. The collapse area is to include a perimeter for the chimney. Due to the possible scale of collapse, it is recommended that the entire structural footprint be designated as a collapse perimeter.
