Reach 3 – Oshawa Harbour to St. Mary's

Reach 4 – St. Mary’s to Bowmanville Harbour

Reach 5 – Port Darlington to Port of Newcastle

Reach 6 – Bond Head to Port Hope West Beach

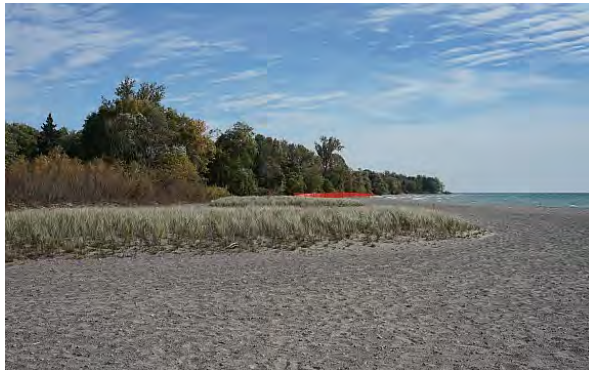
Natural Beach & Embryo Dunes at Darlington Prov. Park.

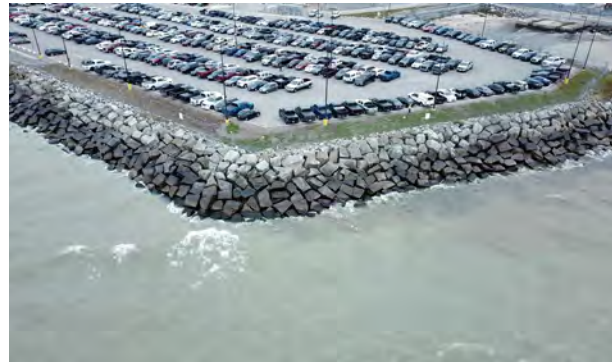
Shore Protection fronting Darlington Nuclear Power Plant

- Reach 3 is 28% armoured, 72% natural.
- Armoured portions of shoreline are limited to shoreline immediately east of Oshawa Harbour, and the shoreline fronting Darlington Nuclear Power Plant and St. Mary's Cement Plant.
- Shoreline protection throughout the reach is generally well engineered armour stone revetments in moderate to good condition.
- Shoreline protection fronting St. Mary's is ad-hoc in places and should be monitored and maintained as required.
- Tolerance for additional shoreline armouring (low/**medium**/high):

- Maintain natural bluff environments and buffers.
- Monitor existing shoreline protection at the Nuclear Plant.
- Monitor shore protection at St. Mary's Plant.

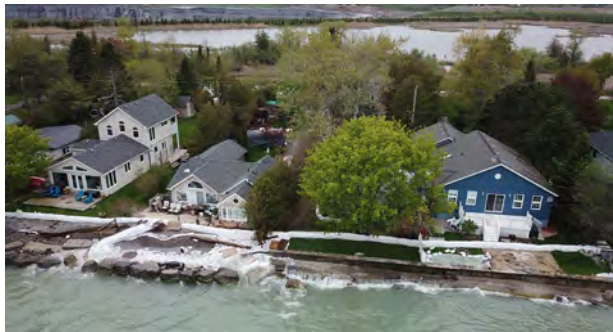
- The Cedar Crest Beach Road community in the western half of the Reach features lakefront properties constructed on the sand spit that separated the lake from the marsh. The buildings are close to the lake and vulnerable to coastal flooding.

Cedar Crest Beach Blvd. during Record High Water Levels (May 2019)

- The shoreline fronting Cedar Crest Beach Road is almost entirely armoured and features a wide variety of structure types, levels of design and condition. All structures have a very low crest due to the low land elevation and suffer from settlement during periods of high lake levels due to ongoing vertical erosion of the lakebed.

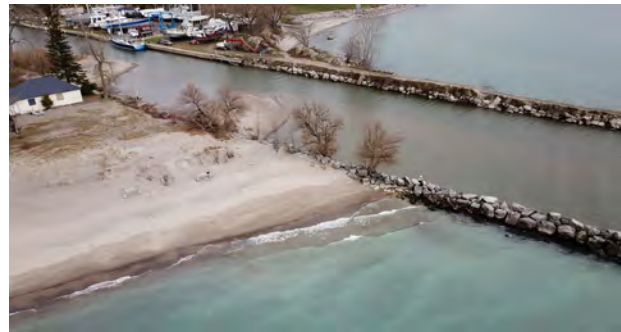
Fillet Beach and Jetties at Port Darlington (November 2018)

- The west jetty at Bowmanville Creek is in extremely poor condition and requires significant repairs and/or upgrades. The structure has limited ability to trap sand or to dissipate wave energy due to its porosity and low crest. The structure roundhead which features a navigation light is in good condition.

Infrastructure and Ecosystem Threats
<ul style="list-style-type: none"> • Flooding and erosion threats for existing development along Cedar Crest Beach Road. • West jetty at Bowmanville Creek requires a significant structural upgrade.
Shoreline Management Recommendations
<p>Cedar Crest Beach Road and West Beach Road:</p> <ul style="list-style-type: none"> • Long-term incremental voluntary land disposition program required for the lands subject to acute risks due to lack of safe access during the 100-year flood and the location of development on a low-lying eroding dynamic barrier beach. • Short- and medium-term management options include continuing to facilitate private shore protection works by individual or, preferably, community scale beach nourishment and shore protection; road reprofiling. • West Jetty at Bowmanville Creek: structure requires upgrade to eliminate wave and sediment transmission into the navigation channel. Dune restoration to eliminate aeolian transport into the channel from the west fillet beach. • Sediment dredged from the navigation channel and fillet beach could be hydraulically bypassed to nourish the Port Darlington East Beach Park.

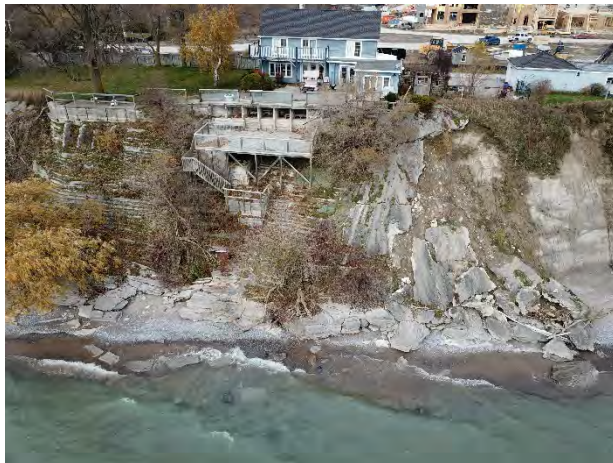
*Eroding Bluffs and Failed Shore Protection
East of Port Darlington*

- Immediately east of Port Darlington East Beach there are a number of properties sitting atop a high, rapidly eroding bluff. Some properties feature shore protection of varying quality and condition, while others are unprotected and continue to erode. These properties are at high risk due to their proximity to the bluff crust.

- Implement a sediment bypassing program from the Port Darlington west fillet beach to nourish Port Darlington East Beach Park.
- A long-term community scale solution is required for Port Darlington East Beach community to reduce erosion and flood hazards, such as protection or retreat. For example, a long-term voluntary land acquisition program for lands subject to acute hazards could be implemented to return the shore lands to public open space.

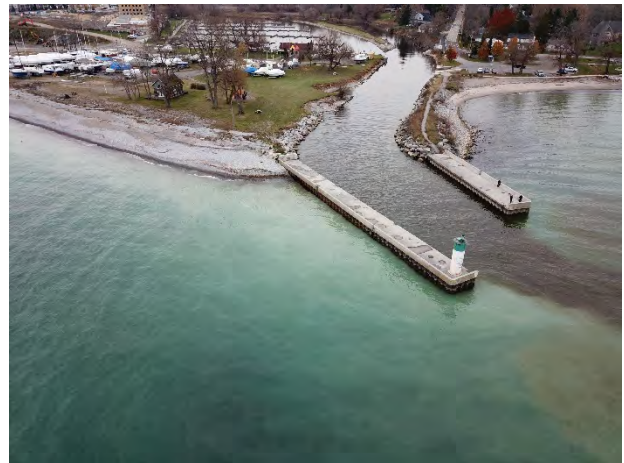
*Cobble Fillet Beach and Jetties at Port of
Newcastle*

- The jetties at Graham Creek (Port of Newcastle) are composite gravity structures and are both in moderate condition. The root of both structures is comprised of native fill material with a thin layer of minimal rock protection. These areas have suffered significant damage during the high-water periods in 2017 and 2019 and have nearly breached, particularly on the east side at Bond Head Parkette. These structures should be repaired and upgraded to prevent the propagation of waves and sediment into Graham Creek.

- Root of jetties at Graham Creek require significant repairs/upgrades.
- Implement a sediment bypassing program for the west fillet beach at Port of Newcastle to nourish the eroding east beach (Bond Head Parkette, Boulton Street).

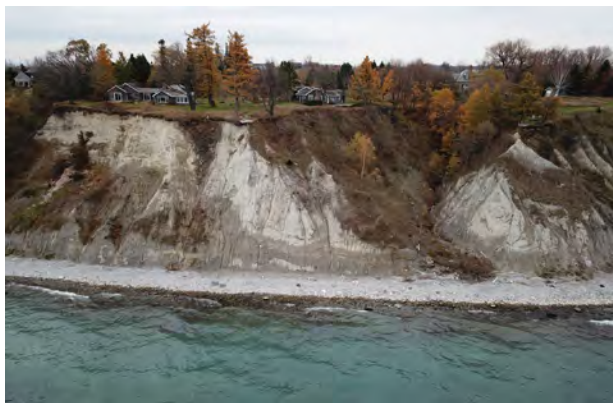
Eroding Bluffs at Bond Head

- Jetties at Graham Creek are at risk of breaching at their structure roots (north of composite sections).
- Boulton Street and Bond Head Parkette threatened by erosion due to sediment deficit.
- Bond Head Bluffs: high erosion rates and large gullies threaten homes close to the bluff edge.
- West rail line (CN and CP) entering Port Hope is at the crest of an eroding bluff.

- Sediment bypassing from west fillet beach at Graham Creek to sediment starved shoreline fronting Bond Head Parkette and Boulton Street.
- Bond Head Bluffs: Avoid further development on hazardous lands. Monitor proximity of bluff crest to existing development and slope stability. Relocate homes at risk.
- Conservation Authority should regularly update hazard mapping at Bond Head to account for latest toe of slope, slope stability, and erosion. The 2020 hazard mapping must be updated frequently.

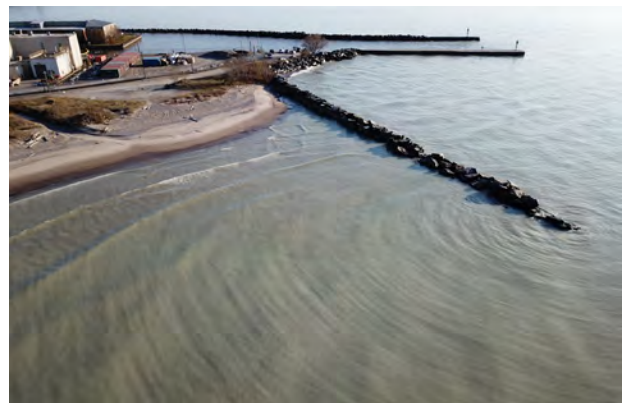
Port Hope West Beach and Jetties
