Port Darlington West Embayment Shoreline Change Assessment

Pete Zuzek, MES, CFM, P.Geo
February 1, 2021

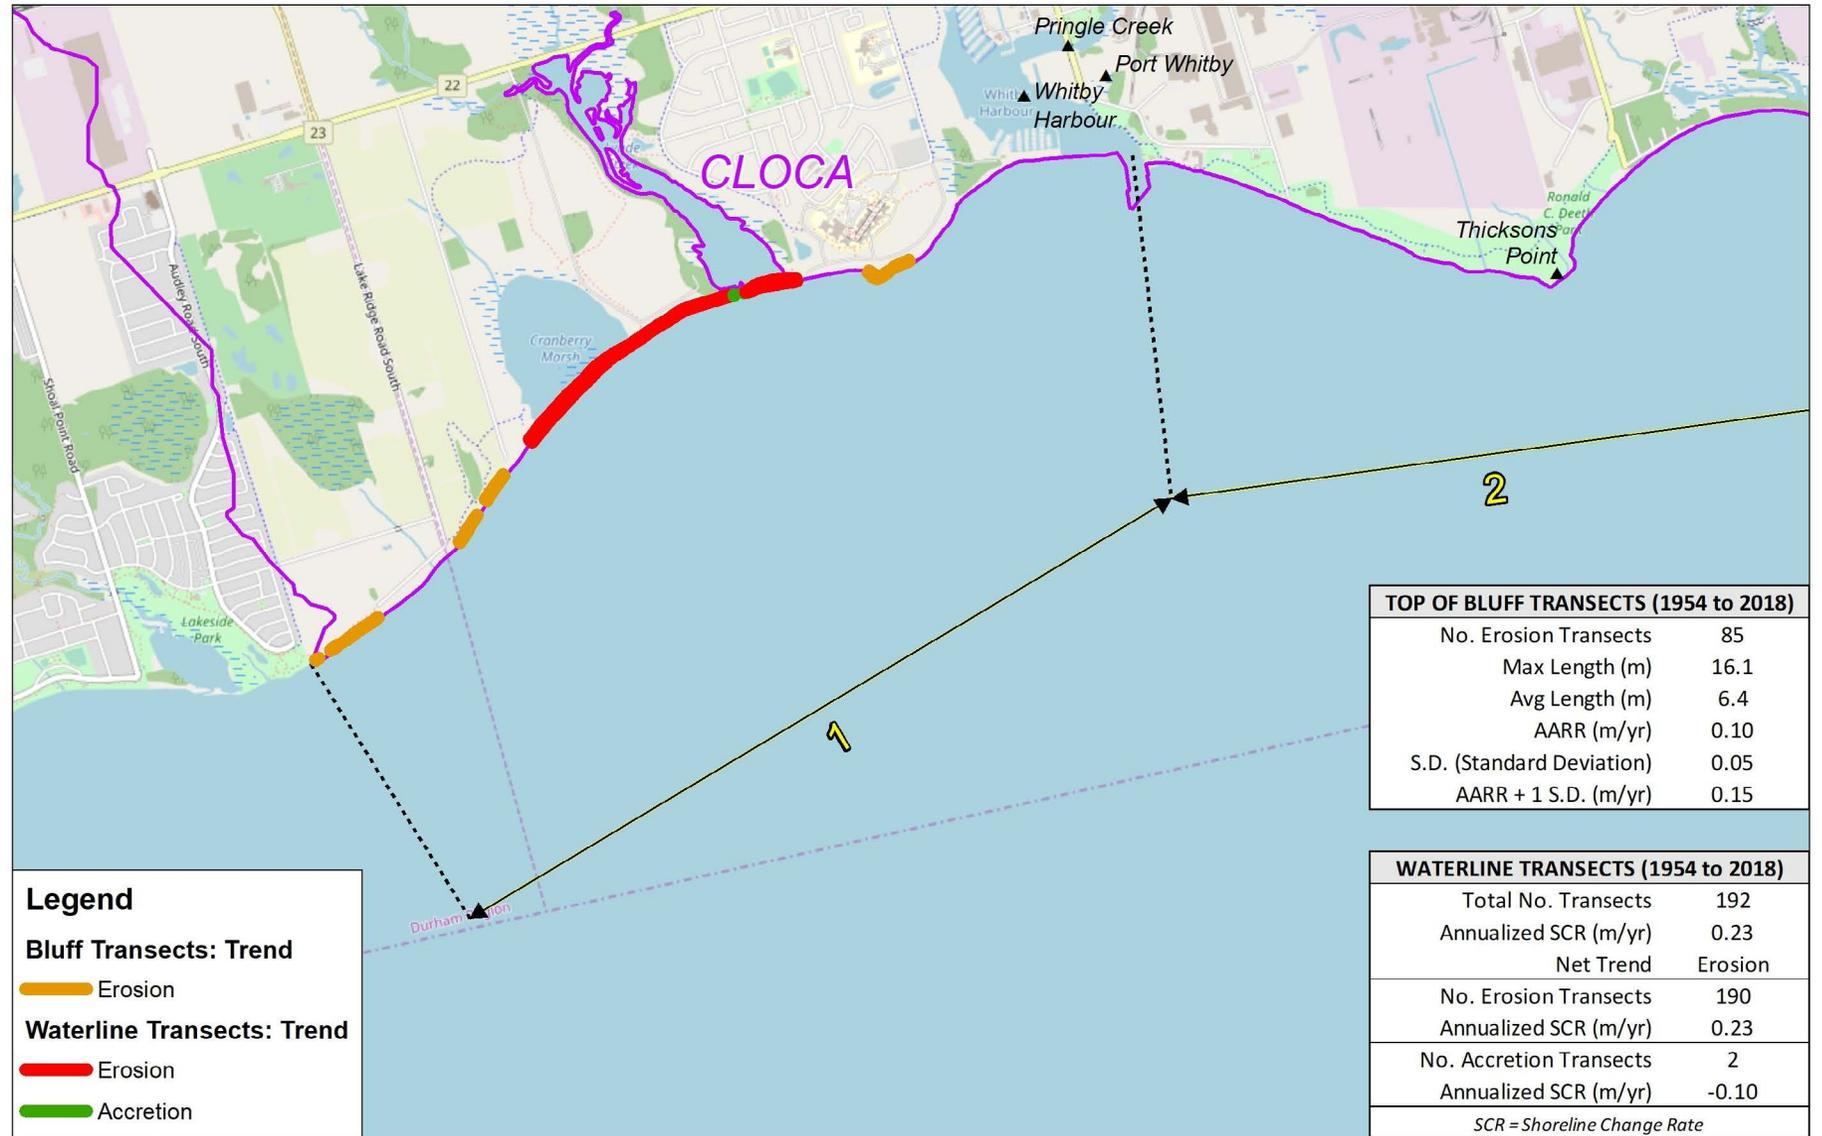
Shoreline Change at Lynde Shores CA (a similar site)

Bluff Transects: Trend

Orange line: Erosion

Waterline Transects: Trend

Red line: Erosion

Green line: Accretion

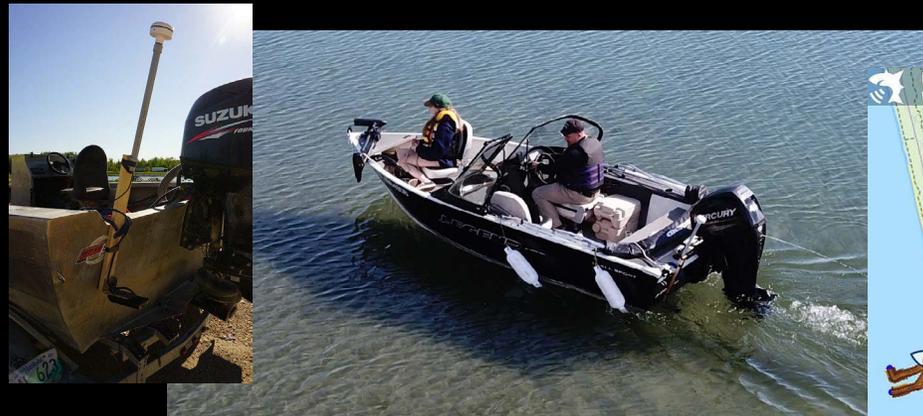
Boat Track and Depth Data

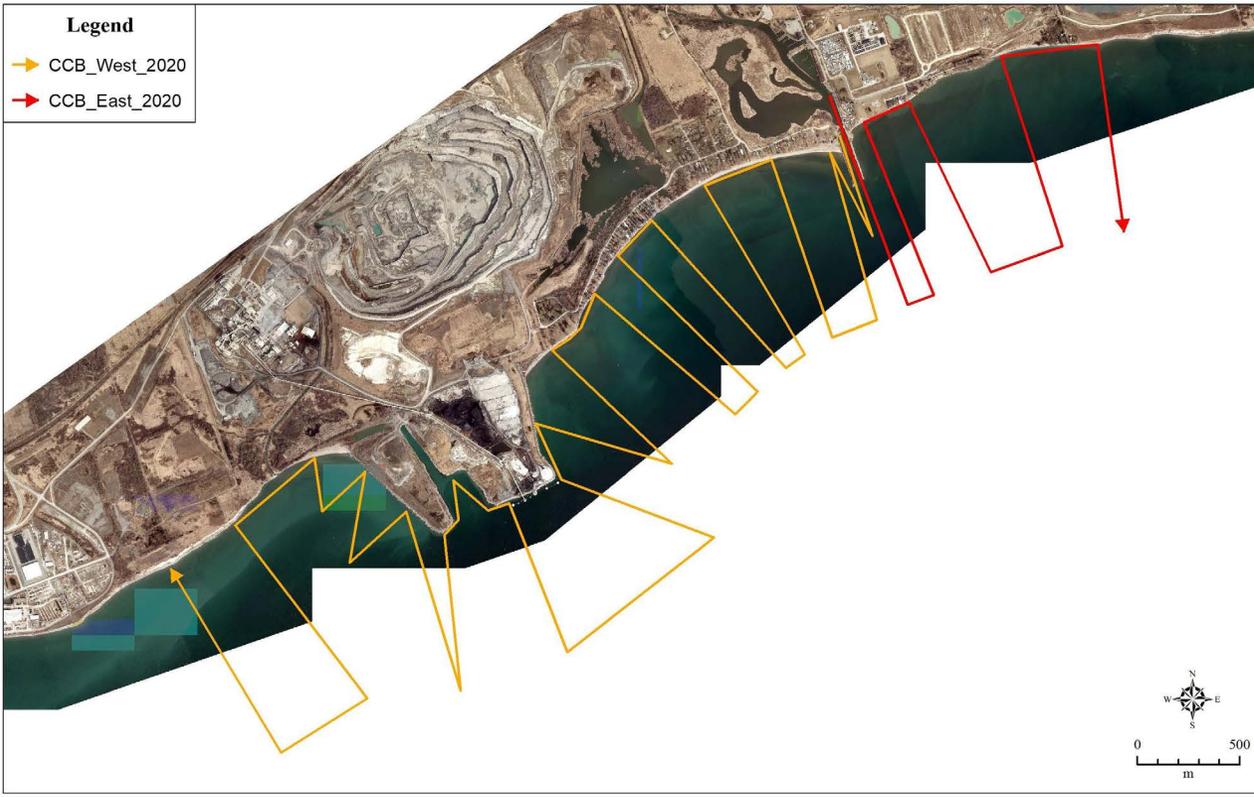
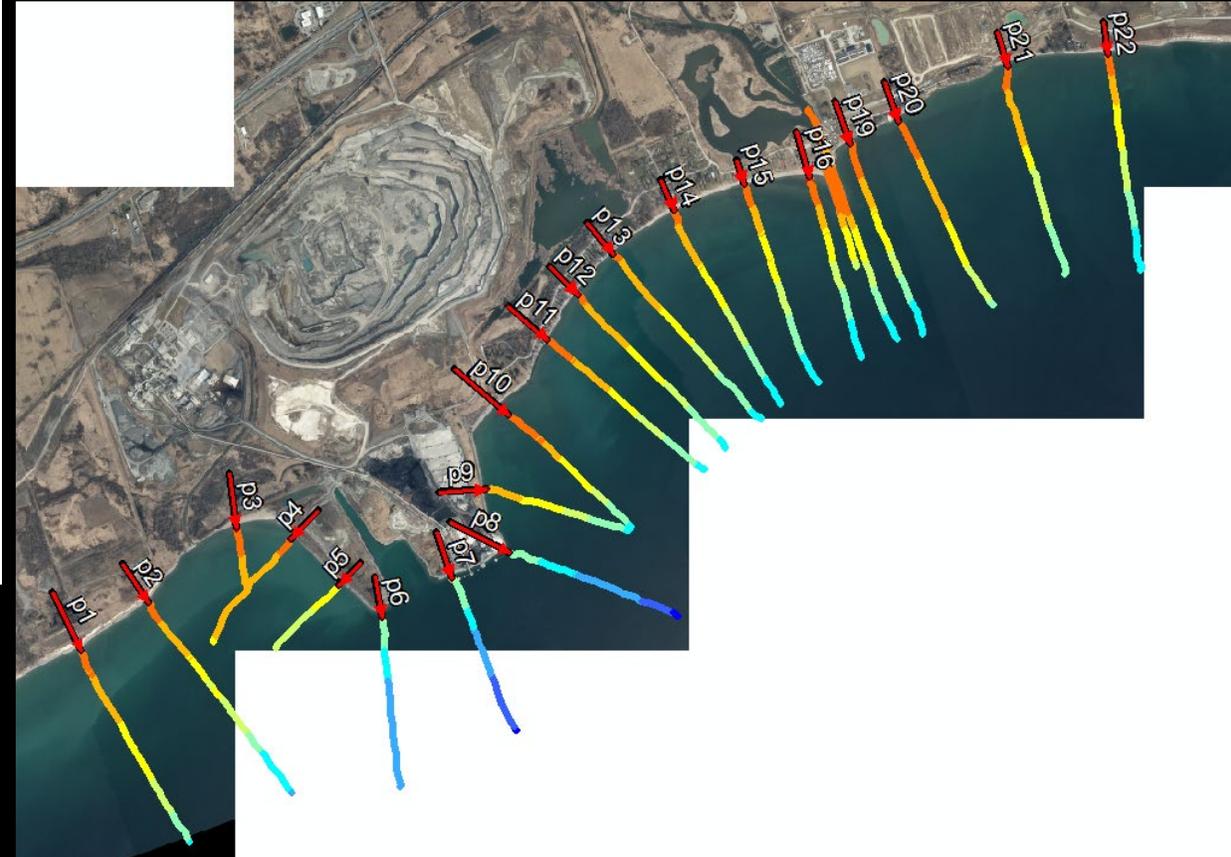
→ CCB_West_2020

→ CCB_East_2020

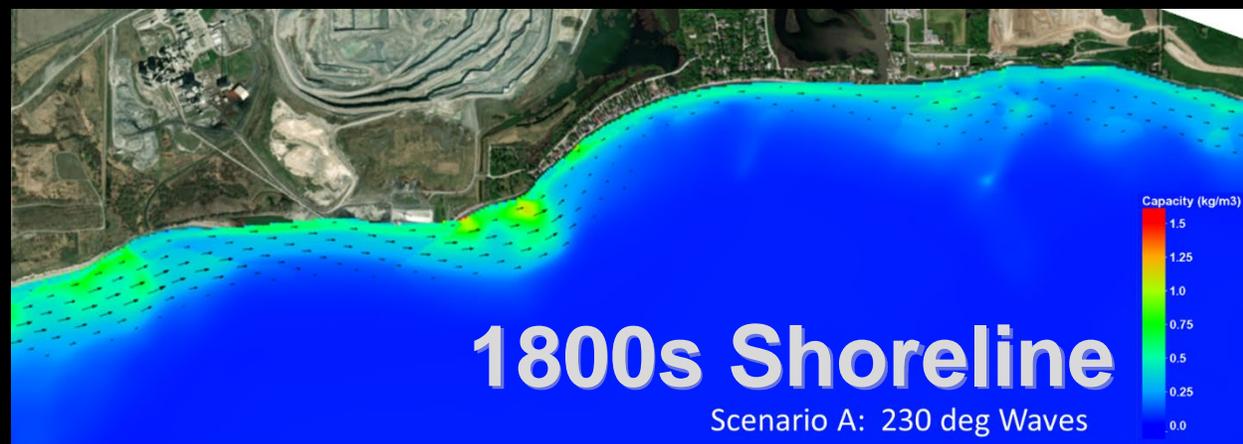
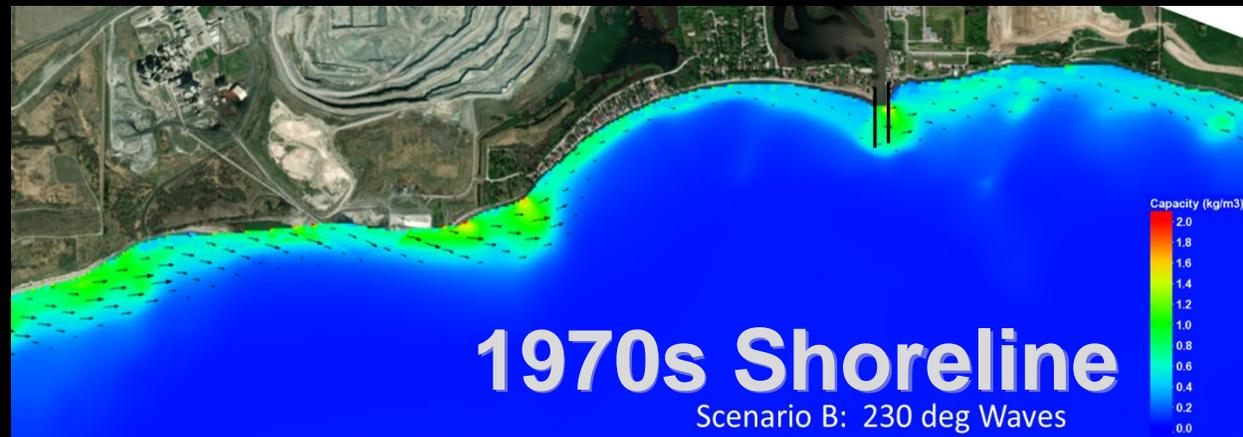
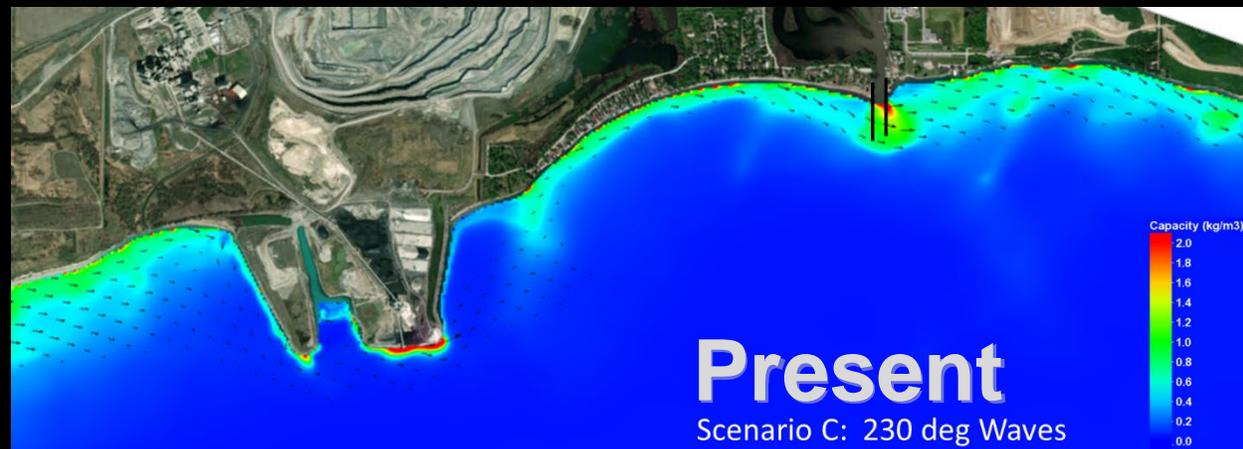
Sediment Transport Capacity for SW Storms

- 1800s: No barriers to trap sediment transport moving west to east
- 1970s: Sediment transport capacity decreases towards the Port Darlington jetties and sand is deposited in West Beach
- Present: Sediment transport capacity decreases towards the SMC Headland and Port Darlington jetties, resulting in sand accumulation in the fillet beaches

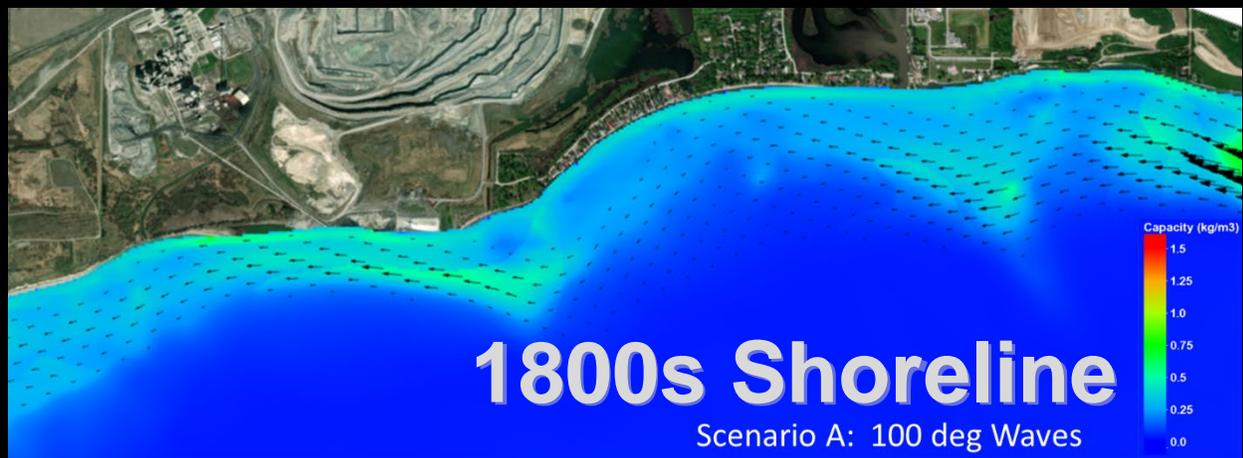
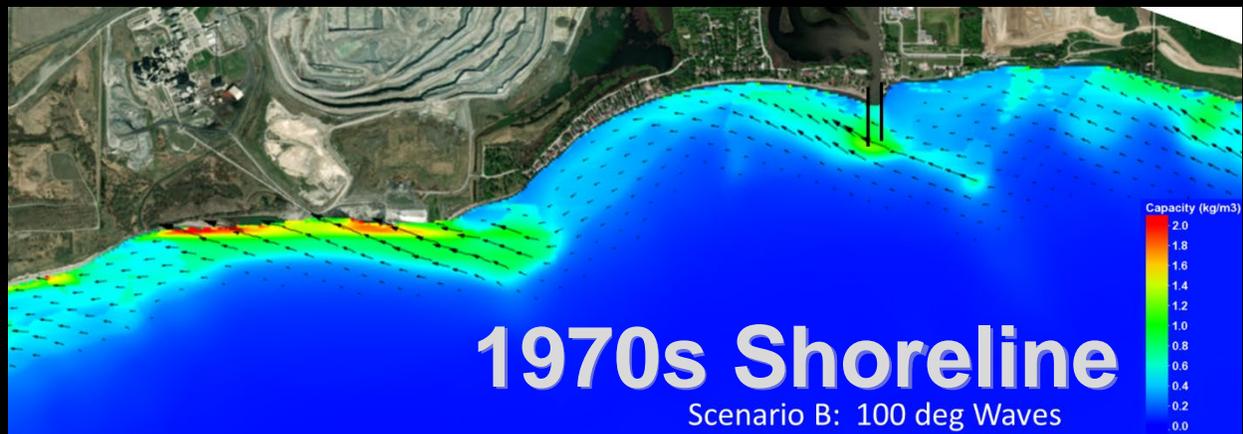
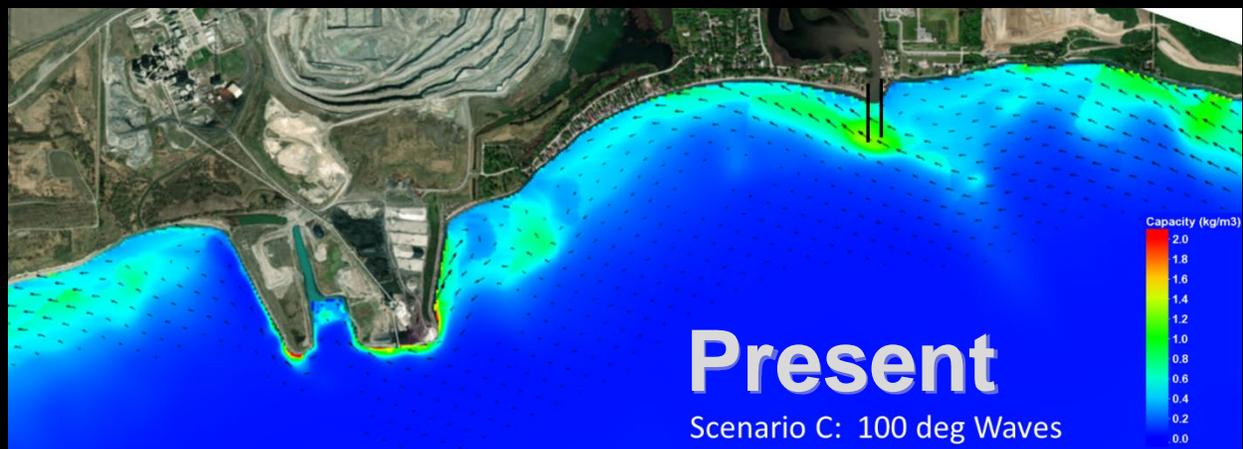
Sediment Transport Capacity for ESE Storms

- 1800s: No barriers to trap sediment transport moving from East to West
- 1970s: Without the SMC Headland, currents have the potential to move sediment westward out of the embayment
- Present: SMC Headland traps sediment in the embayment for southeast storms
