**Heritage Impact Assessment –
Conservation Management Plan
Lambert House
11 Mabel Bruce Way,
Clarington (Bowmanville), Ontario**

Vincent J. Santamaura, Architect Inc.
06 September 2024
Project No. 2024-01

Heritage Impact Assessment – Conservation Management Plan

Lambert House, 11 Mabel Bruce Way, Clarington (Bowmanville), Ontario.

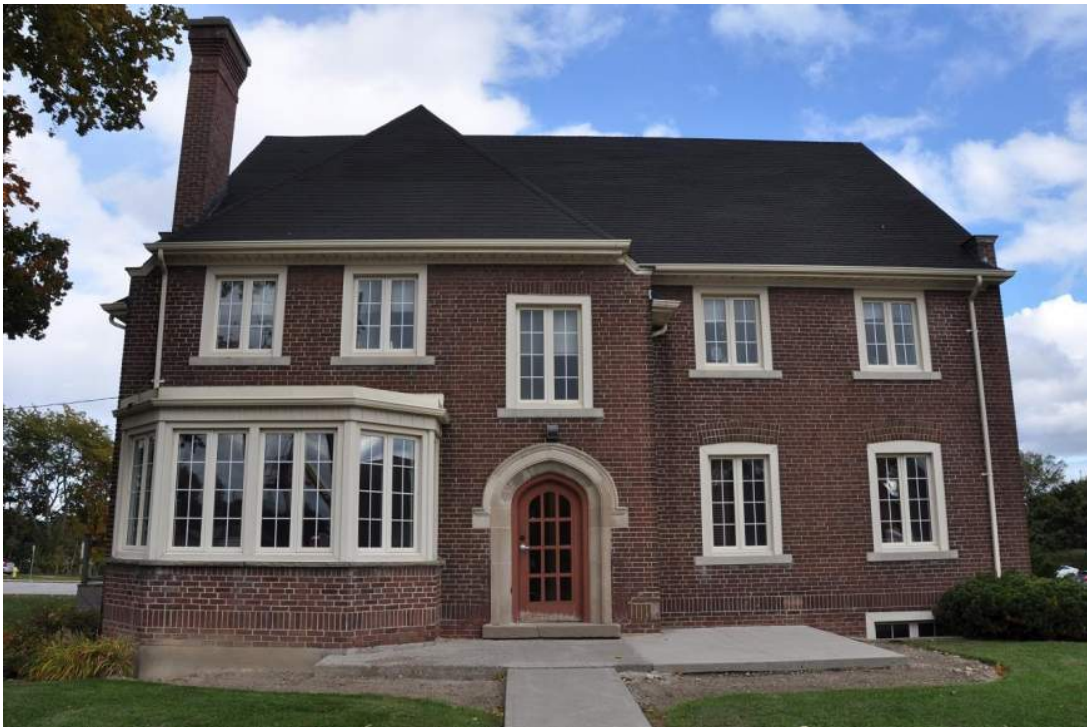
4.1.5.1.A – Existing West (Front) Elevation

Vinyl windows with plastic muntin inserts have replaced the original wooden windows, though stone sills remain. Aluminum flashing has replaced the window surrounds. Only the stone front door surround is remaining. Soffits are now aluminum. Asphalt shingles are the roof material. A large chimney adorns the north façade. Masonry detailing includes a Flemish bond masonry coursing, a soldier course belt course, and voussoir windows headers.

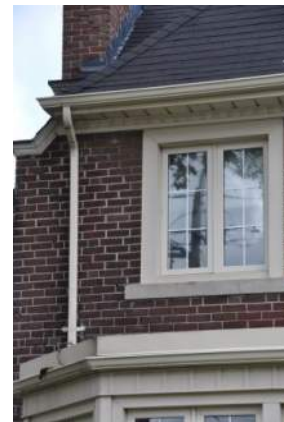
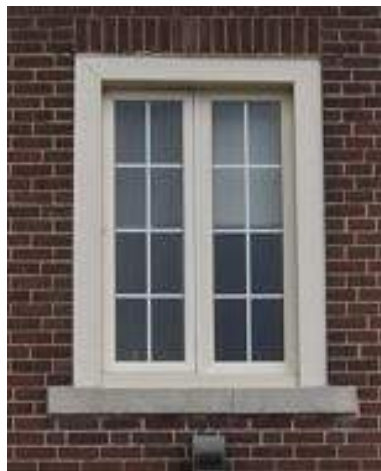
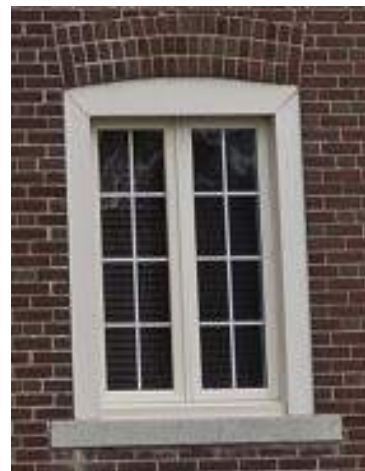
4.5.1.2.B - Windows

Windows –Not original vinyl replacements Non-original window surrounds; - poor

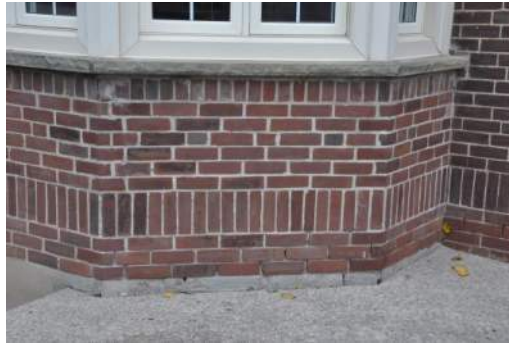
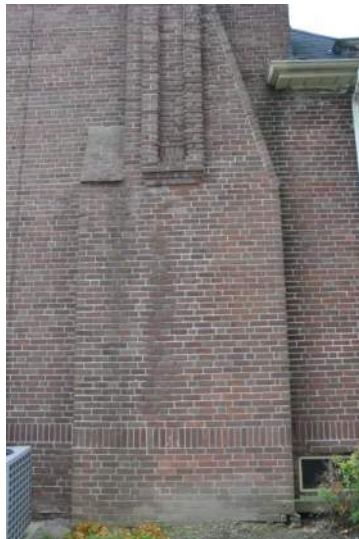
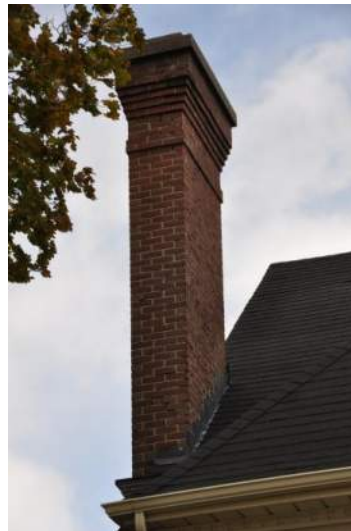
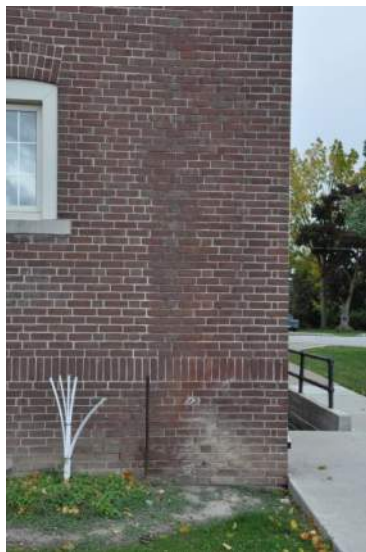
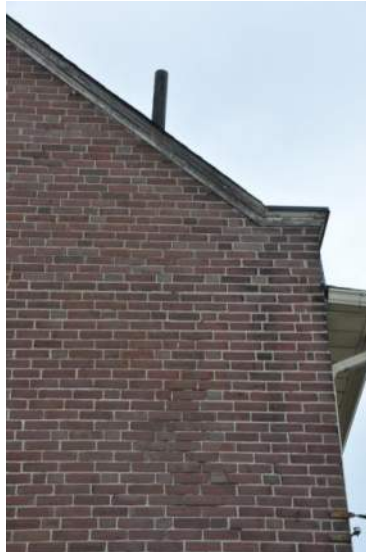
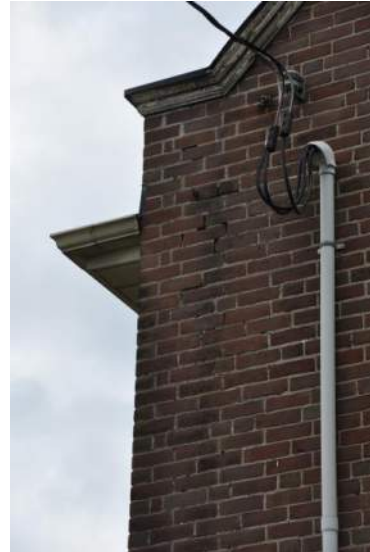
4.5.1.2.C – Masonry Detailing

Cladding - masonry. some deterioration at Grade, Staining, mortar joints cracking and spalling, walls lack insulation; - good

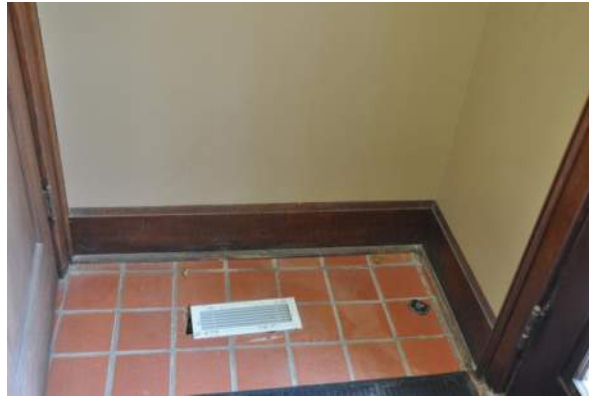
4.5.1.3.A – Entry Vestibule

Portions of the interiors remain unaltered, though years of use, maintenance and safety upgrades have altered parts of the building's interior appearance. The interior detailing consisting of mouldings, window and door trim, baseboards, wood paneling, and terrazzo floors have been largely left untouched. Other higher use areas have been re-painted and had new flooring laid down. Electrical systems have been updated as have the light fixtures. New Mechanical systems and fire safety hardware have been introduced.

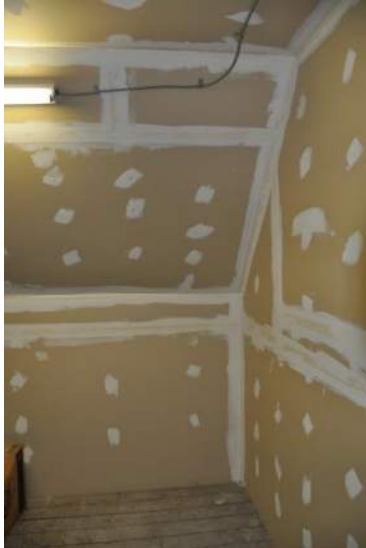
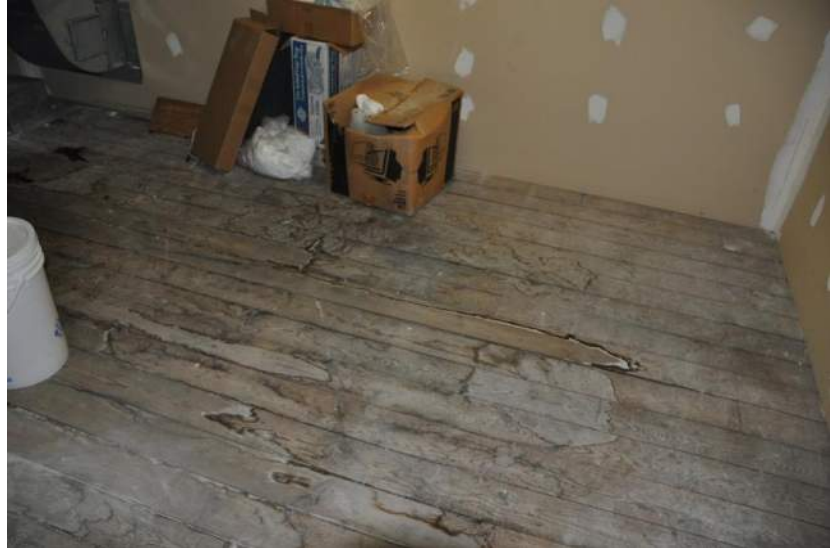
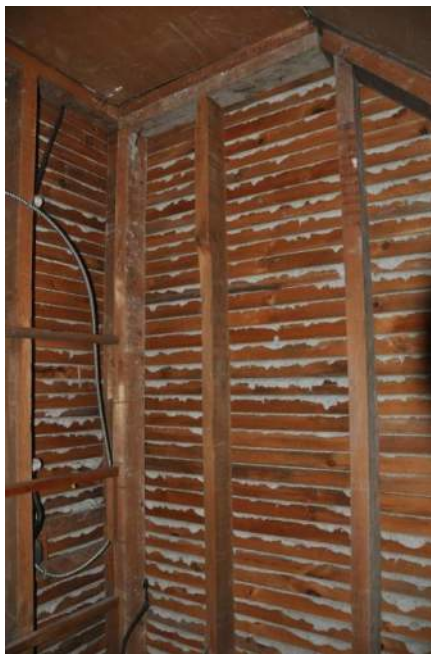
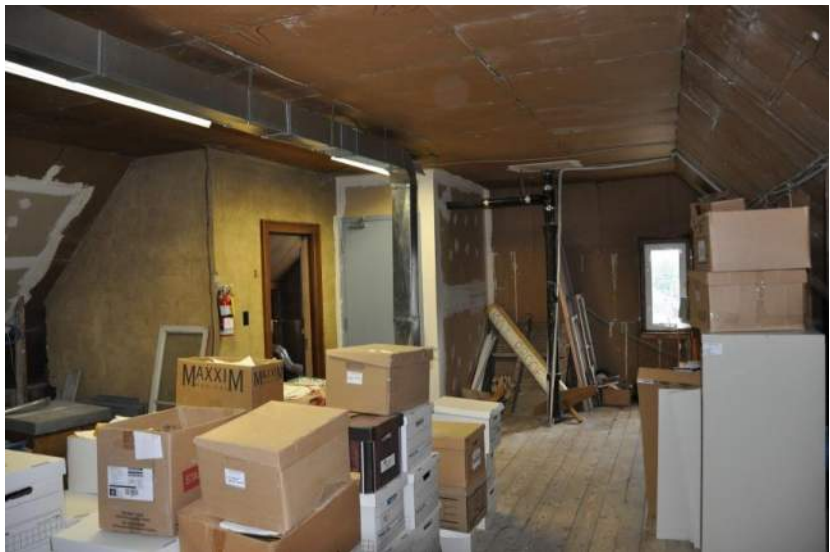
4.1.5.3.F - Attic

The basement and attic areas have been left unfinished except for mechanical and fire safety improvements.

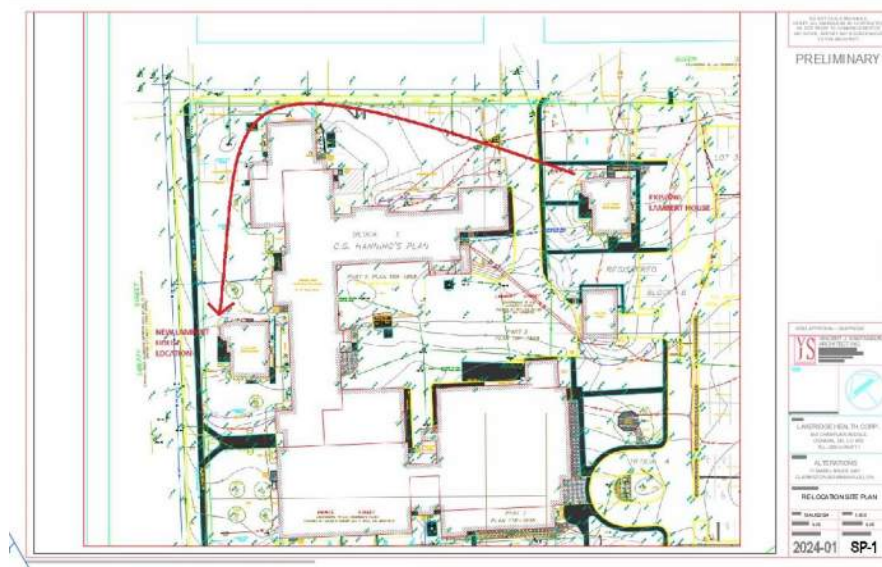
8.2.2.A –Site Plan – Building Re-location (note: not illustrative of building moving route.)

Whereby the Lambert House will be re-located to a new location on the property; set on a new foundation and mothballed pending work on the new Hospital:

- xv) construct new block foundation to match perimeter foundation wall;
- xvi) install internal basement steel beams and columns and pads;
- xvii) install foundation drainage protection and weepers;

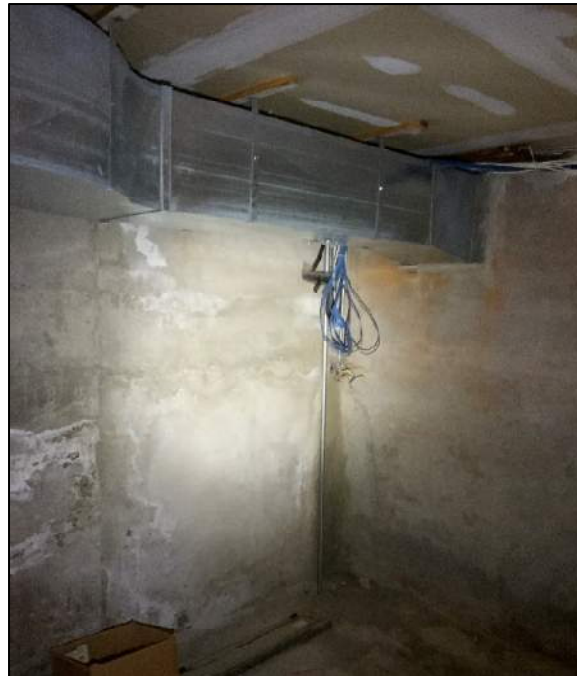
The basement is generally in good condition. Some efflorescence was noted on the exterior walls, indicating an ongoing water ingress through the foundation walls.

Photograph 2: Exterior foundation wall (typical)

The medium concrete scaling does not appear to have compromised the structural integrity of the foundation walls.

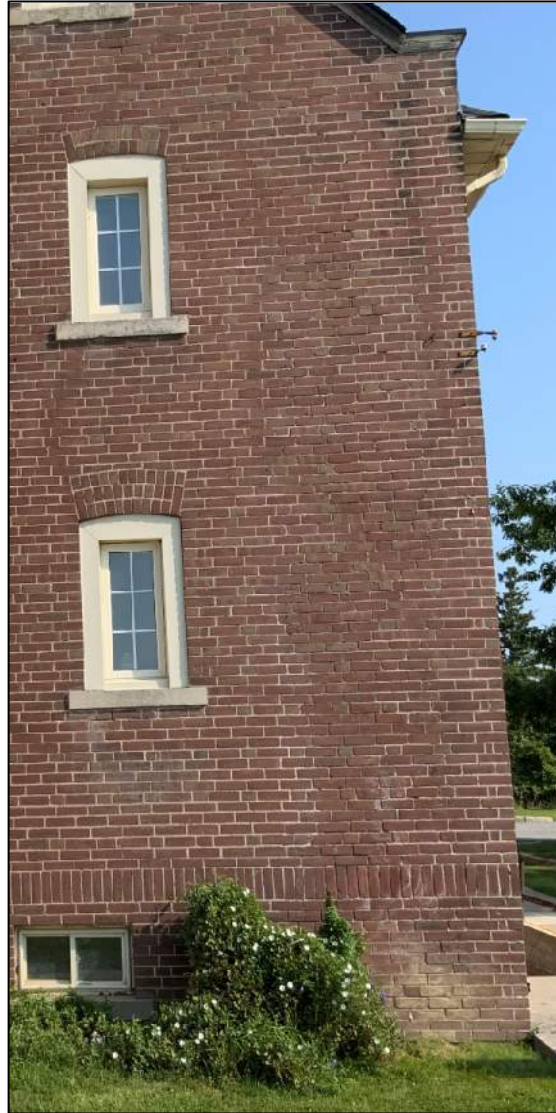
The exterior masonry is in generally good condition, with localized areas in fair condition. Medium mortar deterioration was noted on the south elevation near the east corner.

Photograph 3: Mortar deterioration at south elevation, east corner

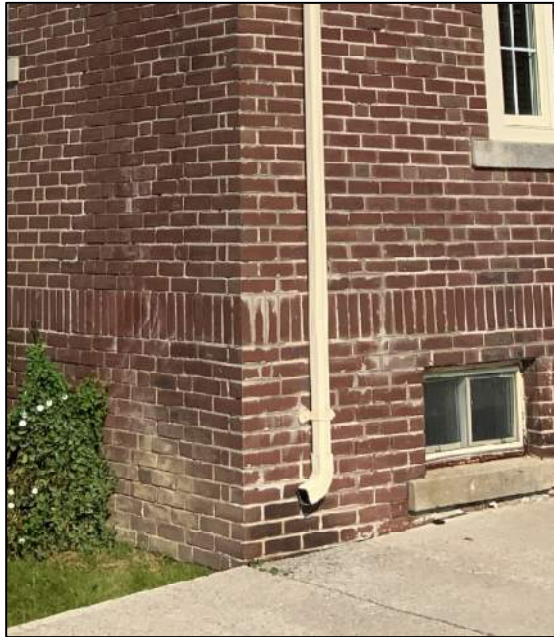
Poorly executed masonry repairs were noted on the east elevation at the south corner, including cut out head joints that extend into masonry units above and below and incompatible mortar. Similar conditions were noted on the east elevation at the north corner and on the north elevation at the upper east corner.

Photograph 4: Poorly executed masonry repairs (typical)

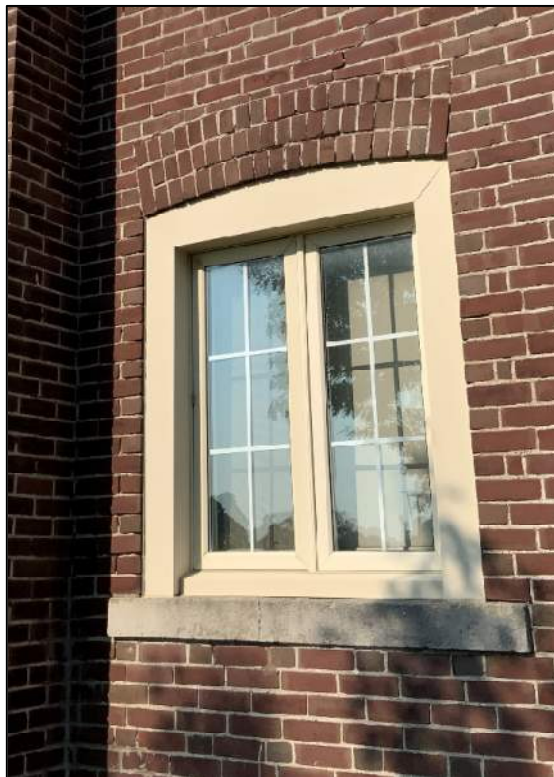
Medium mortar deterioration is visible at several lintels at various locations, including the loss of mortar in some head joints.

Photograph 5: Lost mortar in head joints of arch (typical)

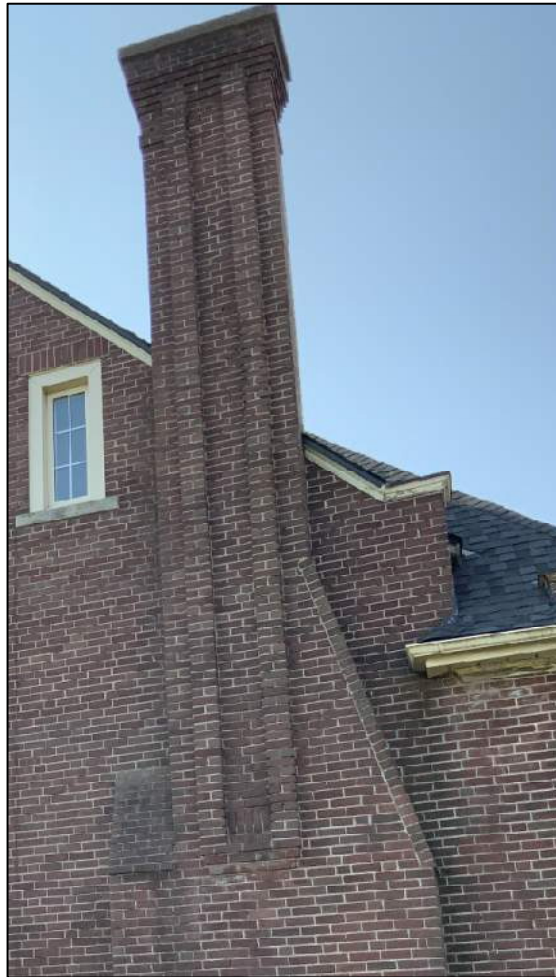
The tall narrow chimney on the north elevation appears to be generally in good condition with some localized head joints deteriorated.

Photograph 6: Chimney, north elevation
