ROY HOUSE FARMSTEAD

HERITAGE IMPACT ASSESSMENT

2774 Concession Road 6, Clarington, Ontario

Final: June 7, 2024

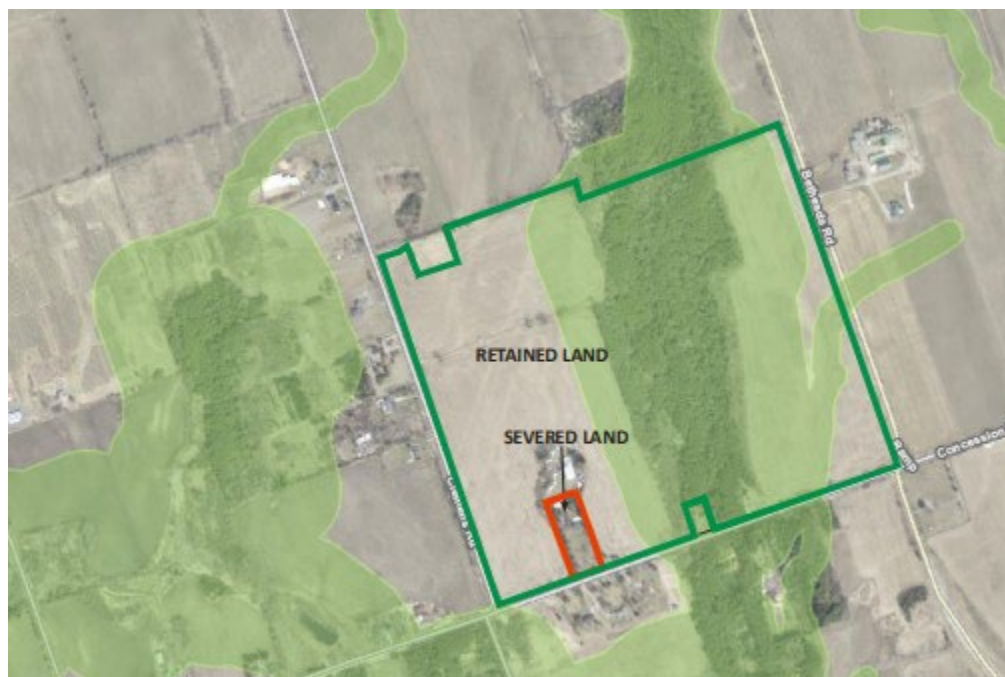
Figure 1: Site map showing proposed severance (Clark Consulting Services, 2023)

The proposed severance includes most of the farmstead, including the traditional driveway, landscaped lawn area, and farmhouse dwelling. It does not include the northernmost barn, which is proposed to stay with the consolidated farm parcel to support the ongoing agricultural operation. The proposed severed residential parcel measures 0.926 hectares (2.3 acres).

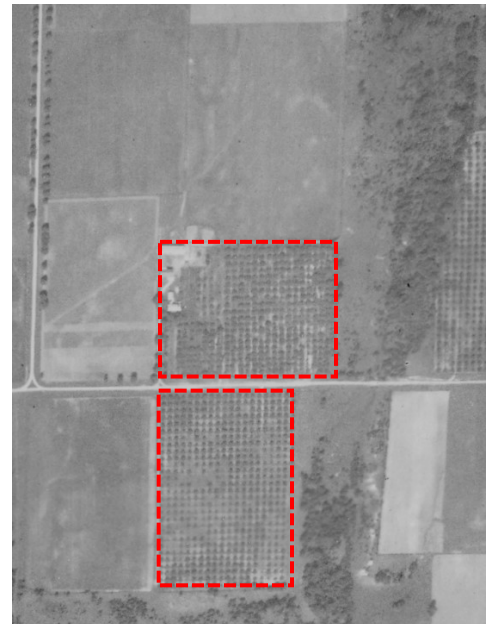
Figure 5: Aerial photograph 1927 showing large apple orchards.

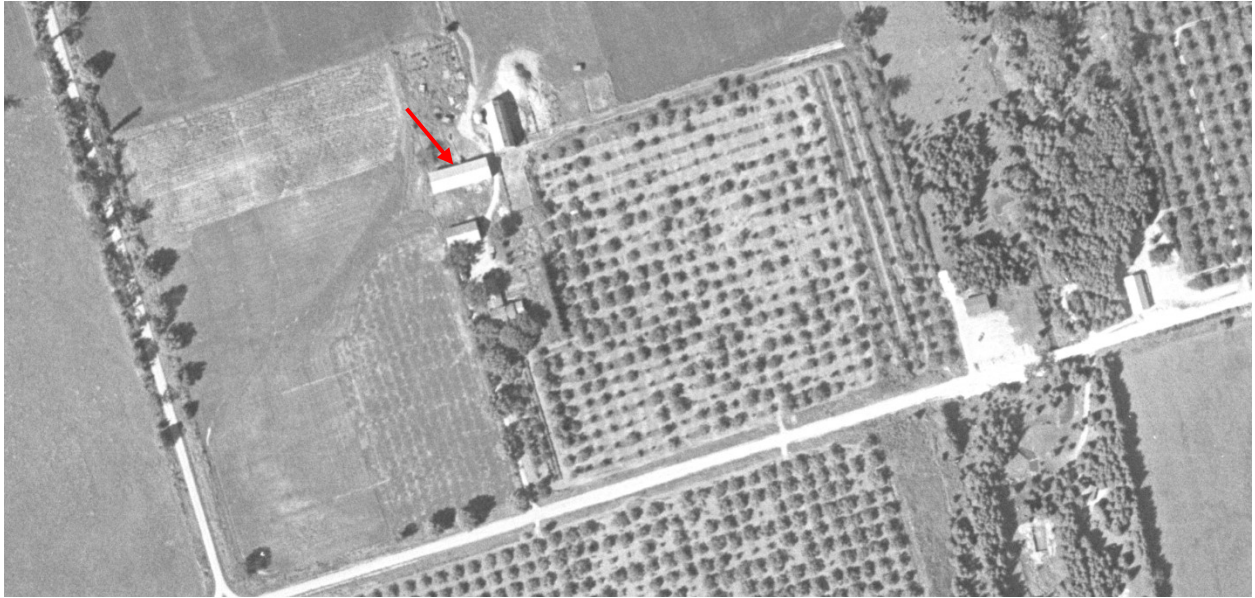
Figure 7: Aerial photograph 1960 showing apple orchards and an additional barn, no longer extant.

By the 1950s a large barn was built to the rear of the farmstead to support dairy operation. The second large barn or implement shed is visible in the aerial photograph from September 1960 but is no longer standing (Figure 7).

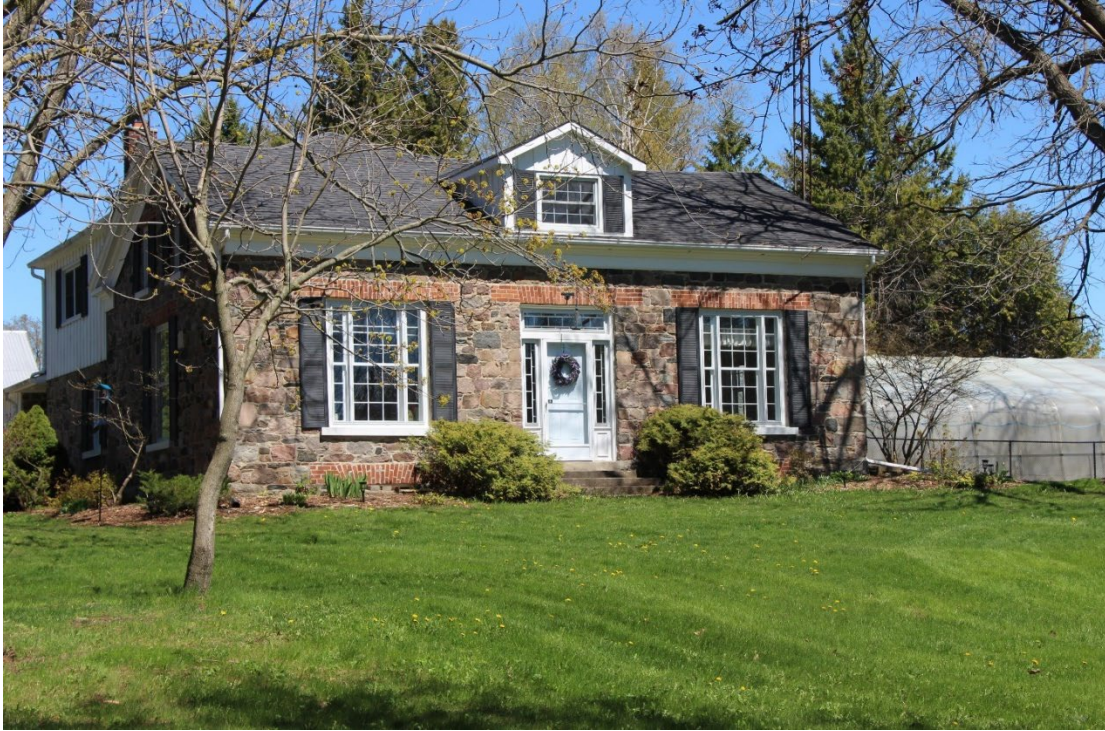
Figure 9: Fieldstone farmhouse on approach from driveway. (May 2024)

The farmhouse is constructed of a dressed field stone masonry façade with minimally dressed rubble stone side walls (and presumably the rear/north wall, of which only a portion appears to remain).

The existing condition of the fieldstone farmhouse appears to be good. There is no evidence of structural issues, or the farmhouse appears to be well maintained. There is evidence of inappropriate mortar repairs to the fieldstone walls, but fortunately, there does not appear to be any resulting damage to masonry units. The asphalt shingle roof

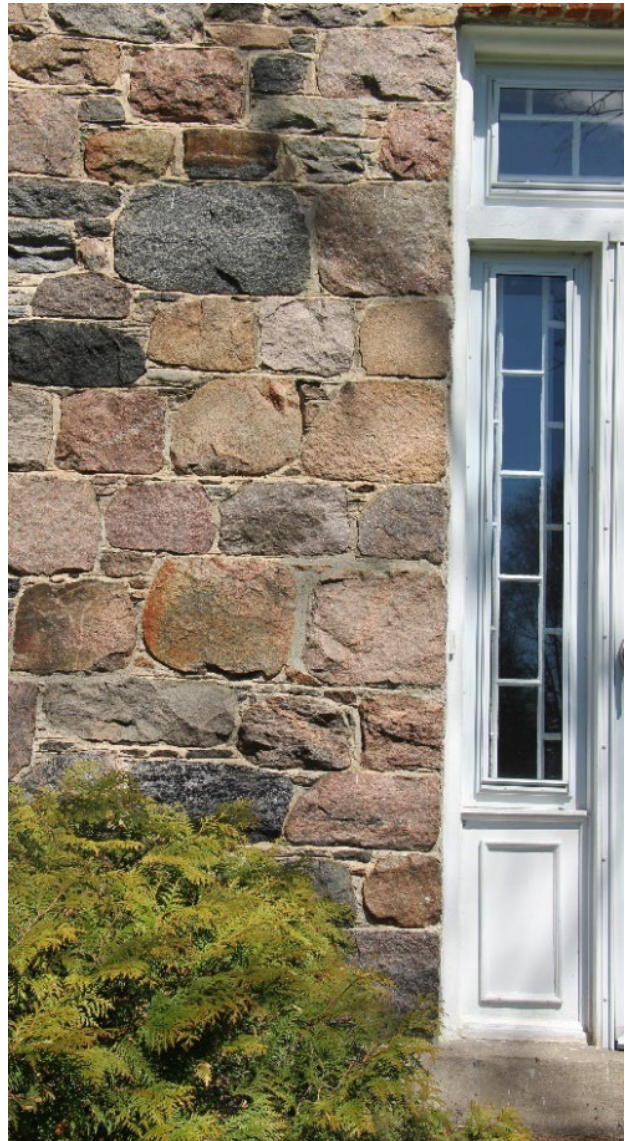
Figure 10: Fieldstone detail. (May 2024)

The geology of the area is characterized by drumlins, creating rolling hills of varying aggregate materials south of the Oak Ridges Moraine but north of the plains adjacent to Lake Ontario. The field stone material appears identical to other field stone buildings in the immediate vicinity of the subject property, and it is likely that the materials were gathered on site or nearby. Most of the stones appear to be granite in various colours.

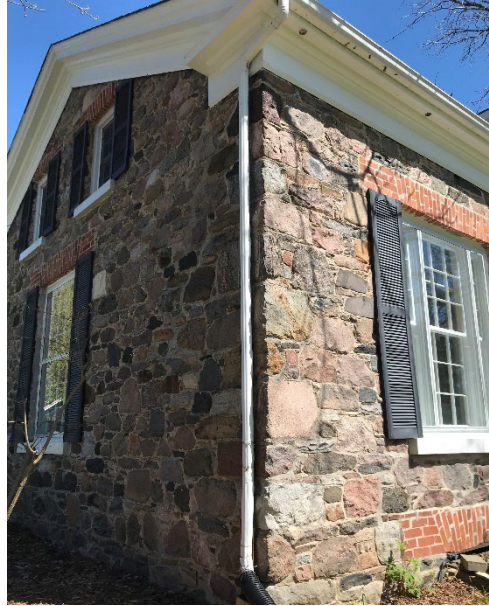
Figure 11: Southwest corner showing "boulder quoins". (May 2024)

On the façade, the fieldstones are coursed approximately every 18", with larger boulders used near the foundation and corners. These could be considered "boulder quoins".

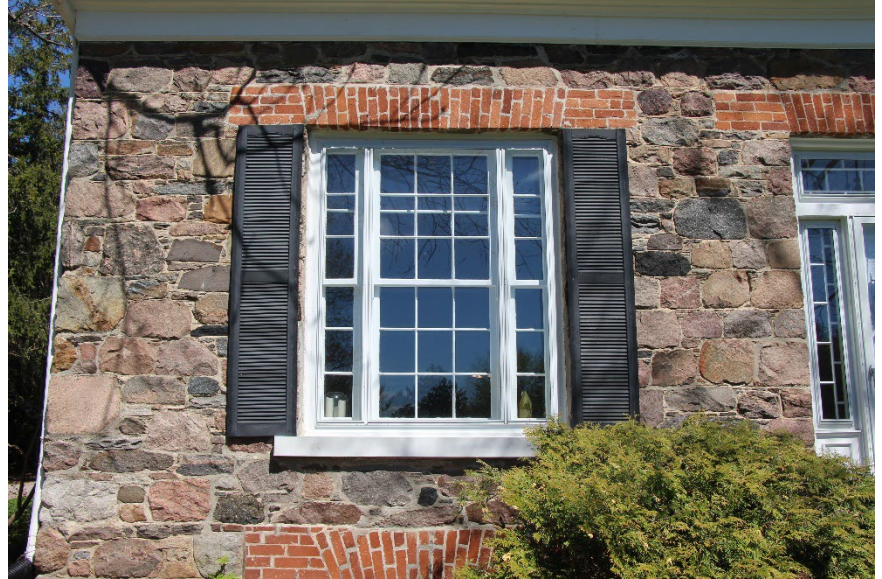
Figure 12: Detail of original tripartite window. (May 2024)

The other two original windows exist on the front façade, discussed in detail below (see Figure 12).

These large, tripartite windows show variations in the glass panes indicative of their age and are arranged in a 9 over 9 pattern on the central sash and 3 over 3 on the side sashes. All three windows appear to have been operable vertically sliding sash windows, although they are currently inoperable and protected by an immovable exterior storm window.

The original windows, which are in relatively good condition for their 170+ year age are not currently operable and are reported to be draughty in winter. It is recommended to retain a skilled heritage carpenter to carry out any necessary repairs and/or adjustments so that they fit snug in their frames and therefore have improved thermal performance and are functional. The replacement of the modern inoperable storm windows with period-appropriate functional storms is also recommended to both improve thermal performance and to allow the normal operation of the original sash windows.

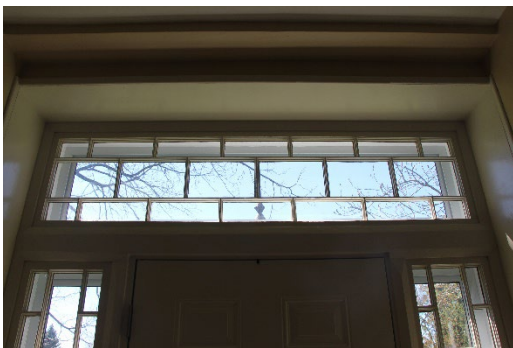
Figure 14: Interior view of original transom detail. (May 2024)

The centrally located front door has a rectangular transom light and sidelights with “Chinoiserie” pattern; both of which appear to be original.

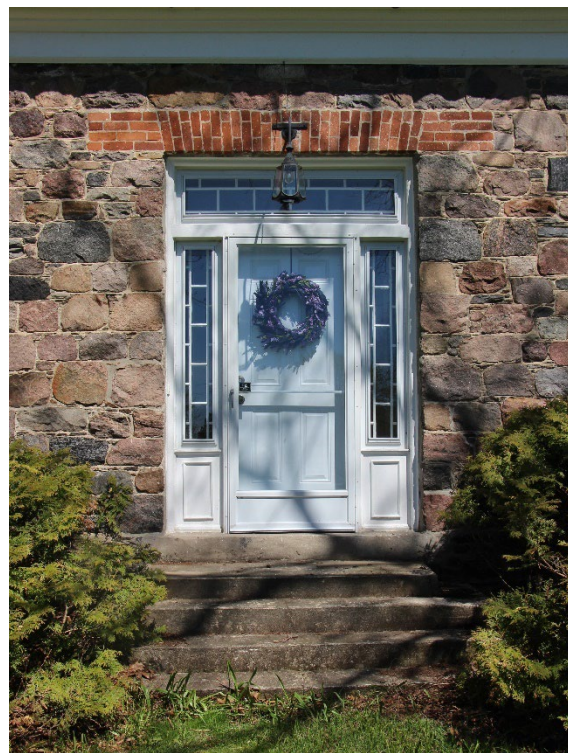
Figure 13: Centrally located front door with original transom and sidelights. (May 2024)

Original windows and doors appear to have been wooden. Windows were wooden, including frames and sills. Sills have been flashed with aluminum. No evidence of original exterior doors is available, but the original wooden door surround is extant (see Figure 13).

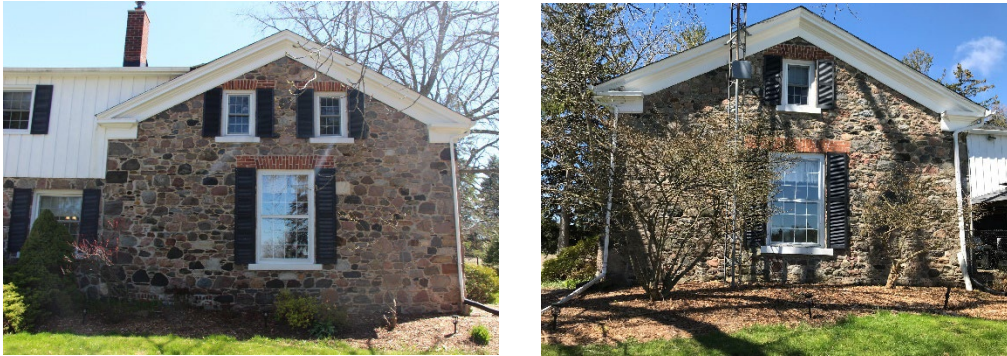
Figure 15: West elevation, left, has two windows on the upper storey; and east elevation, right, has one. (May 2024)

The east elevation has only one window on the second story, but the west elevation features two. This may be related to the view of the property from Clemens Road, where the west elevation is visible. The east elevation is not visible from the public realm.

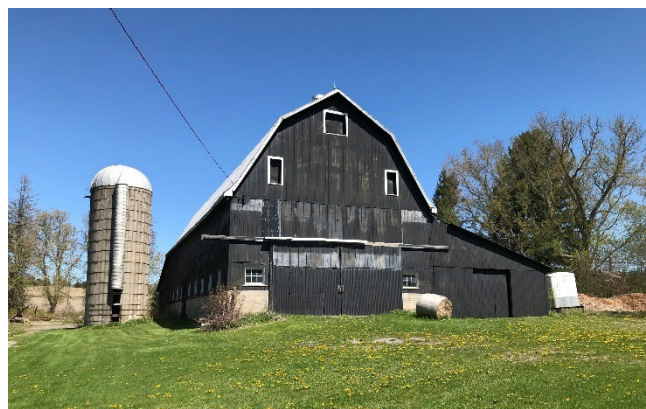
*Figure 16: 1950s gambrel roof dairy barn.
(May 2024)*

Three barns currently exist on the property: a small garage at the head of the driveway that is partially collapsed and appears to be post WWII construction, a 1950s gambrel roof dairy barn with silo, and a third barn clad in aluminum and located close to the farmhouse.

The small garage is in poor condition and partially collapsed. The small barn's condition is unknown, as it is obscured by aluminum cladding on the exterior and stored items within. If the barn has been appropriately maintained, it is likely to continue to stand for a long time, based on the strength of the suspected construction materials (i.e., full log beams). The 1950s dairy barn appears to be in sound condition and well maintained.

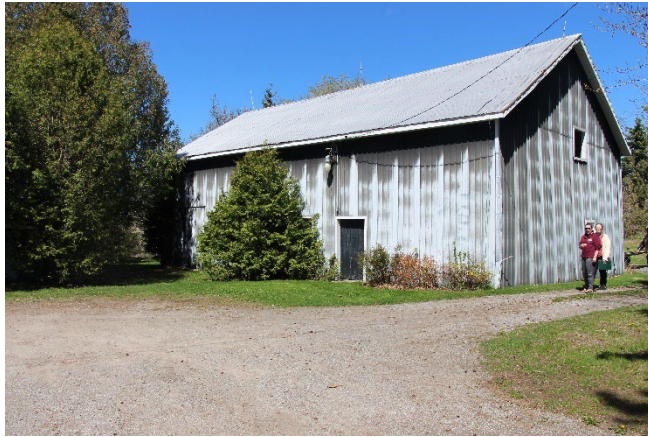
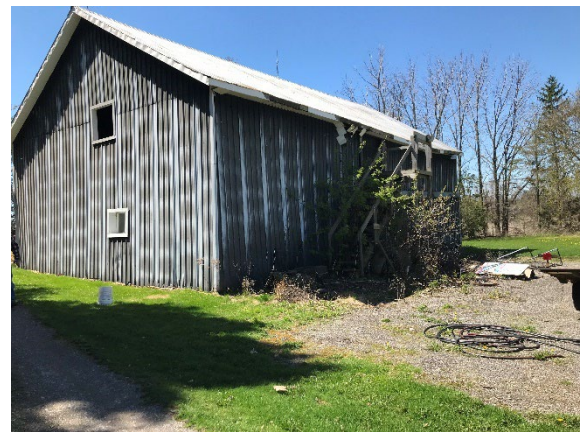
Figure 17: Possibly original barn now clad in aluminum. (May 2024)

At first glance the barn clad in aluminum appears to be post WWII construction, but on further examination it may be the farm's original barn. It is an appropriate scale and orientation for a pre-1860 barn,

although possibly slightly taller today due to renovations. The structural stability of the barn is unknown, and interior access was not possible, but there is evidence of full logs used in the construction of its frame.

Many of the larger (and likely later construction) barns of the area are constructed of wood frame with fieldstone foundations. There is no evidence of a fieldstone foundation on this barn, and it appears to be a typical English barn of the mid-1800s constructed of frame and log.

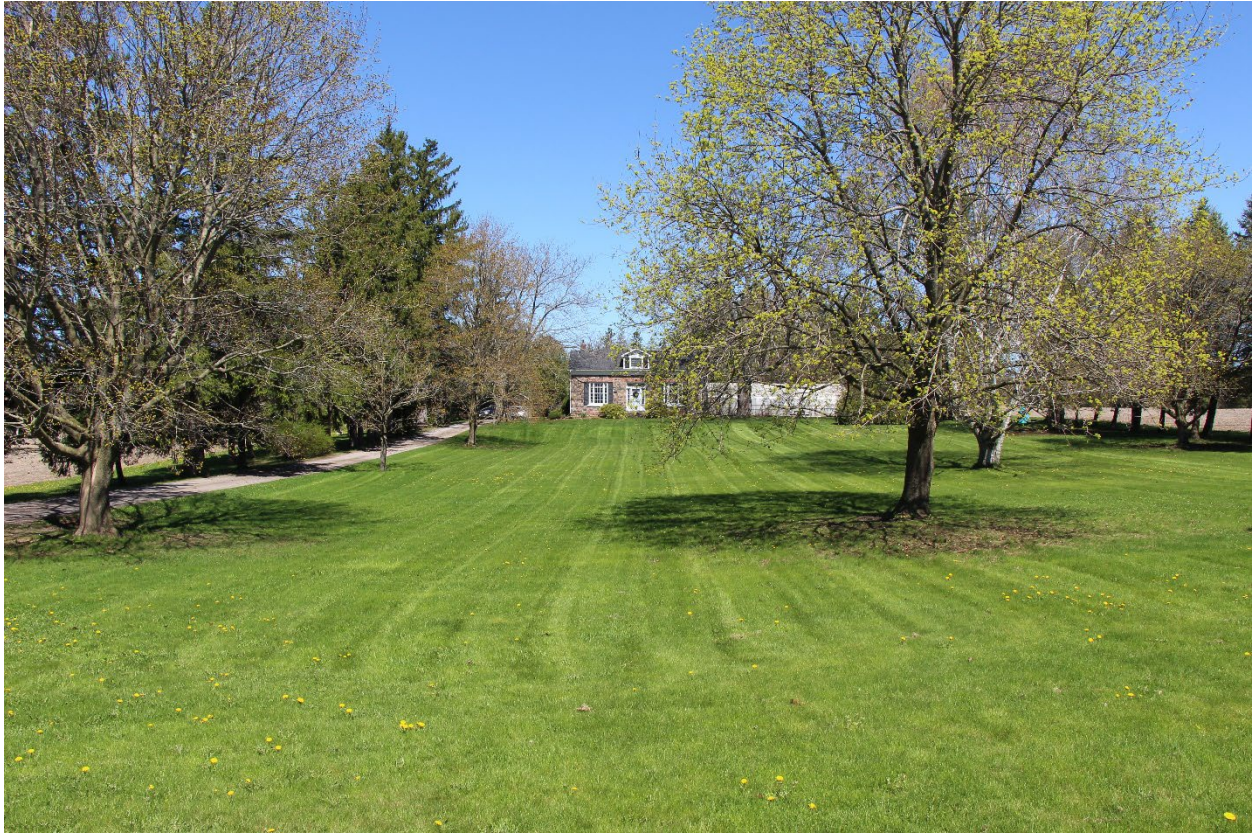
Figure 18: Dwelling from the public realm/Concession Road 6. (May 2024)

The location of the farmhouse within the farm parcel is a key aspect of its Regency/Picturesque features. The farmhouse faces south, toward the Concession Road, at the end of a long driveway. From the roadway the farmhouse appears low and horizontal, a Regency characteristic.

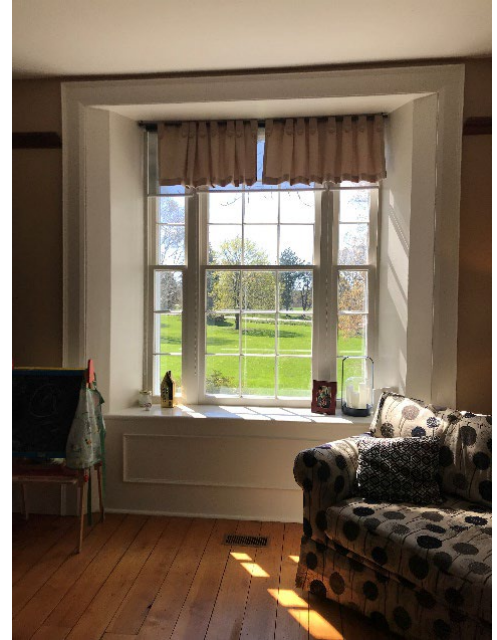
Figure 19: Interior view from southwest, likely original, window. (May 2024)

In total, five ground floor windows appear to be original. Ground floor windows on the side and rear elevations are vertically sliding sash windows, with panes arranged in a 12 over 12 pattern. These windows are found on the west, east and north elevations of the farmhouse.

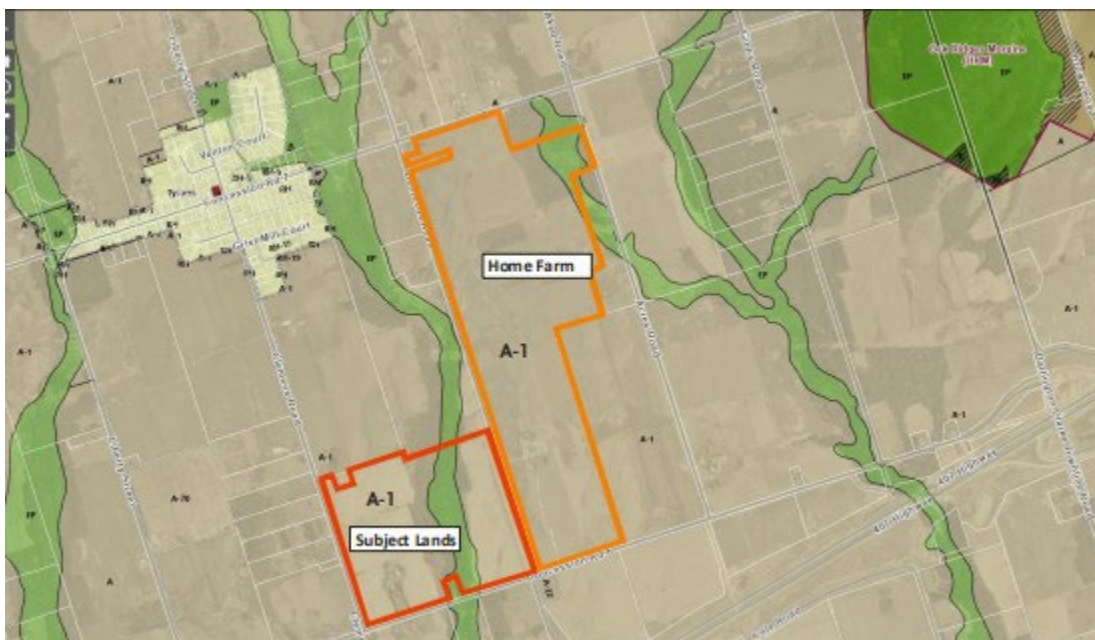
Figure 17: Farmland consolidation. (Clark Consulting Services, 2023)

In this case, the owners propose severing the farmstead from the surrounding agricultural lands, which will be consolidated with farmlands to the immediate east, across Bethesda Road, per the image below.
