Re: Budget Decision on the Cafeteria Building at Camp 30

Prepared by GBCA

Goldsmith Borgal & Company Ltd Architects

3.1 CONDITION REVIEW - CAFETERIA/DINING HALL

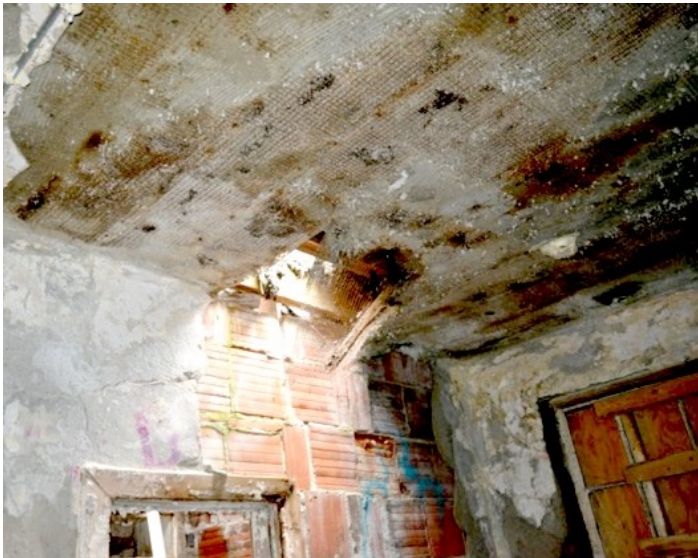
Mold apparent in lath and concrete ceilings.
