Tree Inspection & Assessment of Red Oak, 21 Beech Street, Bowmanville, Ontario

September 22, 2020

Prepared for: Ken Mercer
Supervisor
Public Works Department
Municipality of Clarington
40 Temperance Street
Bowmanville, ON
L1C 3A6

Prepared by: Michael Richardson
Ontario Line Clearing & Tree Experts Inc.
7790 Telephone Rd
Cobourg, ON
K9A 4J7

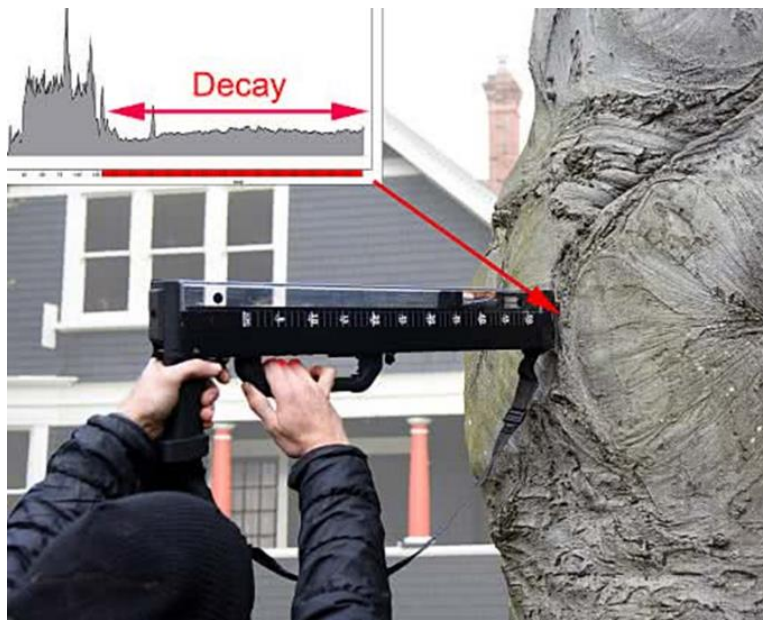
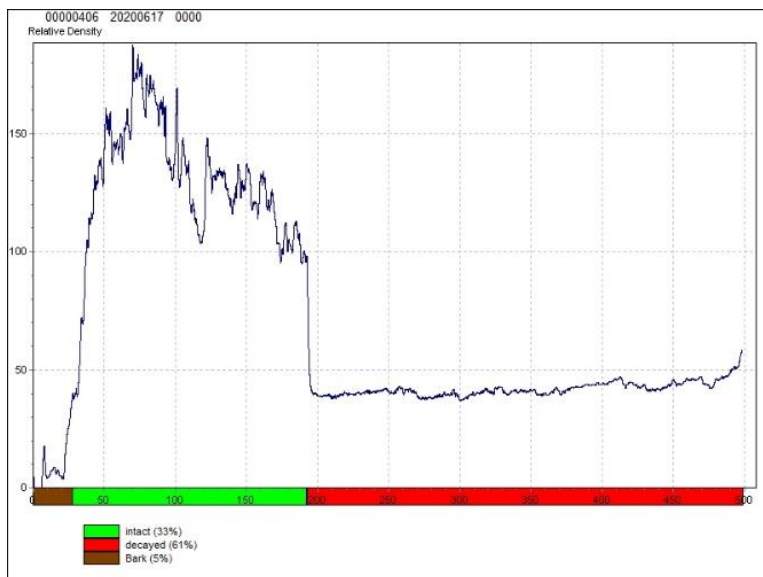
Resistance drilling confirms the decay is centrally located and there is a solid intact shell wall.

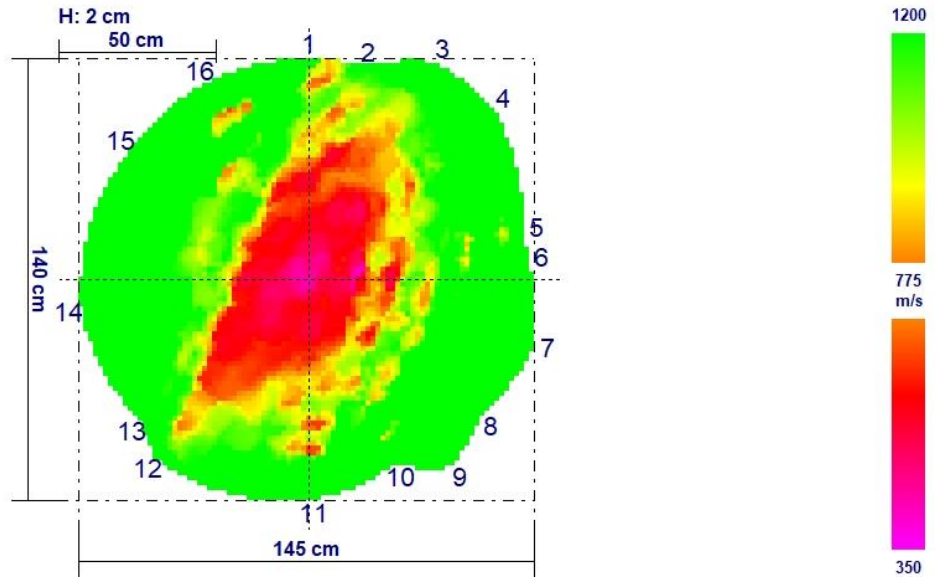
The tomogram shows loss of solid wood in the cross-section primarily progressing from the center (pith) area towards the edge. Green indicates solid wood while yellow indicates incipient decay and reds and purple complete loss of physical structure.

Central heartwood decay is expected and typical of large old oaks.

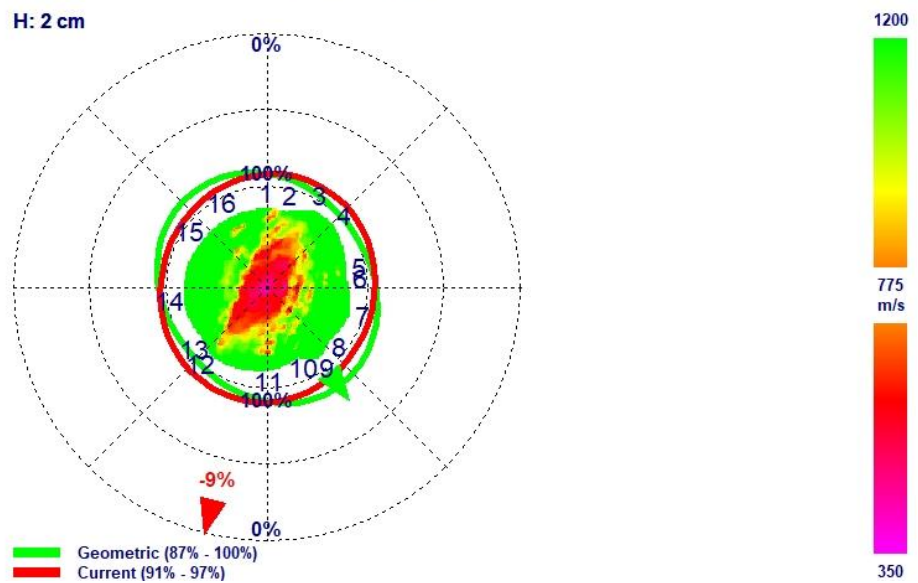
The second tomogram image indicates a maximum loss of 9% of the load carrying capacity of the cross-section as compared to the geometrically same cross-section with no decay.
