MUNICIPALITY OF CLARINGTON

TRIAGE REPORT FOR
INSPECTION – RINK REFRIGERATION & PAD
ORONO ARENA & COMMUNITY CENTRE

2 PRINCESS STREET, ORONO, ON

SEPTEMBER 23, 2020

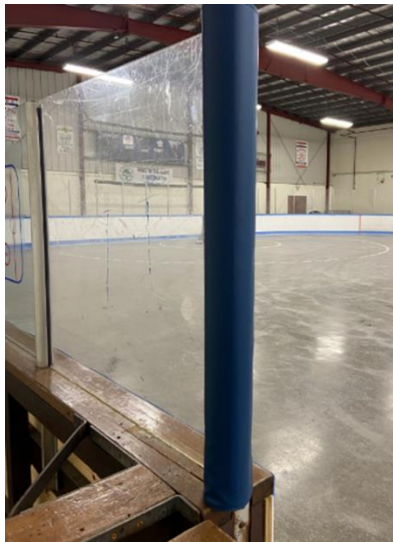
Figure 11: Ice rink boards and glass

- Boards and glass are aging, with some plexiglass scuffing, as well as distorted wood tops and cracking around the players bench.
- Some corrosion of the metal frame is noted on the metal around the doorways into the rink zone.
- Portions of the wooden boards show signs of being replaced recently, but serious wear can be seen near foot level in places.
- Board facings show significant waviness, likely as a result of moisture issues with the wooden components underneath.

Category	Recommended Action
Immediate Actions	
Short-Term Actions	<ul style="list-style-type: none"> • Consider replacing portions of wooden boards that show significant wear near foot level.
Capital Expenditure Planning	<ul style="list-style-type: none"> • Plan to replace the ice rink boards and glass at the same time as the floor replacement. <ul style="list-style-type: none"> ○ I.B. Storey Inc. recommends a modern board system with an aluminum frame to resist metal corrosion and provide flexibility for safety, along with a soft protective plastic piece along the caprail before the glass to prevent player injury and curved terminations for enhanced safety.
