MUNICIPALITY OF CLARINGTON

*TRIAGE REPORT FOR*  
INSPECTION – RINK REFRIGERATION & PAD  
NEWCASTLE MEMORIAL ARENA

103 CAROLINE ST. W, NEWCASTLE, ON

SEPTEMBER 23, 2020

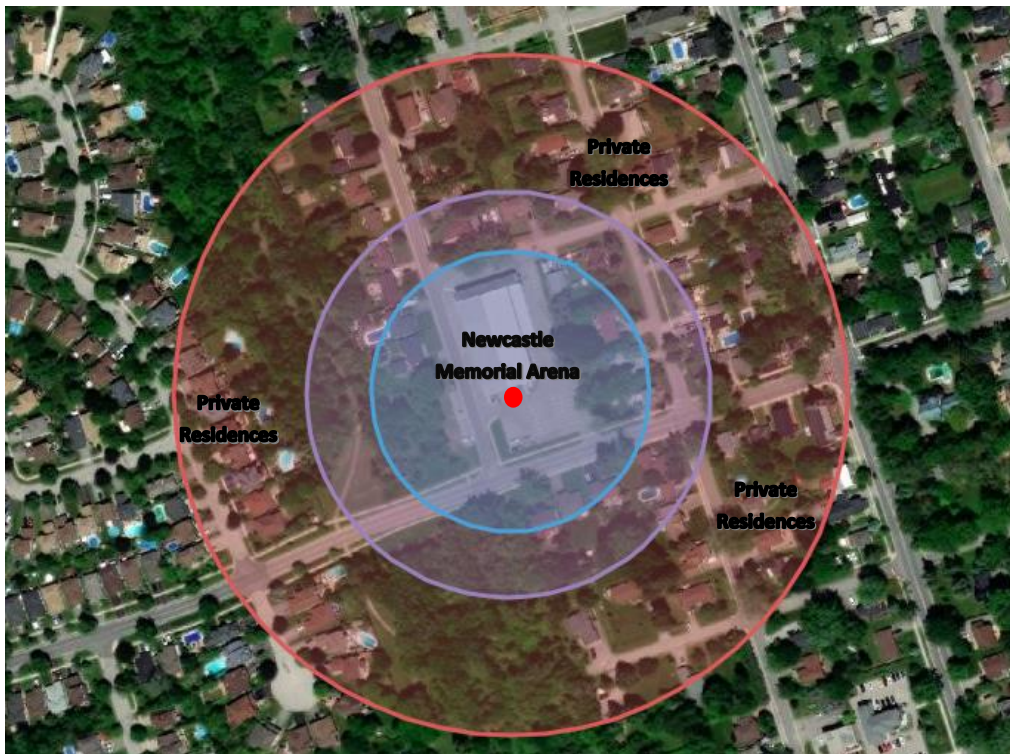
Figure 17: Health and safety danger ranges for visualization and decision-making.

- IDLH range does not factor in wind distribution and refrigerant charges have been estimated as no detailed signage is available. These ranges are presented for visualization and decision-making purposes only.

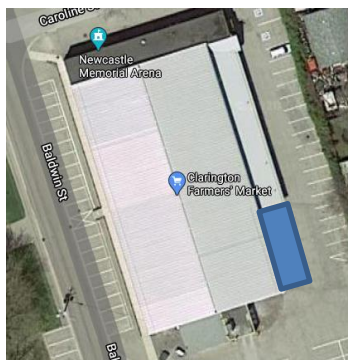
The building currently has 4 dressing rooms, while 6 dressing rooms is the current standard. It is recommended that two additional dressing rooms be added onto the building as part of any building overhaul.

Figure 18: Building overview with recommended dressing room addition in blue.
