# Camp 30/Bowmanville Boys School Bowmanville

## Stabilization & Security Measures Report for Building 5 - Cafeteria Hall

October 2024

Prepared by GBCA

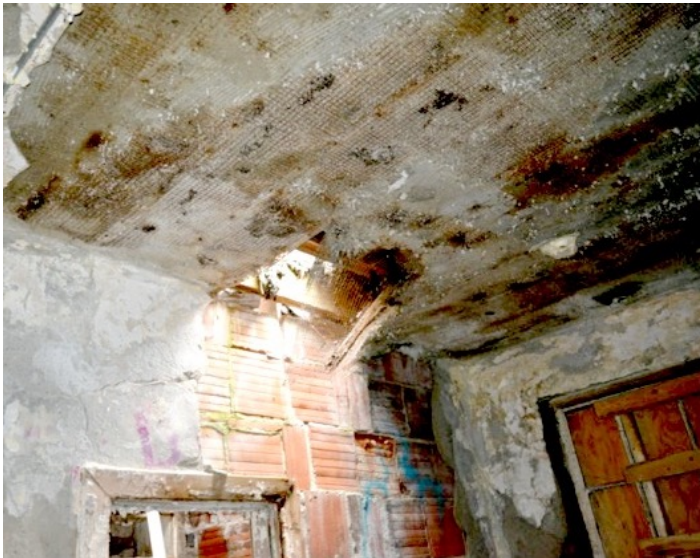
Mold apparent in lath and concrete ceilings.

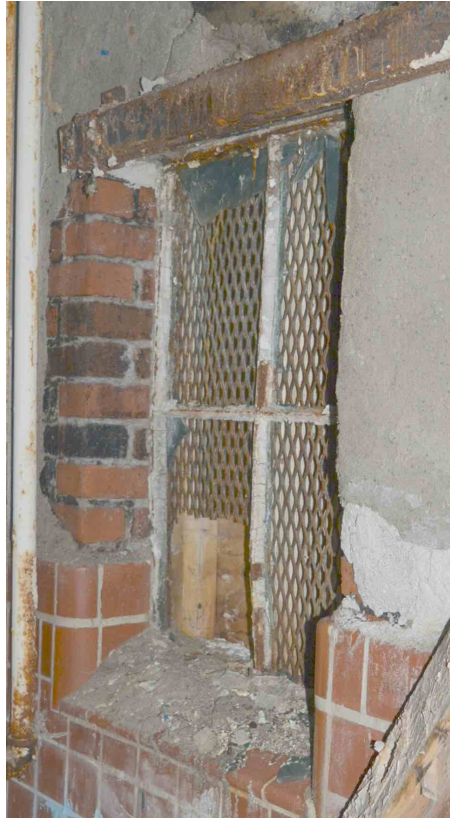
Metal basement window with metal barrier and typically sloped sill.
