Development Proposal Concerns

Concerns with Environmental Site Assessment Quality (O REG 153/04)

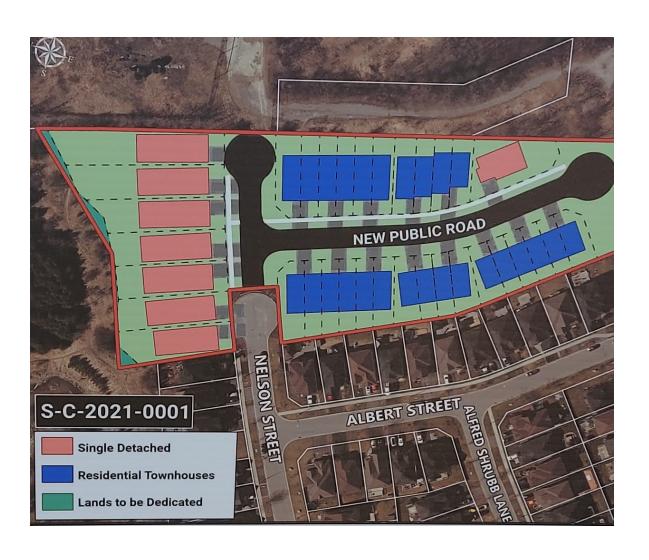
Proposed Plan Results in the Following:

- 26 Townhouse Dwelling Units
- 8 Single Detached Units
- Two Dead End Roads with single access point at the corner of Albert and Nelson Street.
- Increased Traffic and Noise. Potential of an additional 68+ Vehicles travelling down Albert / Nelson Street multiple times per day.
- Increased Safety Risk to Small Children in the existing Neighborhood

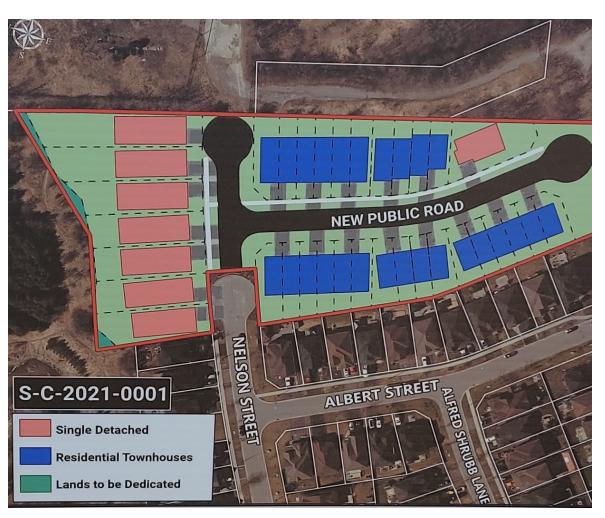
Recommendation 1:

- Replace the proposed residential townhomes with single detached units.
 - This would reduce the total number of units from 34 dwellings down to between 18-20 dwellings.
 - This would reduce traffic volume through Nelson and Albert Street by 50% vs. the current one proposed.
 - I believe this would align with the original plan submitted by the builder when the neighborhood was first constructed.

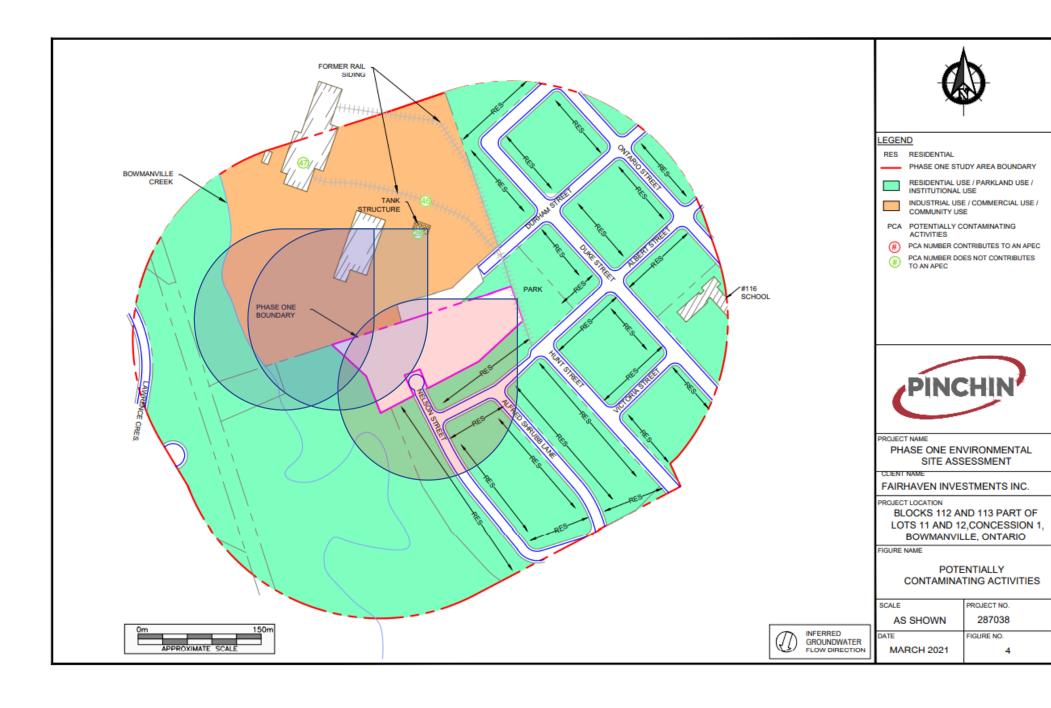
- In the report, Pinchin indicates that the topography in the area slopes in the "southwestern direction" and the unconfined groundwater flows in that same direction.
- All of the PCA's are identified as being "Upgradient/Transgradient"
- The map on the following slide shows the location of the PCA's relative to the phase 1 property.
- o I plotted a shaded area onto the map starting from a point on each of the PCA's in a "southwestern direction" to show where they intersect the phase one property.
- 2 out of 3 PCA's Identified are in relatively close proximity to the phase one property and would indicate the potential for contaminates/spills to flow onto/under the phase one property.
- o Despite this, the environmental site assessment concludes that there is low likelihood that any of the PCA's would have resulted in an area of environmental concern.

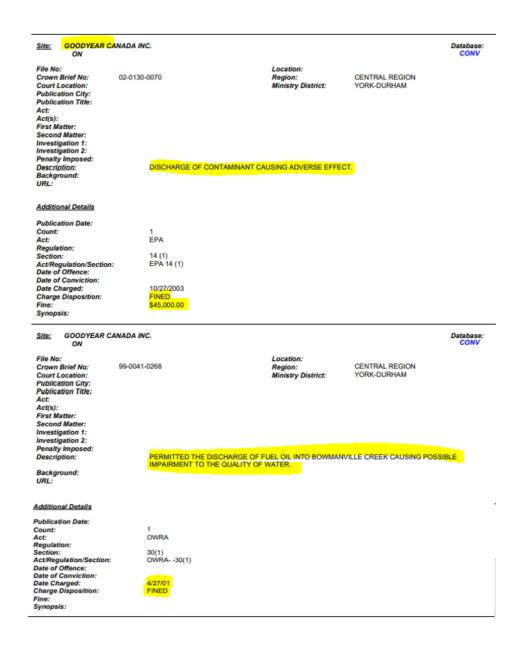
- This is another caption from the ERIS report that was also alarming as you can see in the highlighted text
 Significant Fines were imposed as a result of discharges of contaminates into the environment.
- Neither of these dates listed are aligned to dates of other spills that were discussed in the report and as such are presumed to be other significant spills not investigated in the report.
- ☐ I could not find anywhere in the ESA report where these incidents were discussed.

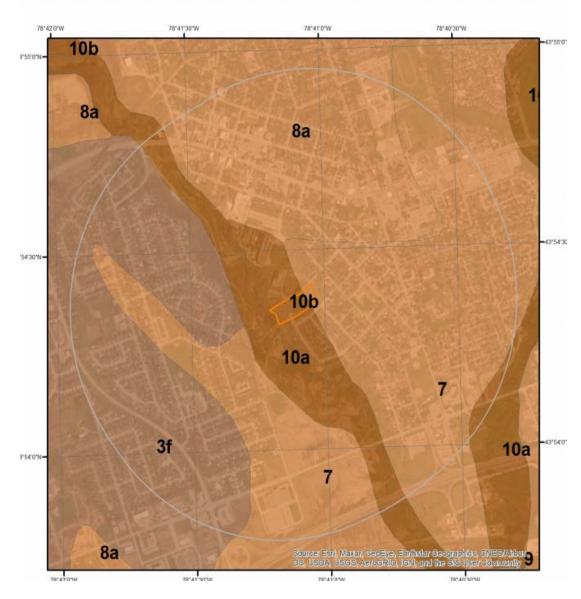
Unit ID 10a

Geological Deposit: River deposits
Deposit Age: Quaternary

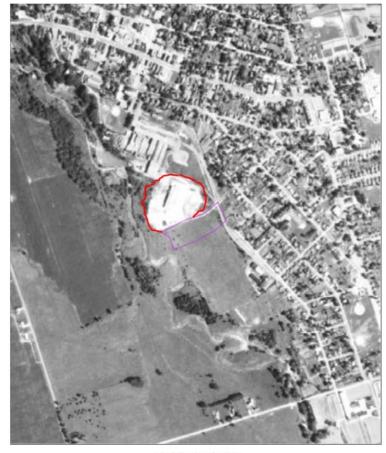
Aerial Photograph - 1964

Based on Ariel Photograph it Appears there was a lot of activity going on right up to the edge of the phase one property.
