Re: Budget Decision on the Cafeteria Building at Camp 30

Prepared by GBCA

Goldsmith Borgal & Company Ltd Architects

3.1 CONDITION REVIEW - CAFETERIA/DINING HALL

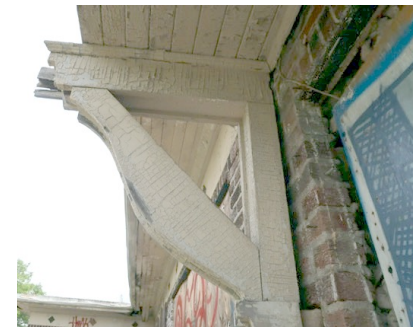
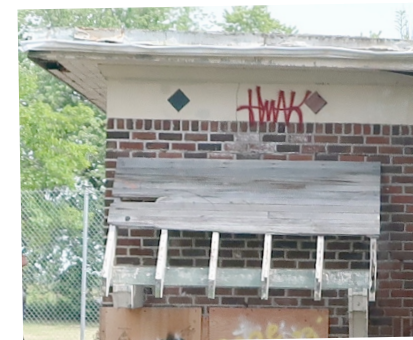
Wood canopy and bracket

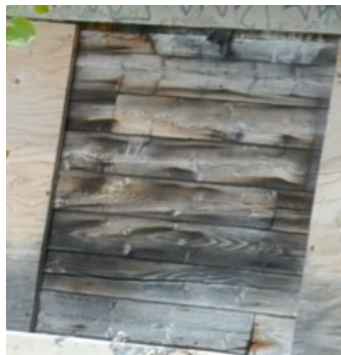
Example of horizontal wood siding on clerestories neglected to the point there is no paint remaining. It was noted that some boards have been removed or have come loose.

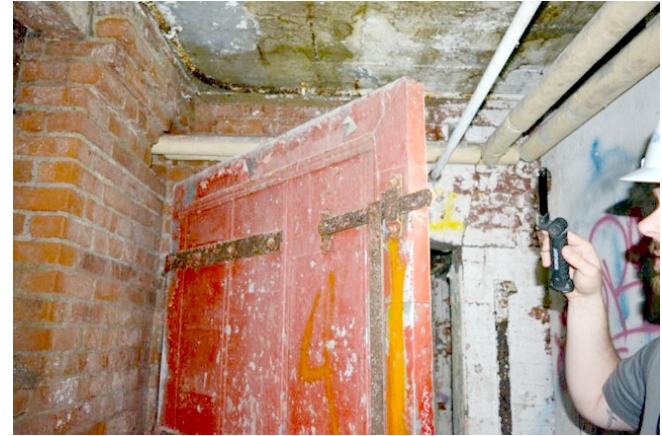
Metal door to the boiler room in the basement. A rectangular door in an arched opening.

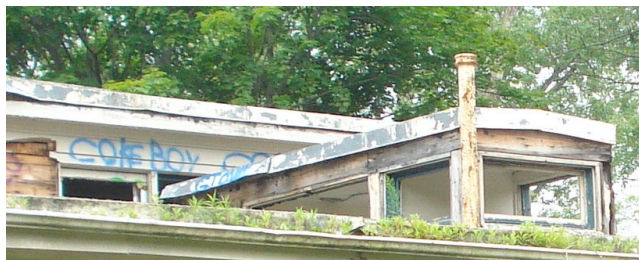
Small cupola as it appeared in 2014.
