# Camp 30/Bowmanville Boys School Bowmanville

## Stabilization & Security Measures Report for Building 5 - Cafeteria Hall

October 2024

Prepared by GBCA

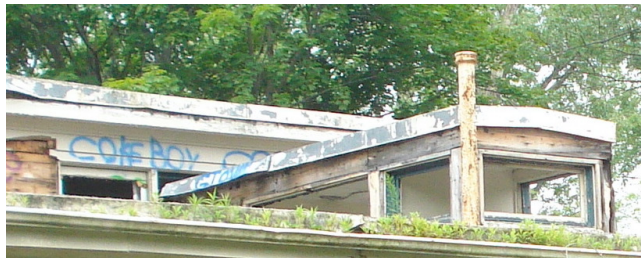
Small cupola as it appeared in 2014.

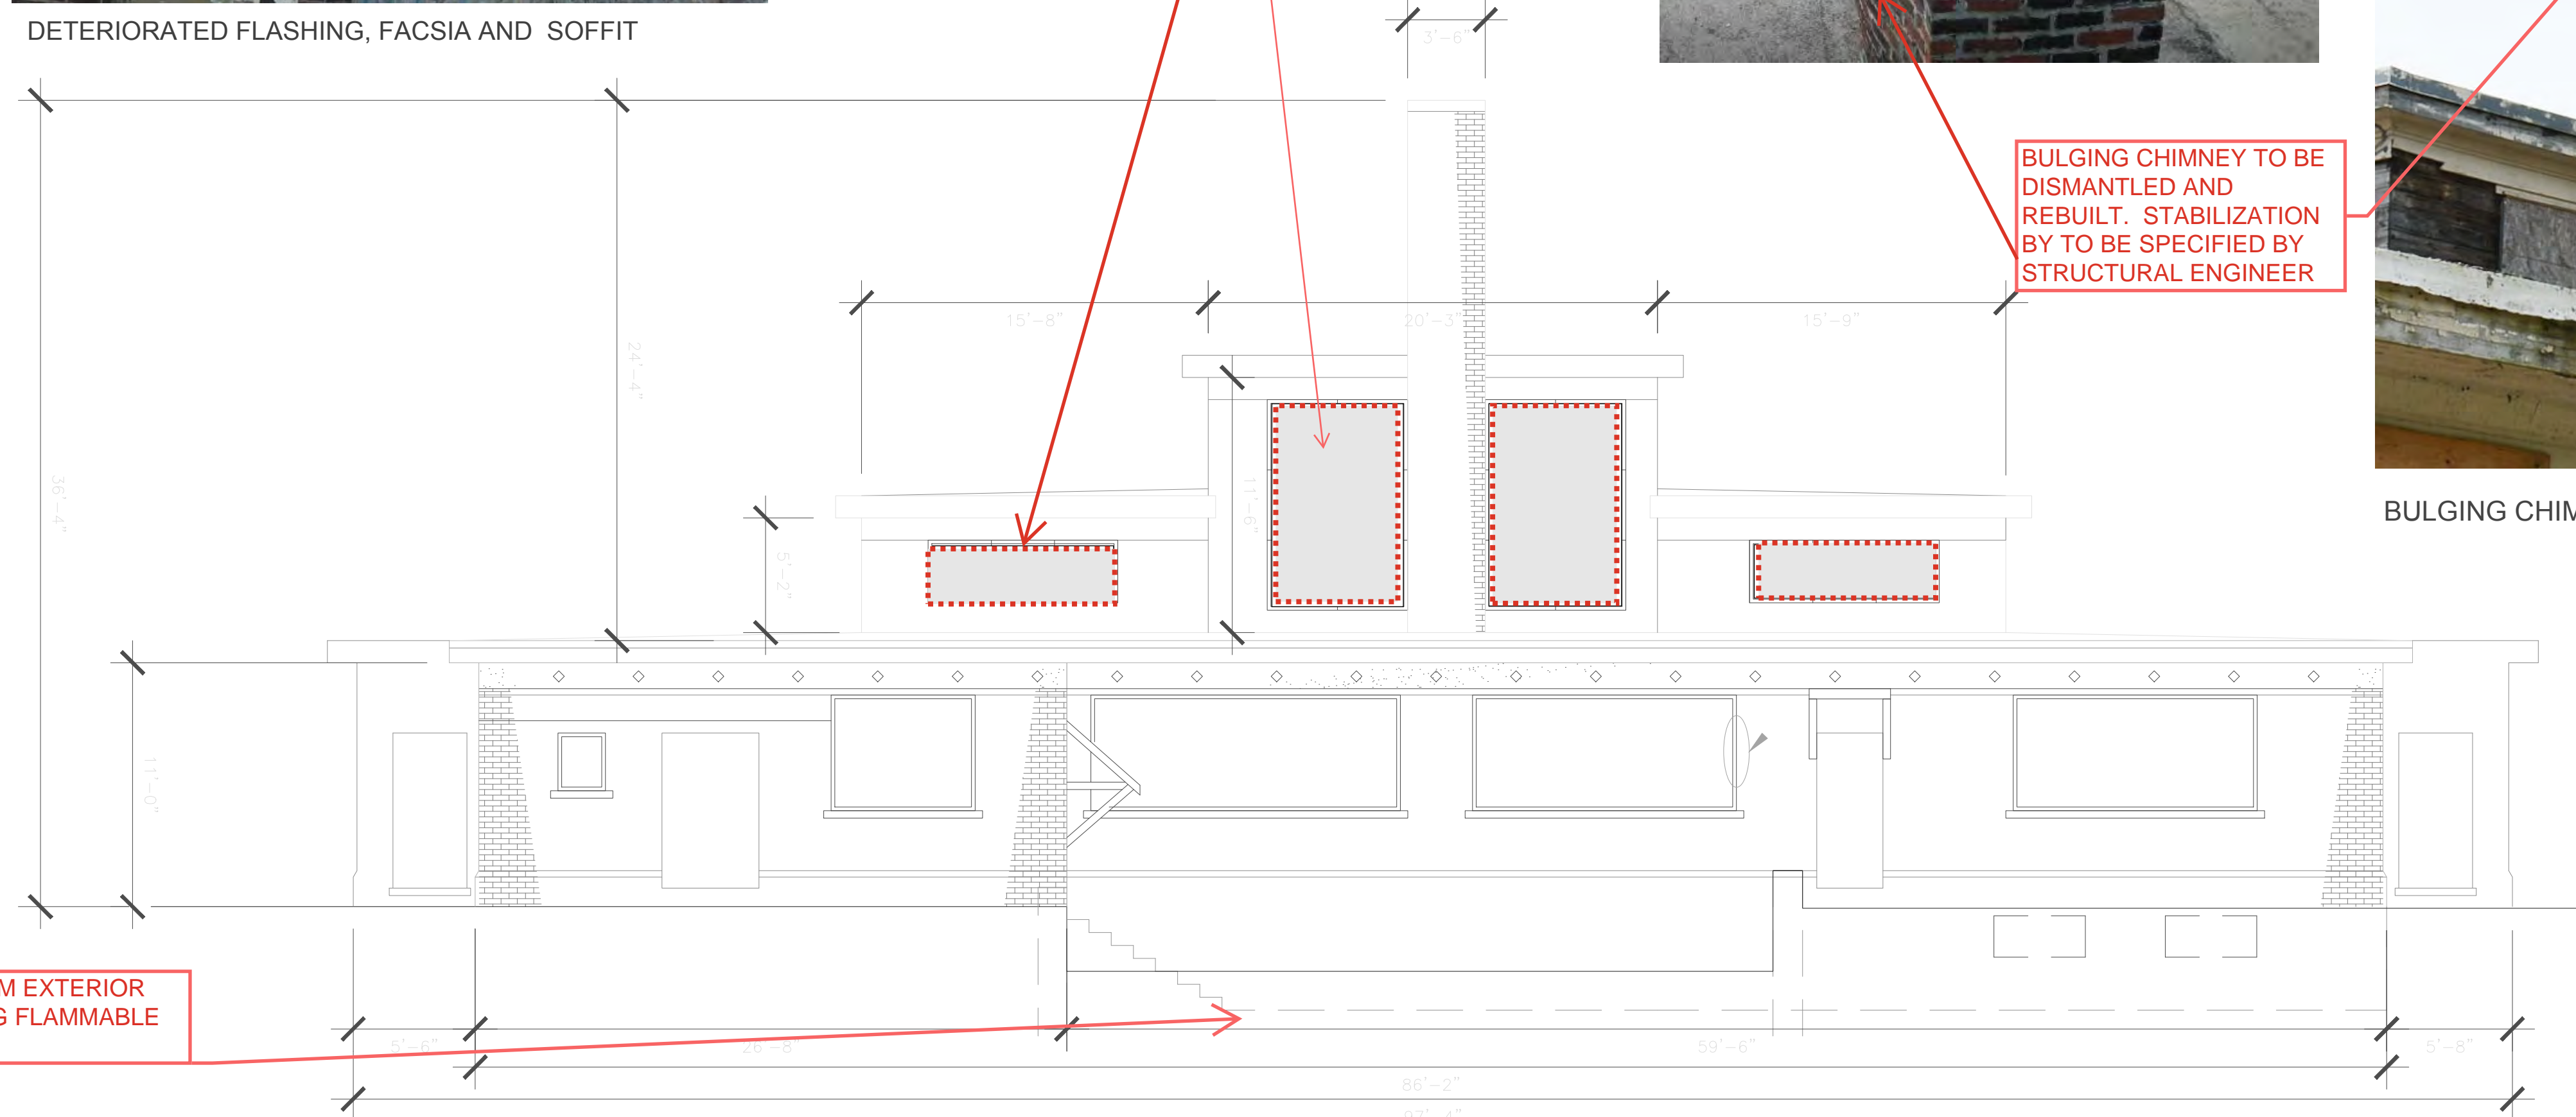
DETERIORATED CANOPY AND BRACKETS TO BE REMOVED AND STORED

REMOVE DEBRIS FROM EXTERIOR INCLUDING ANYTHING FLAMMABLE 100%
